Property: 123 Main Street, Anytown, NY  
Date: 15Jan2021  
Present: Louis Csak, insp.; ####, buyer; ### agent.  
Conditions: 40's, overcast

**Executive summary:** (details in report)

The house was not well maintained, and the garage foundation is beginning to show serious issues, and very likely there is a regular water occurrence that will eventually affect the main foundation badly.

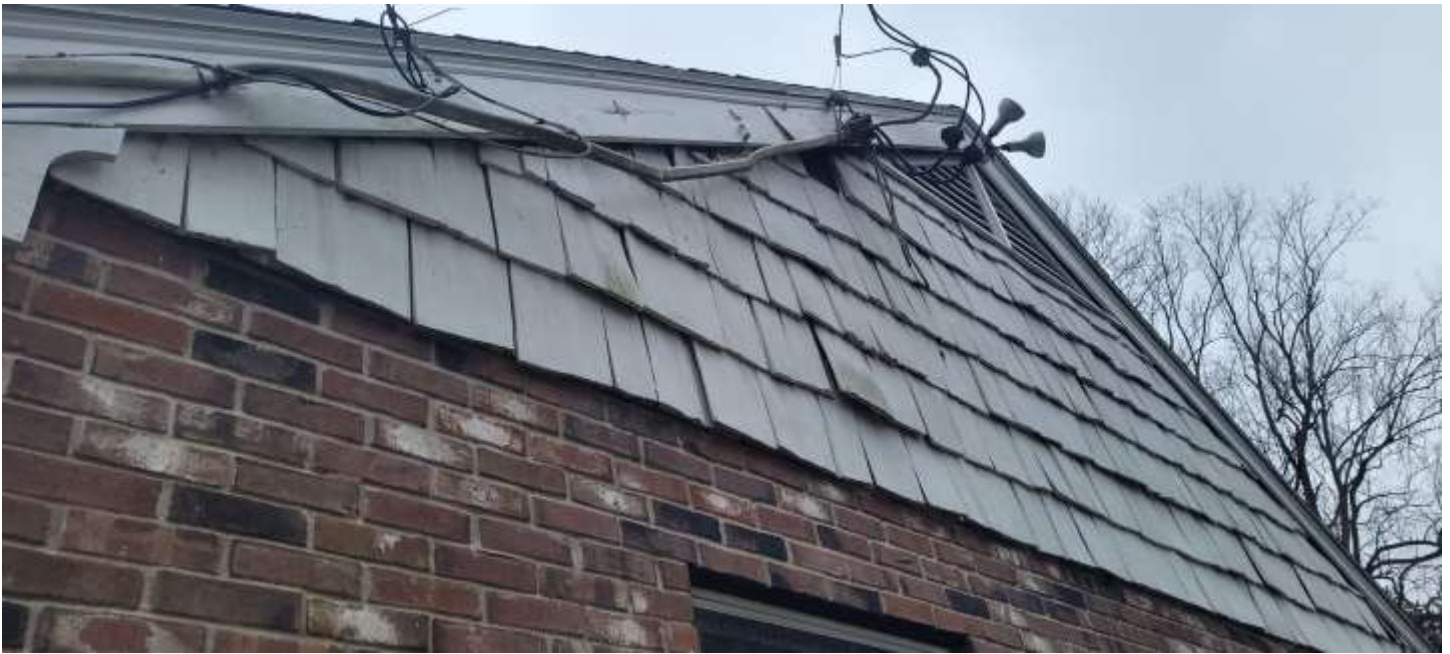
Shingles in good visual condition.

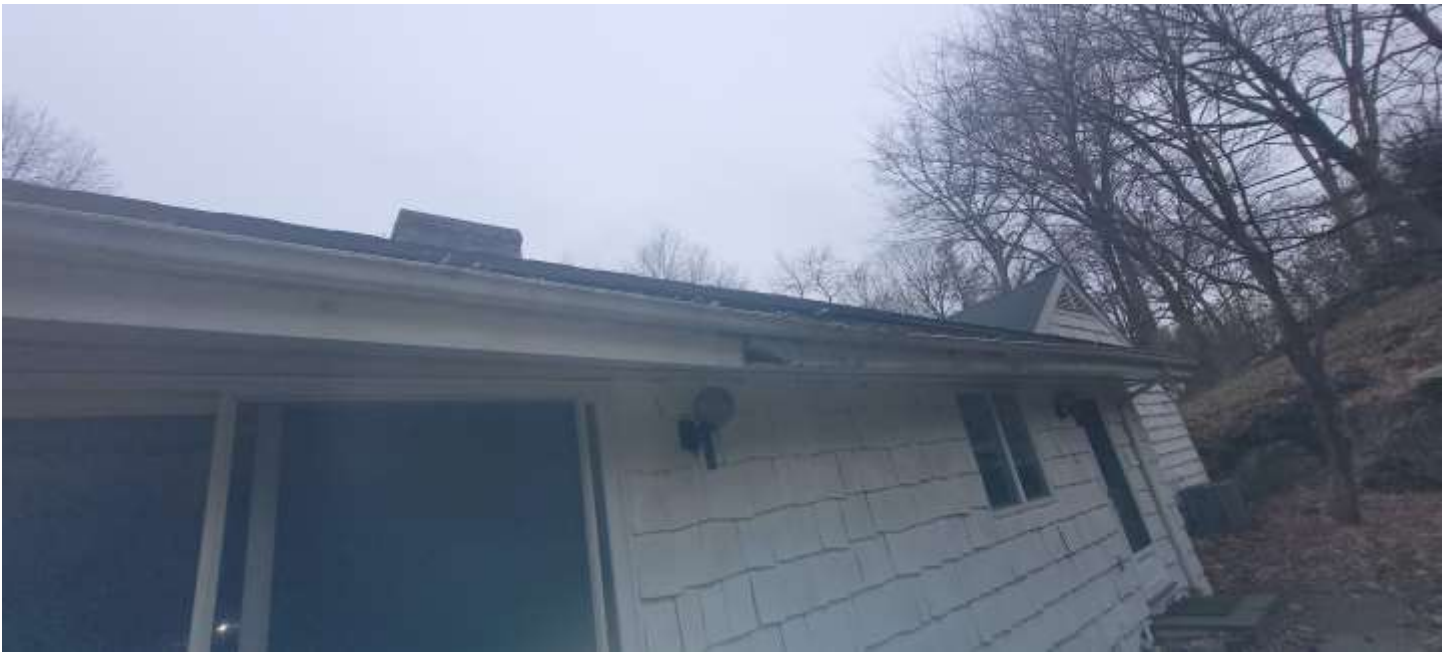
Soffits show some wear here. Gutters are showing signs of being clogged. Shingles in good visual condition. I suggest these gutters be cleaned, and repaired.

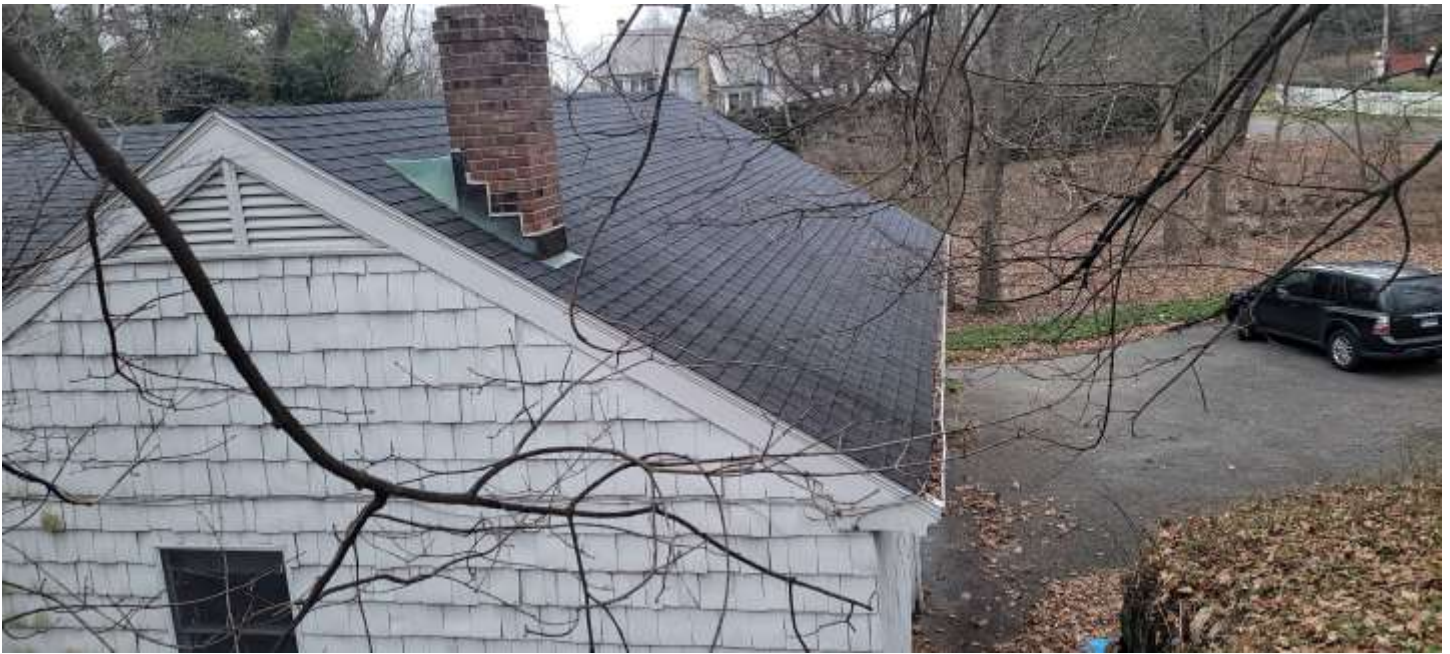
Chimney in good visual condition.

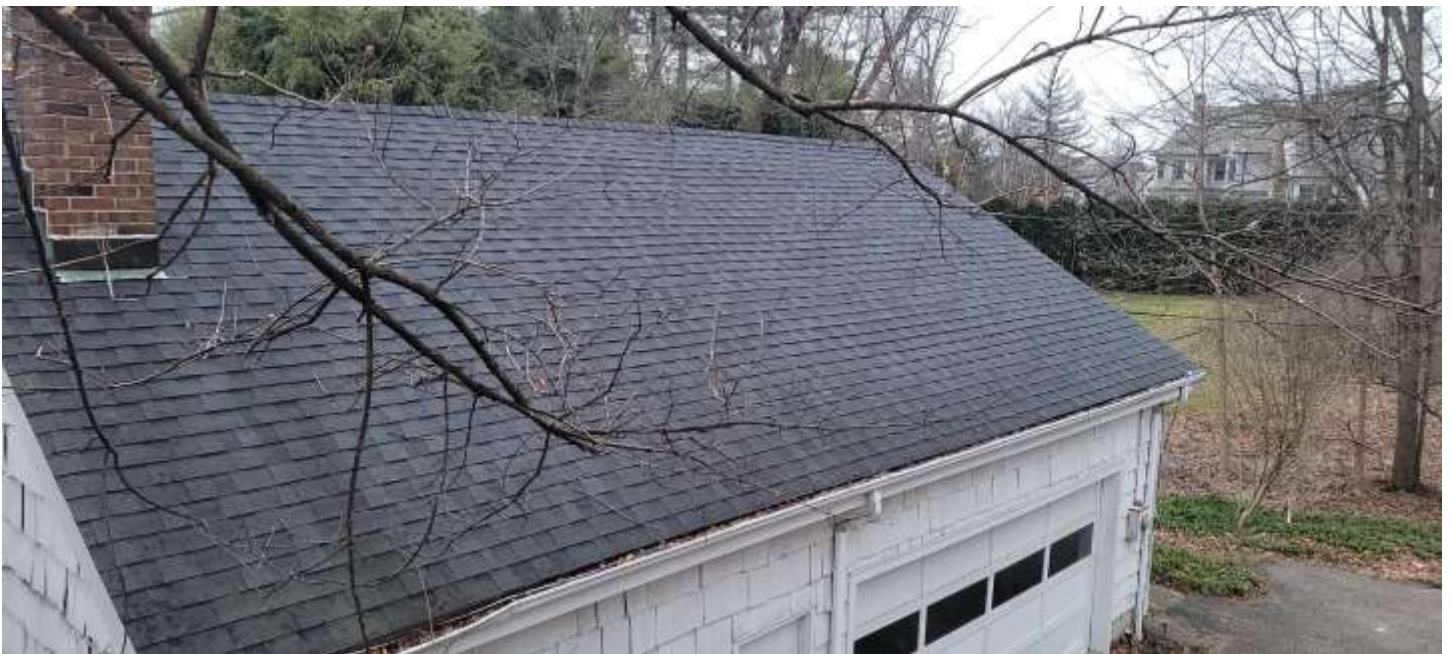
Gutters are clogged.

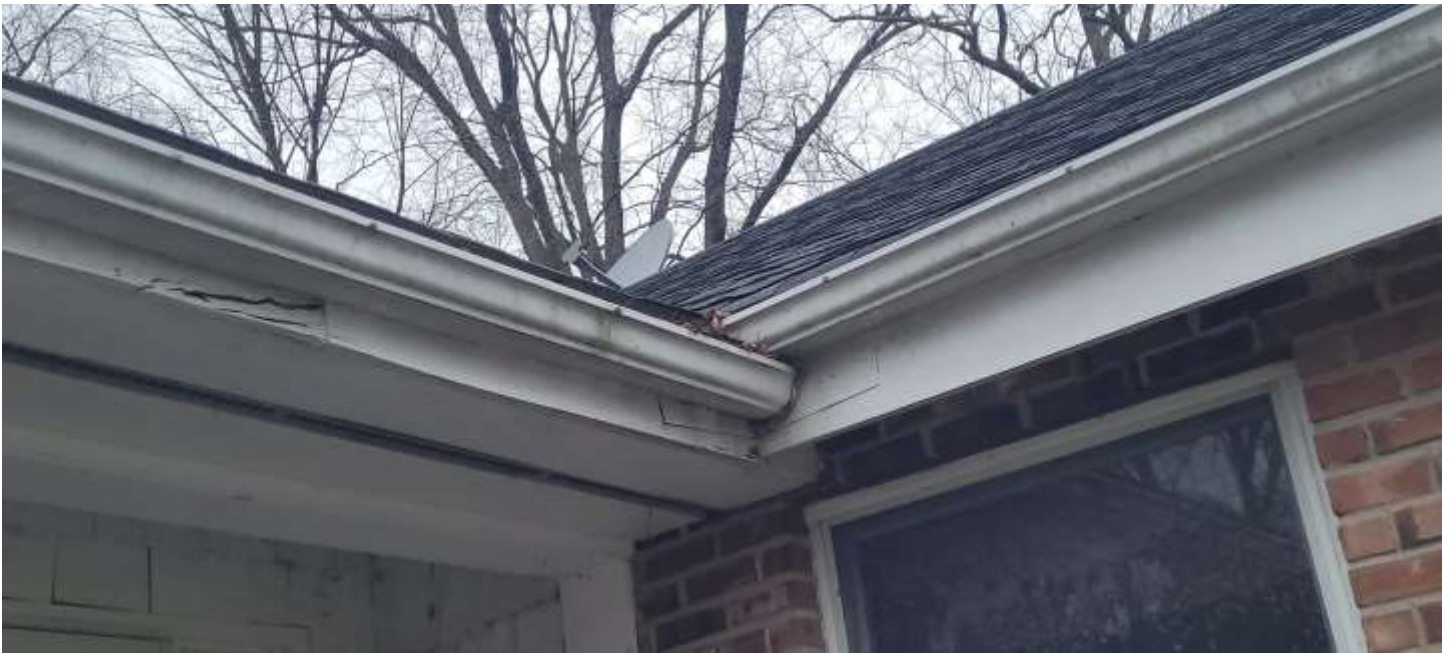
Gutter and soffits in good visual condition. Chimney in good visual condition.

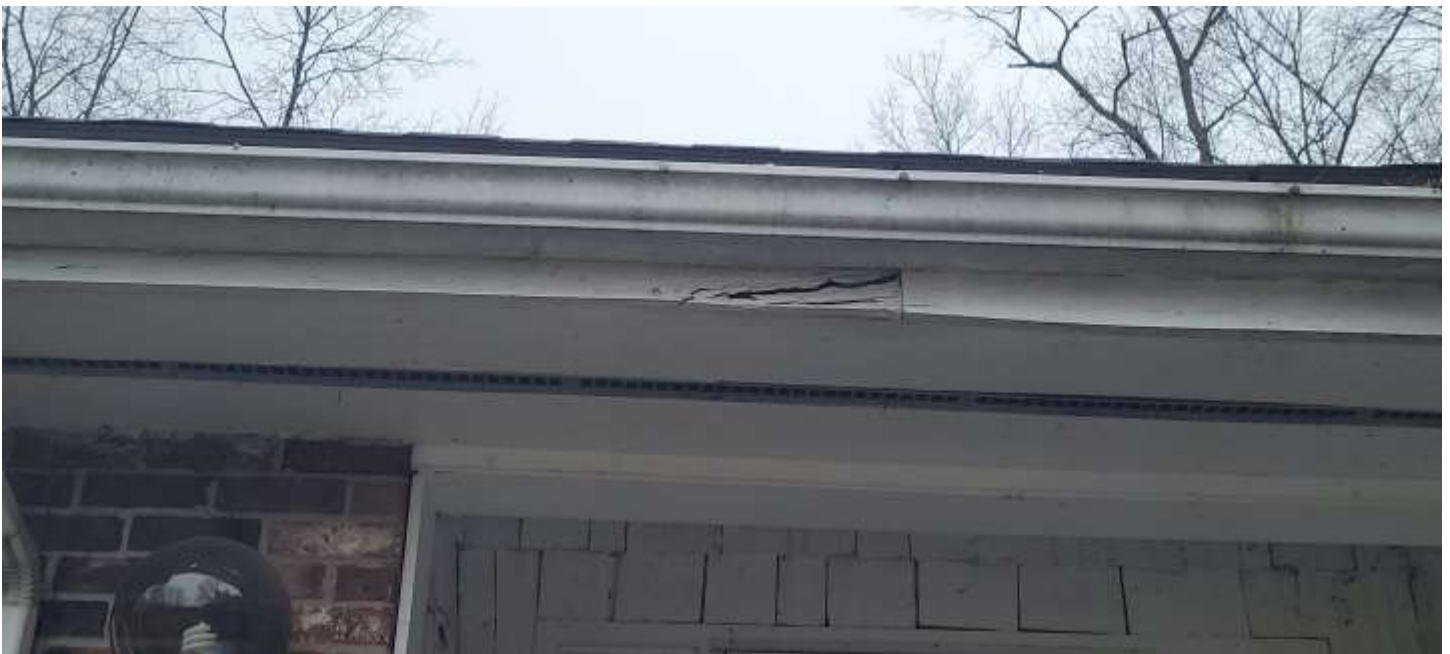
Soffits here are showing wear. Gutters are clogged.

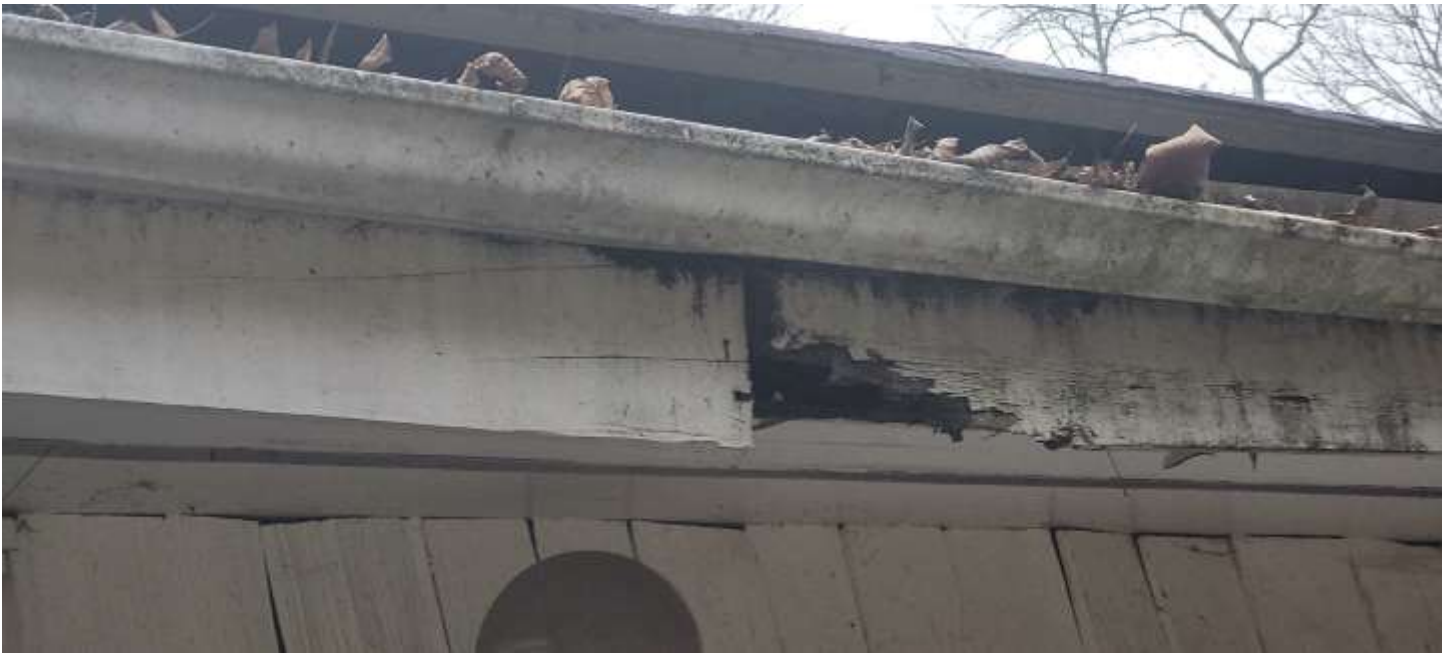
Soffits here are showing wear.

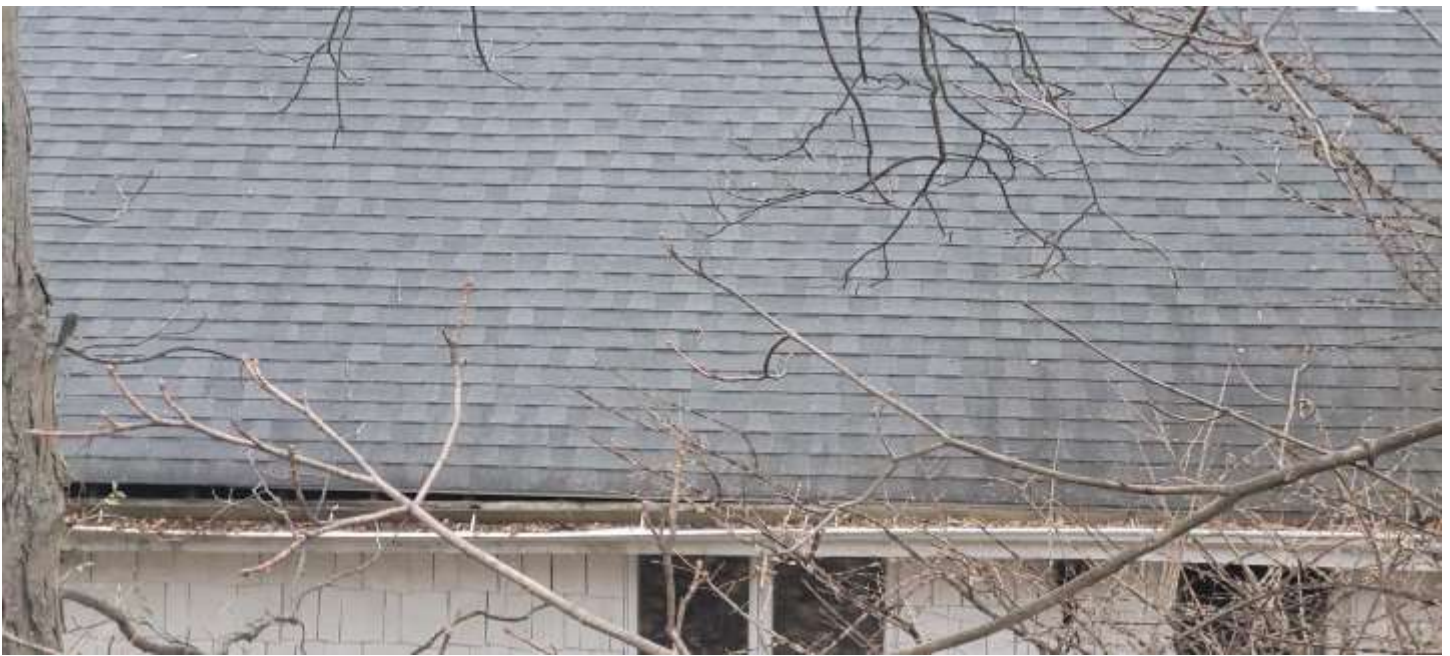
Soffits here are clearly in disrepair. And that gutter is broken.

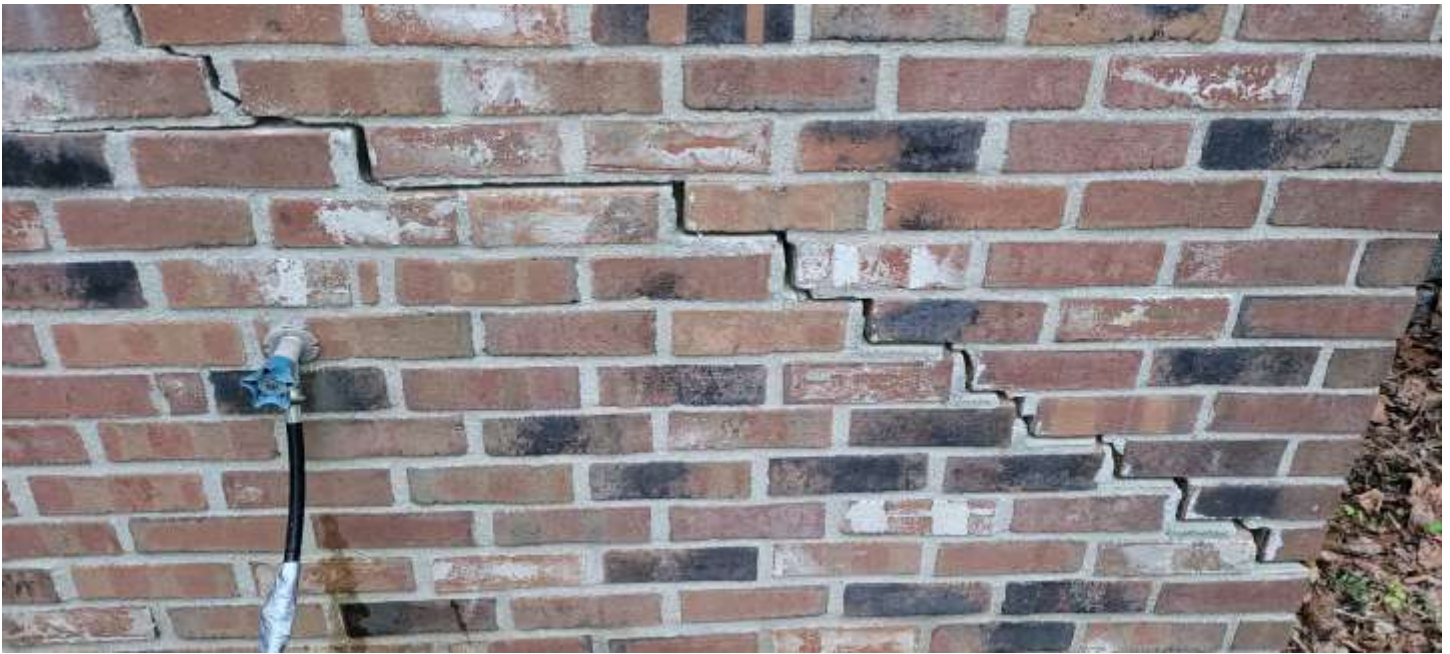
Where the brick was not cracked due to the ground moving, it was in very good visual condition.

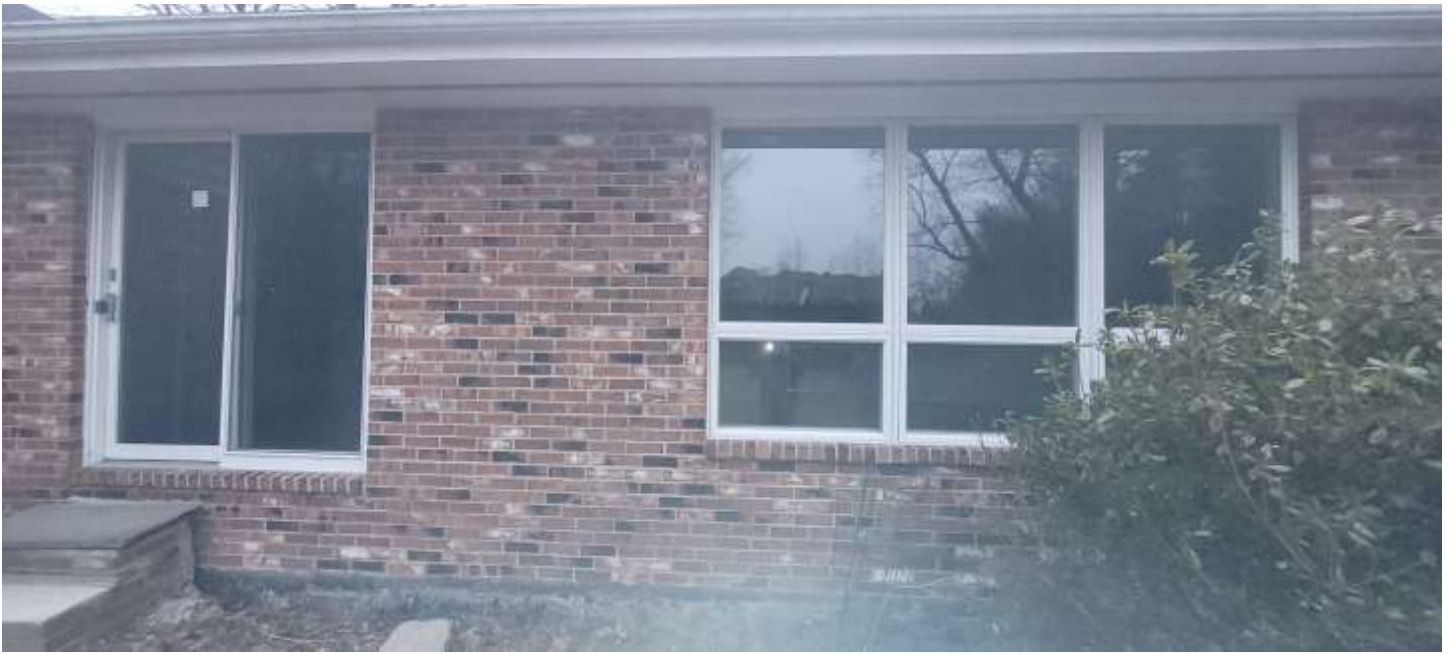
Where the brick was not cracked due to the ground moving, it was in very good visual condition.

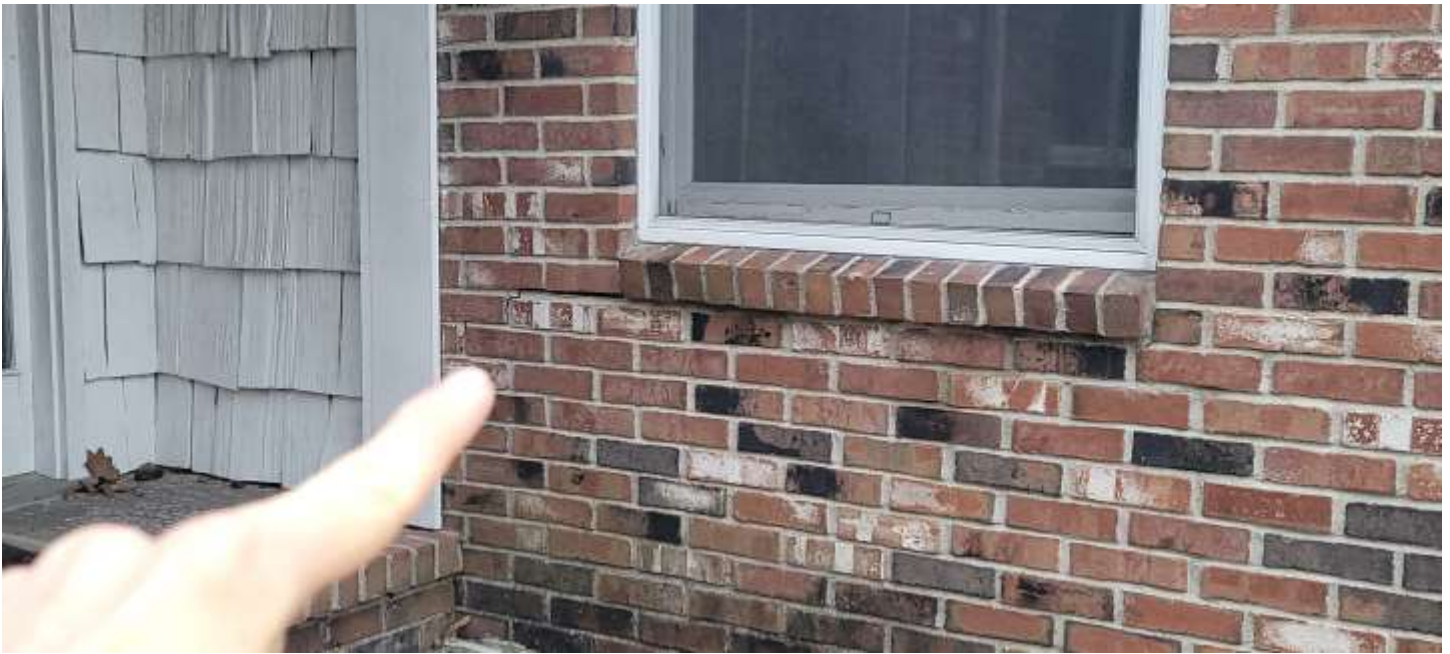
There's one spot here that's indicative of the foundation moving just a bit under this section of house. That should be re sealed.

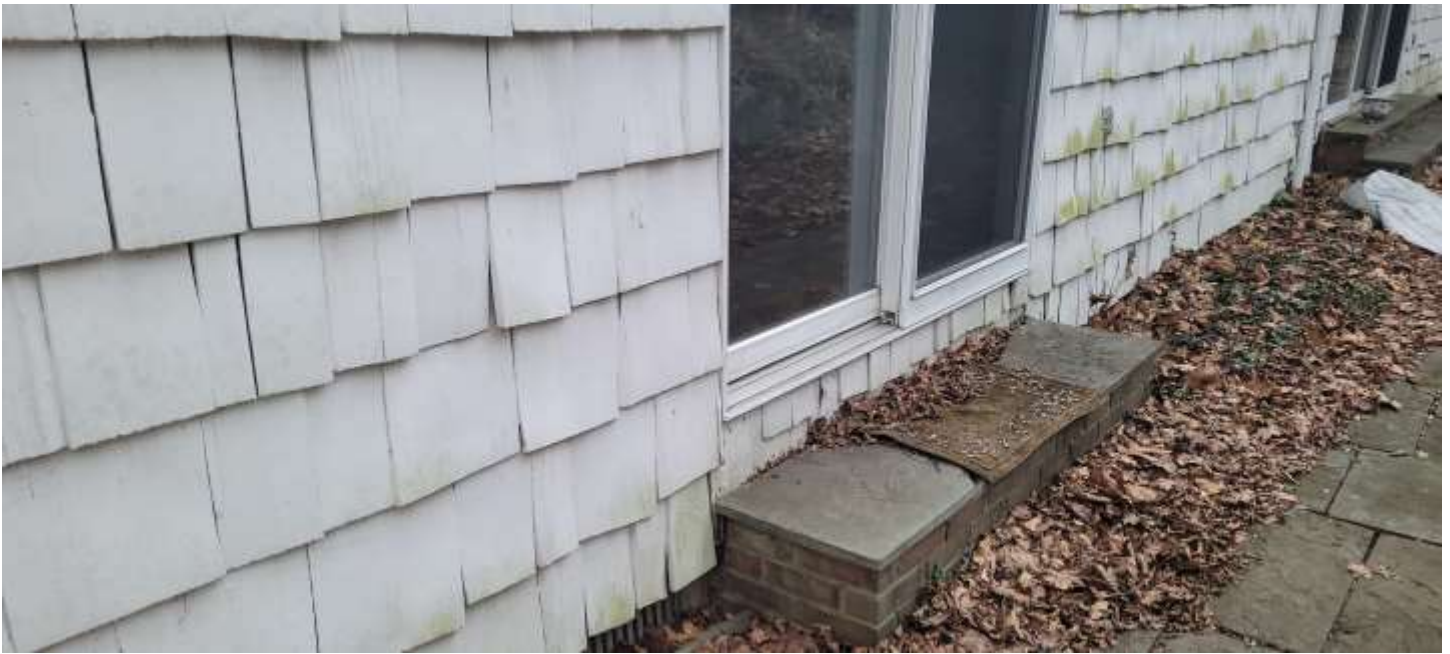
Painted wood generally well maintained and in good condition. Windows, window siding in good visual condition. Typical.

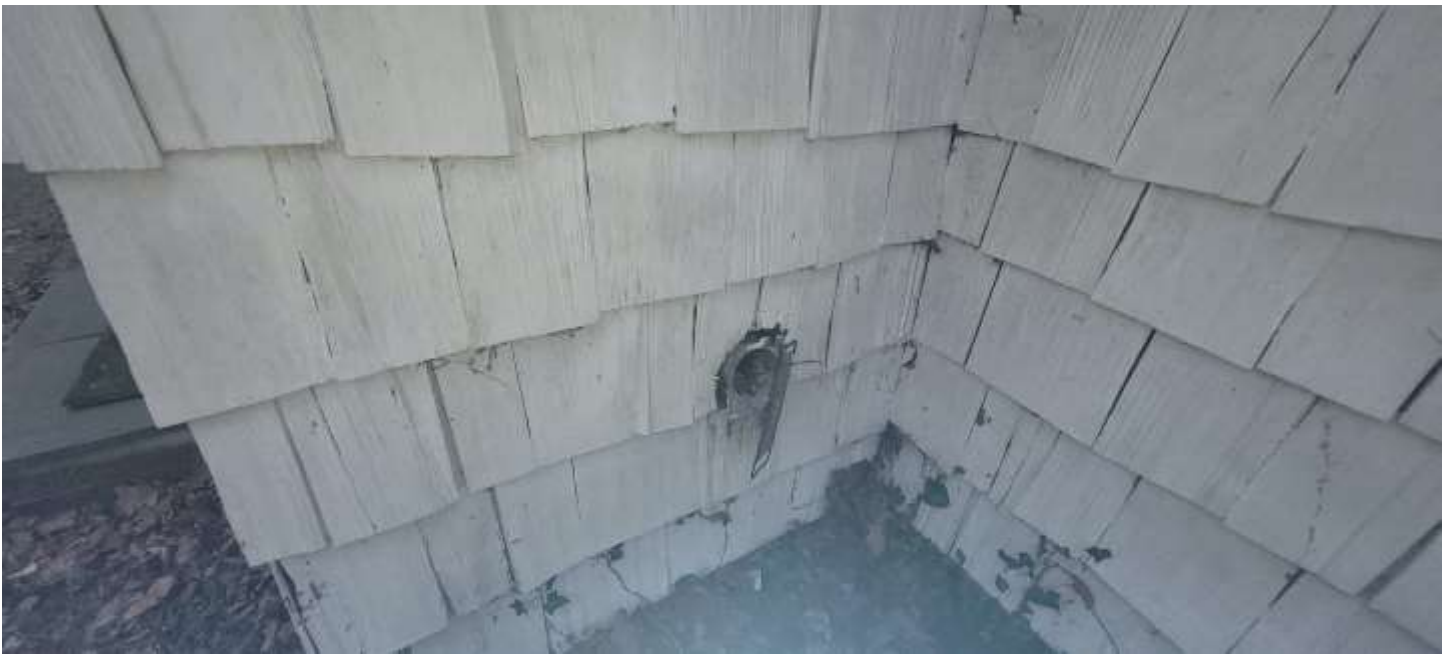
Painted wood generally well maintained and in very good condition.

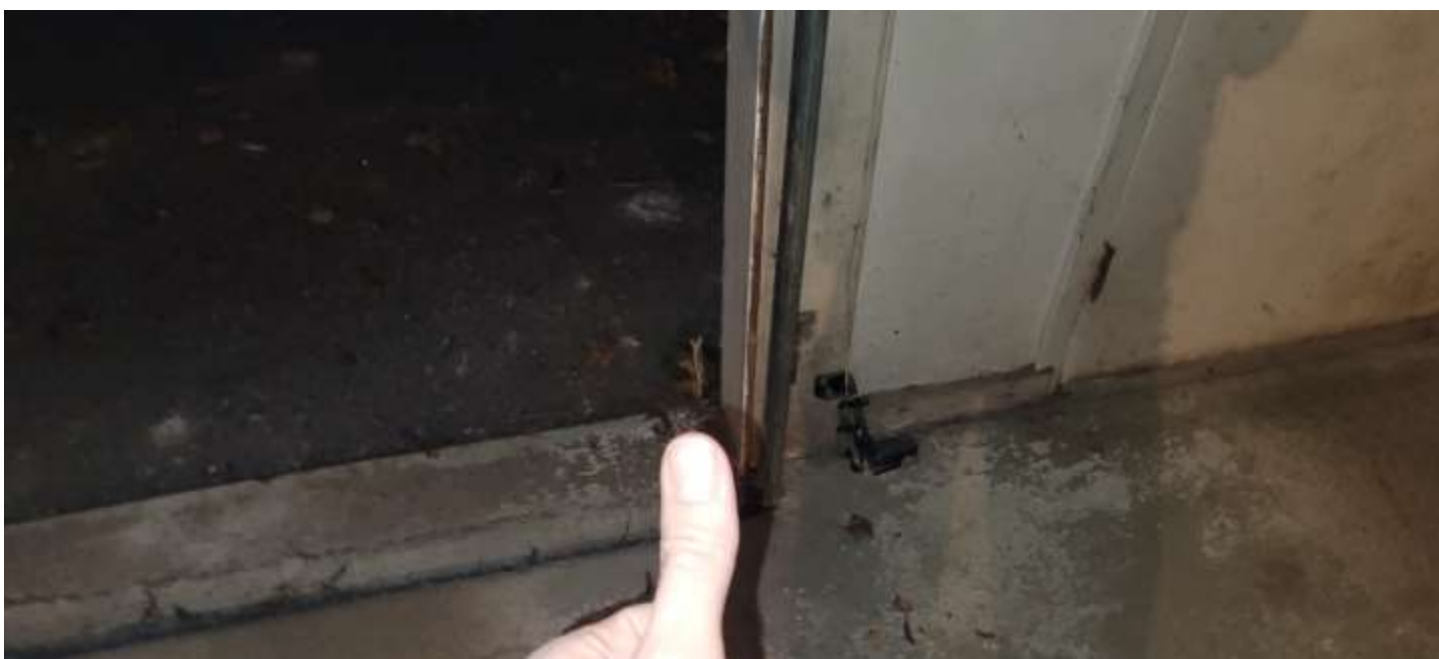
Garage slab had two large cracks.

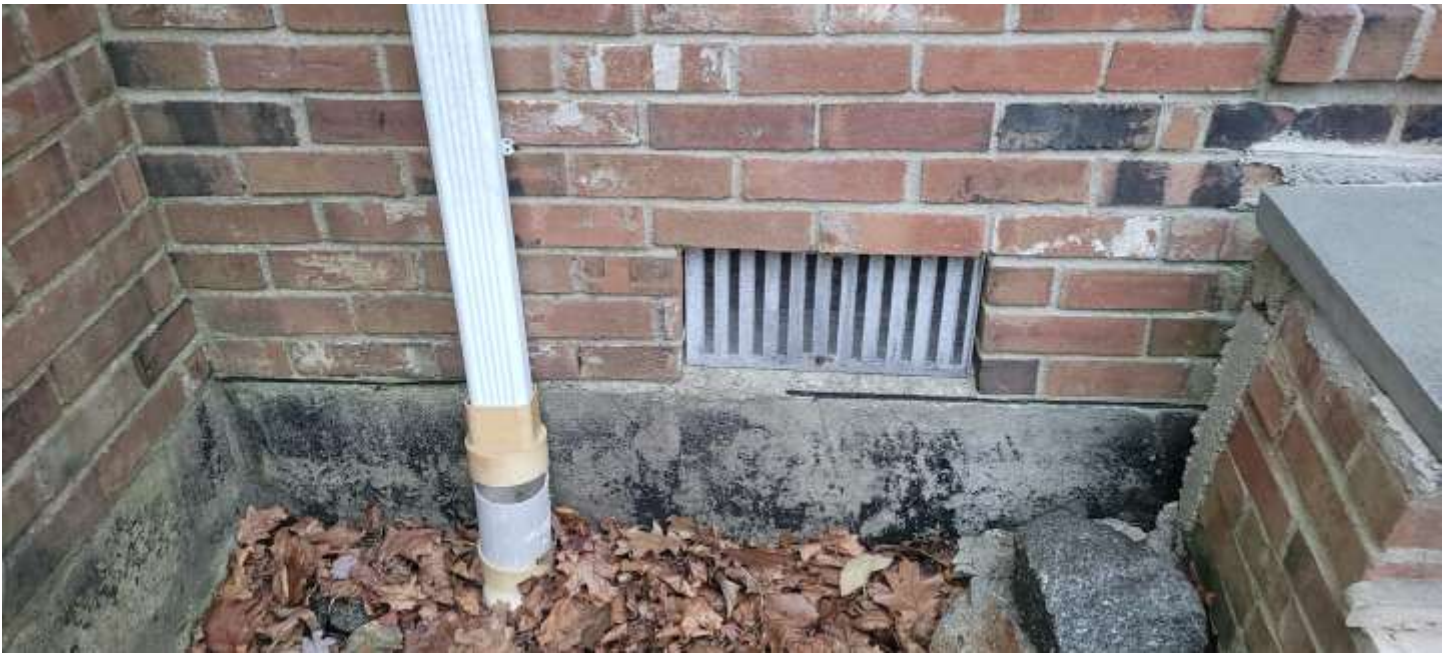
Alternatively, there may have already been some kind of underground brook or water flowing, and this additional water from the construction behind 5 Angus Lane is aggravating a situation that always existed.

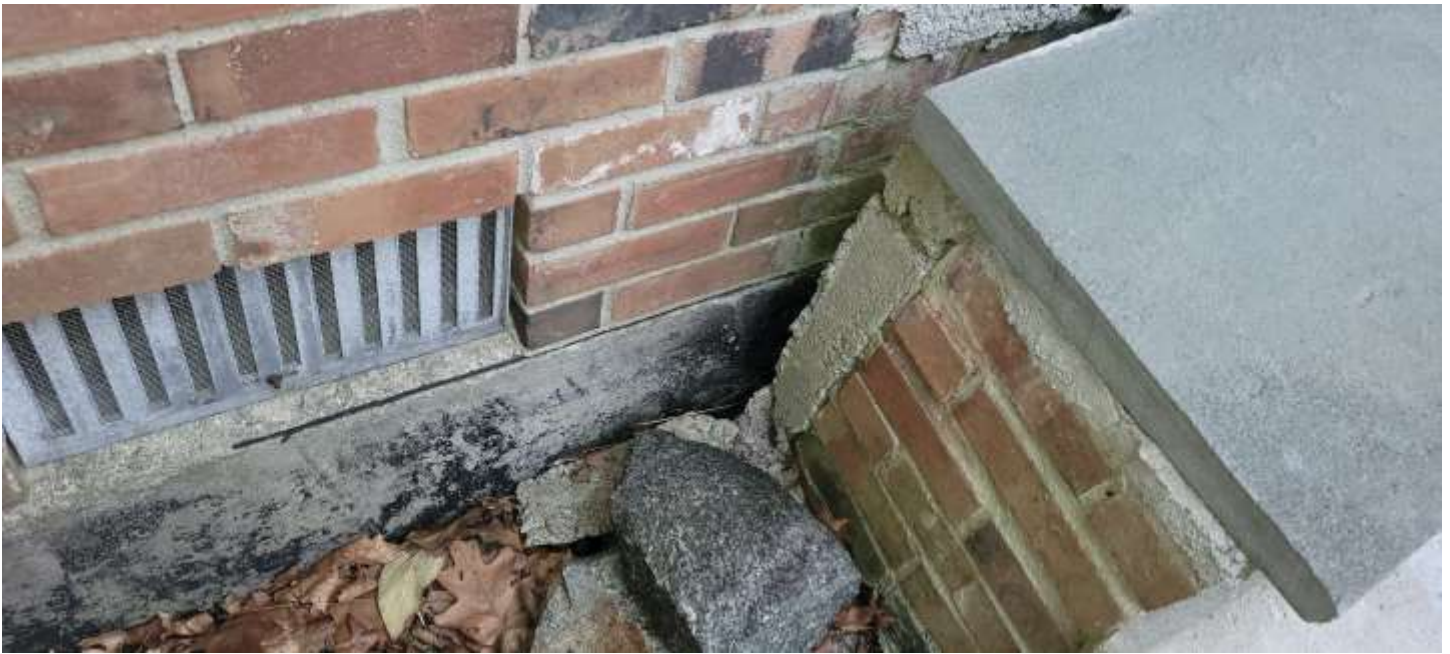
That downspout should be connected. It is dumping water directly on the foundation where there is almost certainly erosion taking place.

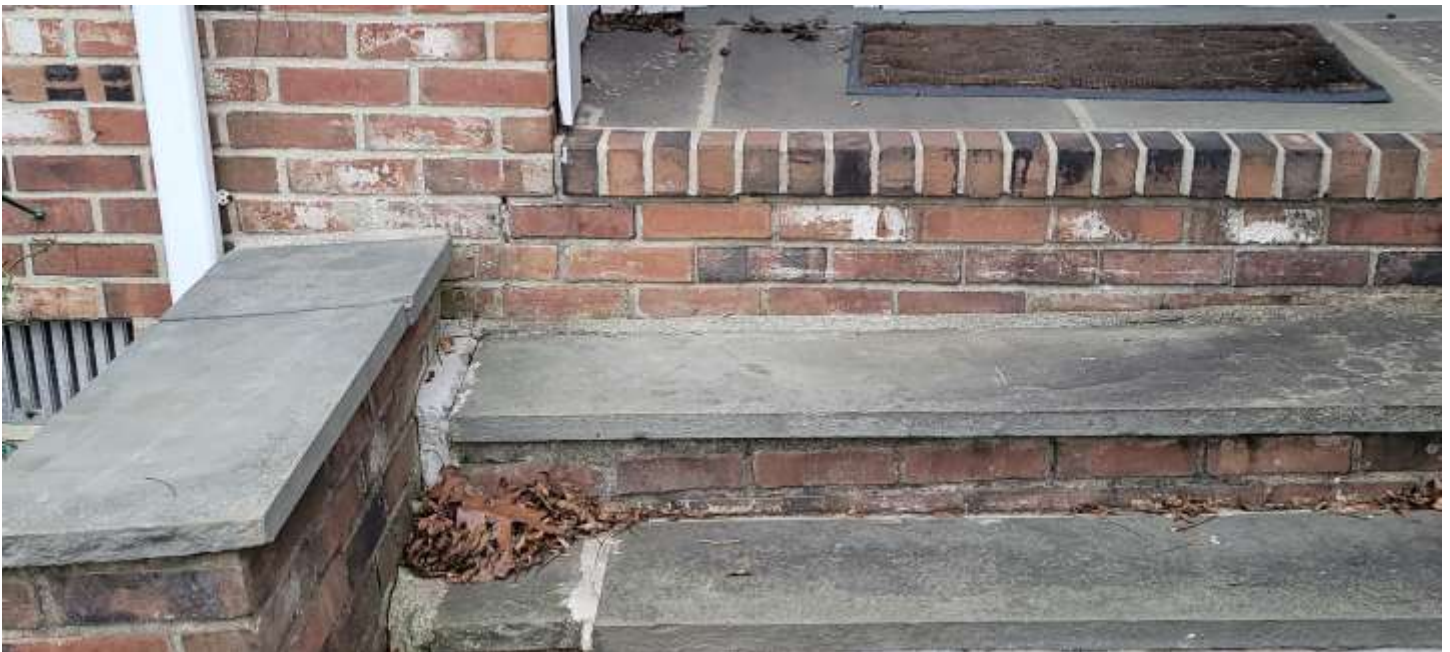
Notice the stairs pulling away. There should be a railing here, is this is a fall hazard. Also notice the stairs are not directly connected to the foundation. An examination under the house did not show nearly the damage to the foundation, (actually very little damage) that you might expect given the condition of these stairs.

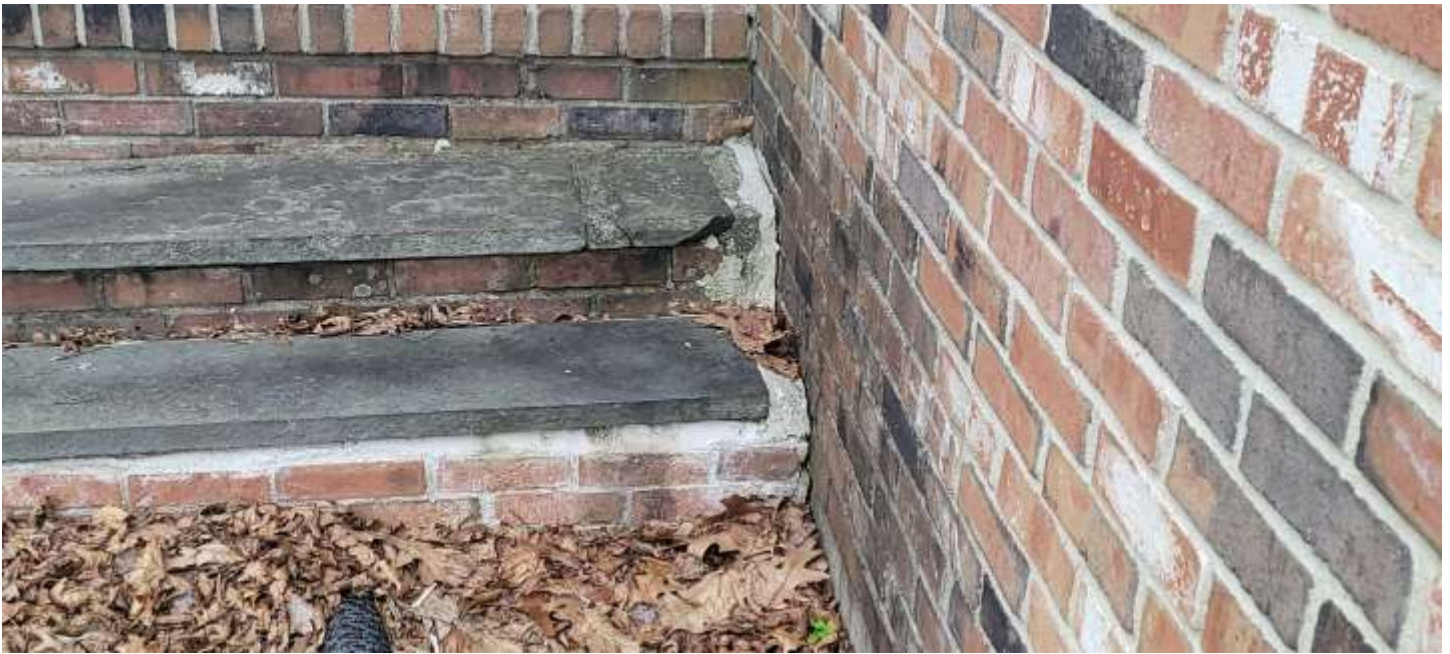
Notice the stairs pulling away. There should be a railing here, is this is a fall hazard. Also notice the stairs are not directly connected to the foundation. An examination under the house did not show nearly the damage to the foundation, (actually very little damage) that you might expect given the condition of these stairs.

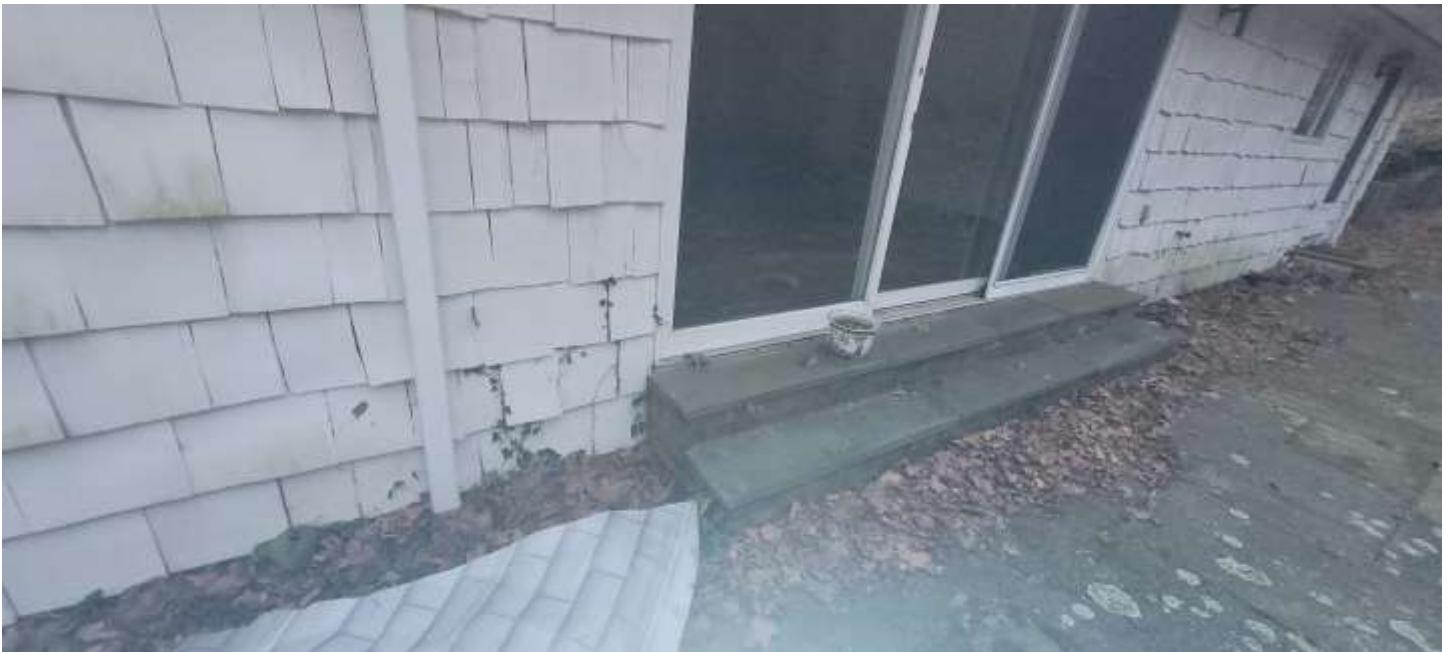
Notice the stairs pulling away. There should be a railing here, is this is a fall hazard. Also notice the stairs are not directly connected to the foundation. An examination under the house did not show nearly the damage to the foundation, (actually very little damage) that you might expect given the condition of these stairs.

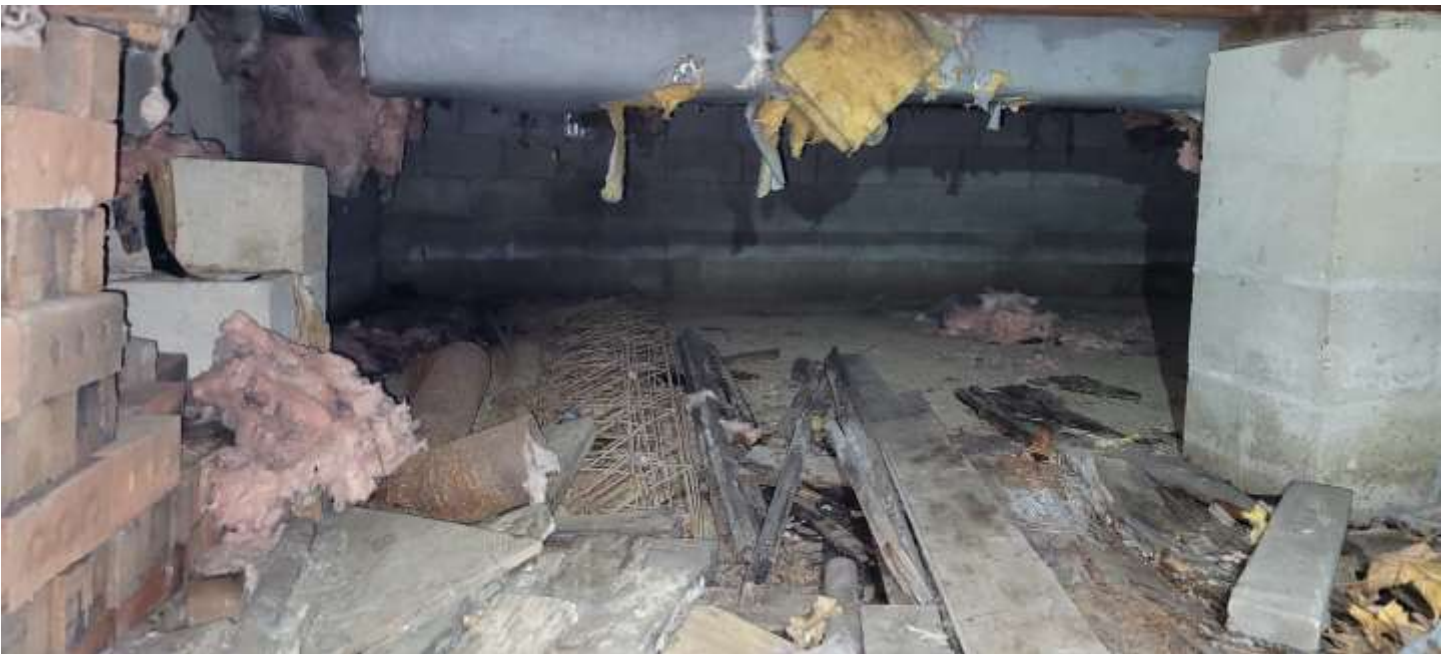
Foundation here does not show any movement.

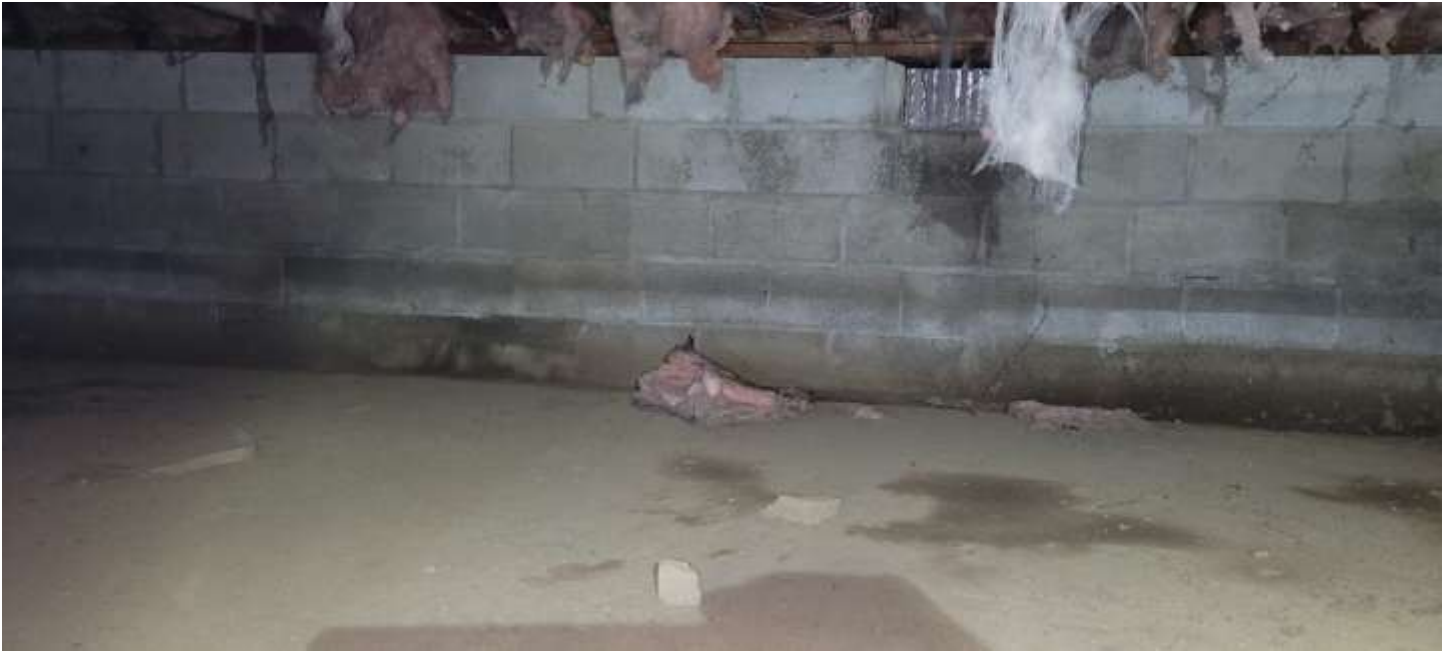
The main foundation for the house showed very little signs of movement (1/4"). This is unlike the slab of the garage, which is showing significant signs ( 1 – 2 inches) of movement.

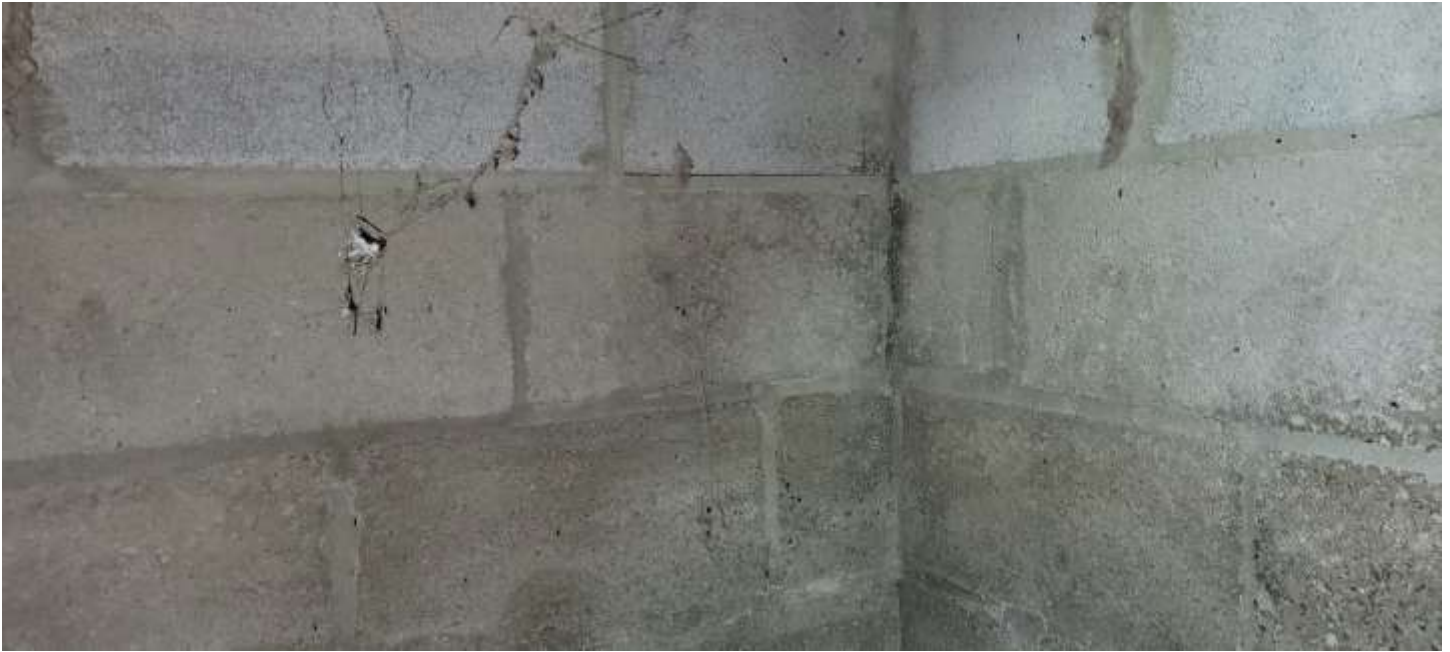
The main foundation of the house looks very good here. I suspect you had animals in this basement that ripped up the fiber glass insulation. There is effluorescence, which indicates the presence of water. This seems to be consistent with some kind of water flow under and around the foundation of this house.

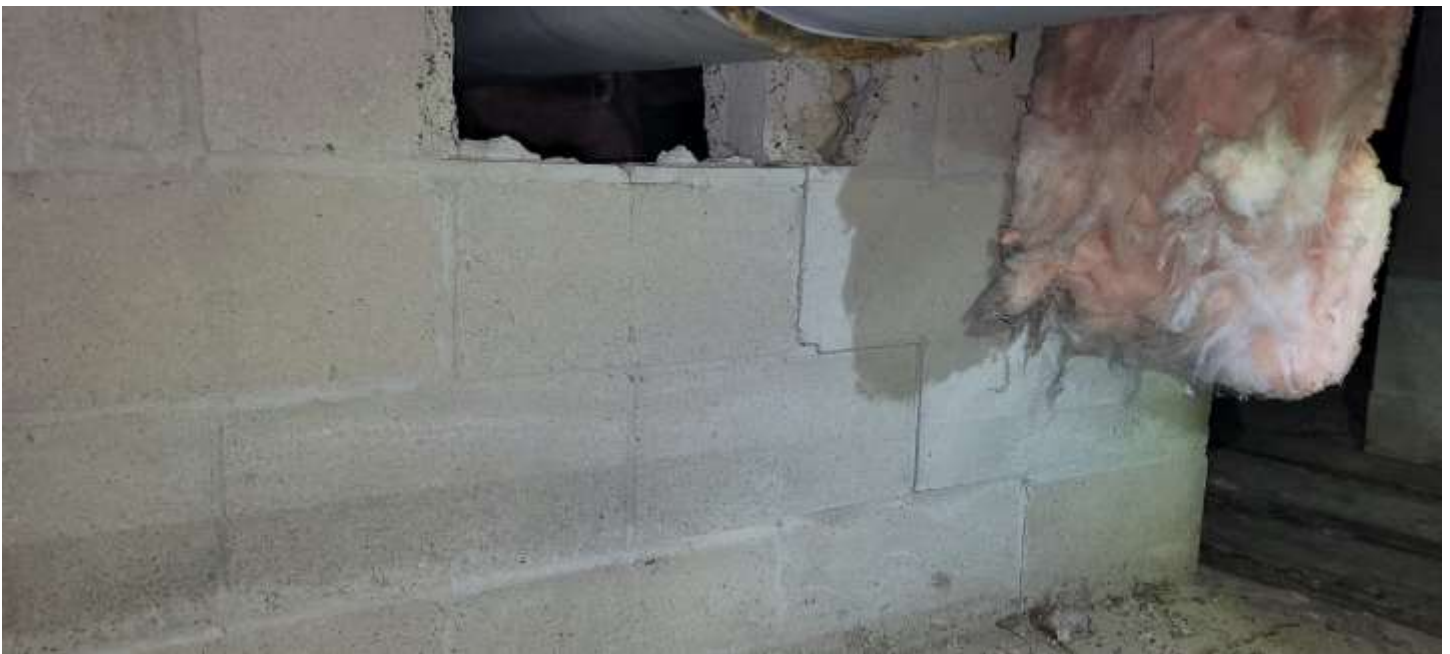
Small crack there.
