Property: 123 Main Street, Anytown, NY  
Date: 15Jan2021  
Present: Louis Csak, insp.; ####, buyer; ### agent.  
Conditions: 40's, overcast

**Executive summary:** (details in report)

The house was not well maintained, and the garage foundation is beginning to show serious issues, and very likely there is a regular water occurrence that will eventually affect the main foundation badly.

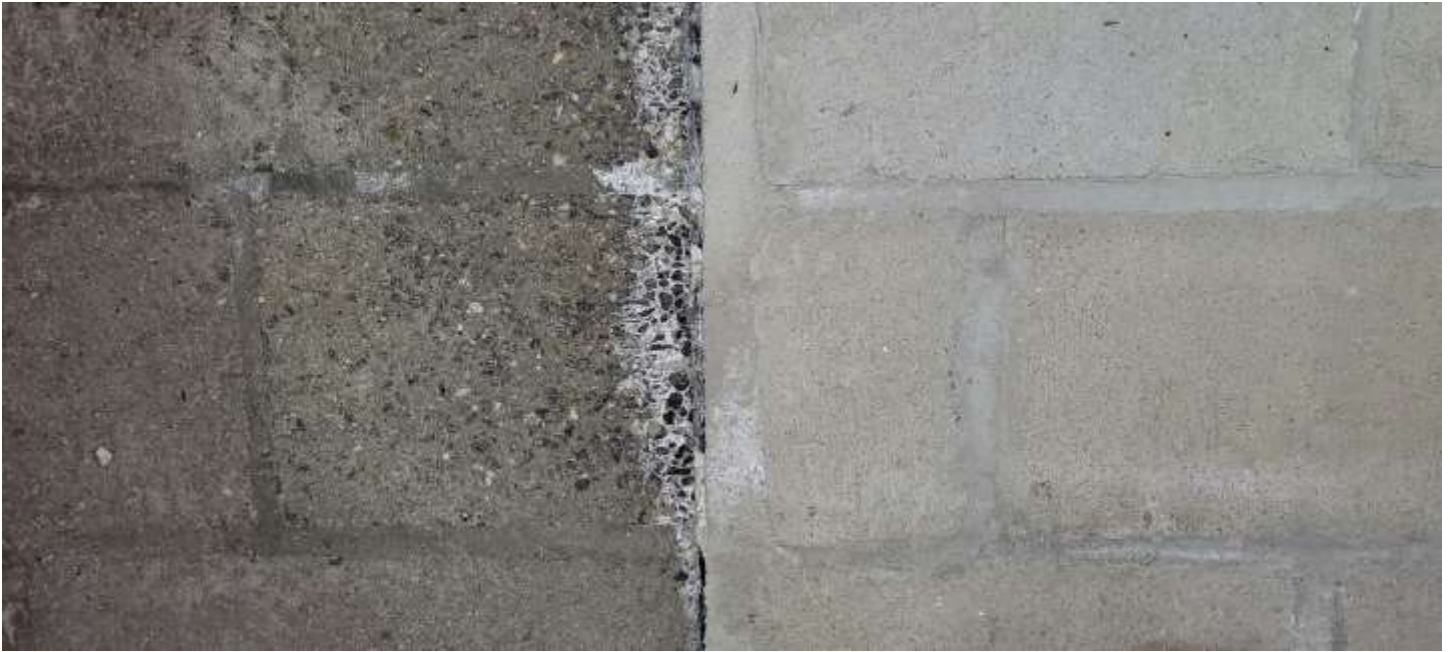
Somewhat larger crack here. This is also reflected in the bedroom above it. This seems to have moved about 1/4"-3/8".

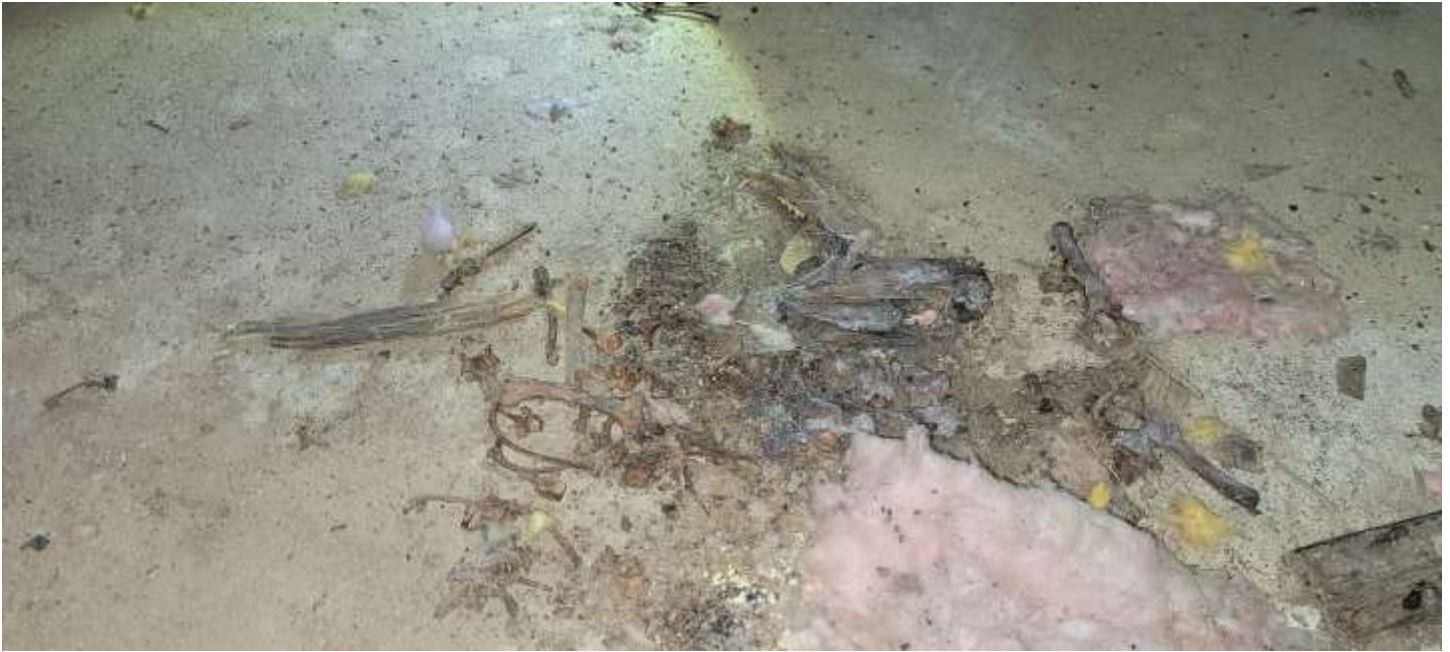
The main foundation of the house looks very good here. I suspect you had animals in this basement that ripped up the fiber glass insulation. There is effluorescence, which indicates the presence of water. This seems to be consistent with some kind of water flow under and around the foundation of this house.

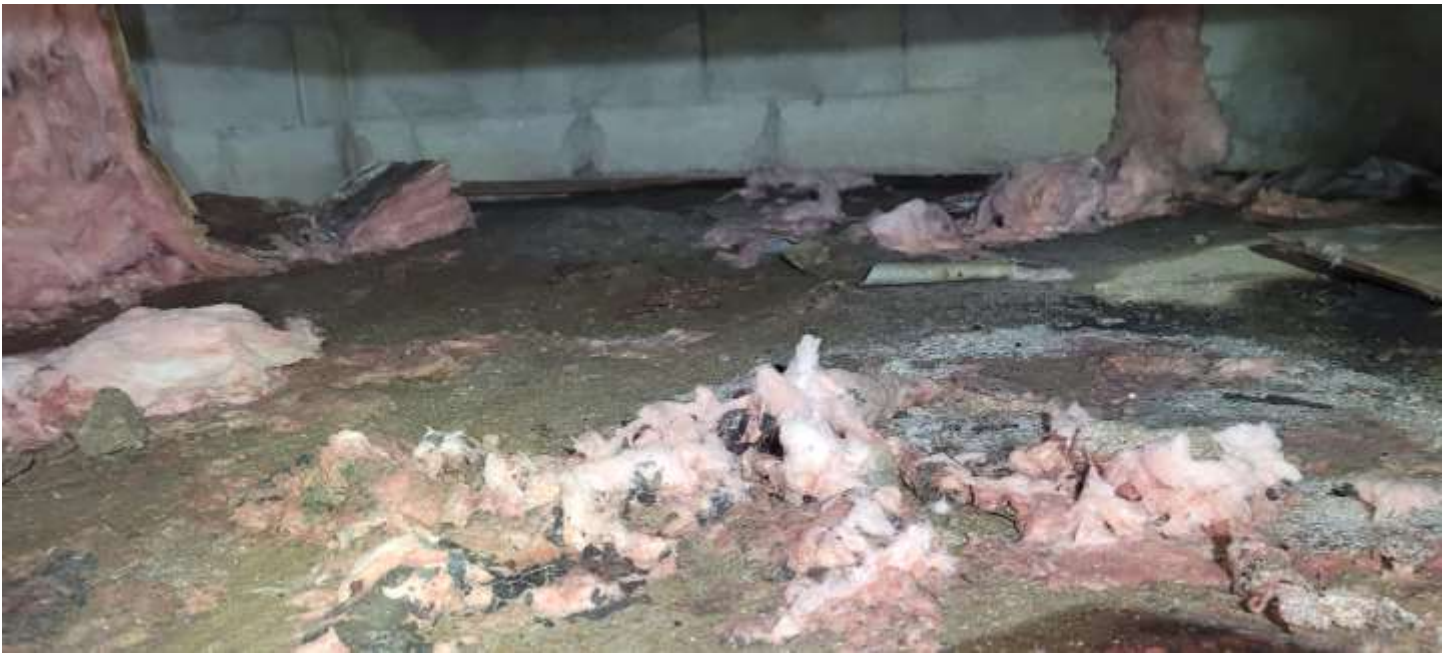
This is looking into the area under bedroom (next to garage). Clearly there is some water here.

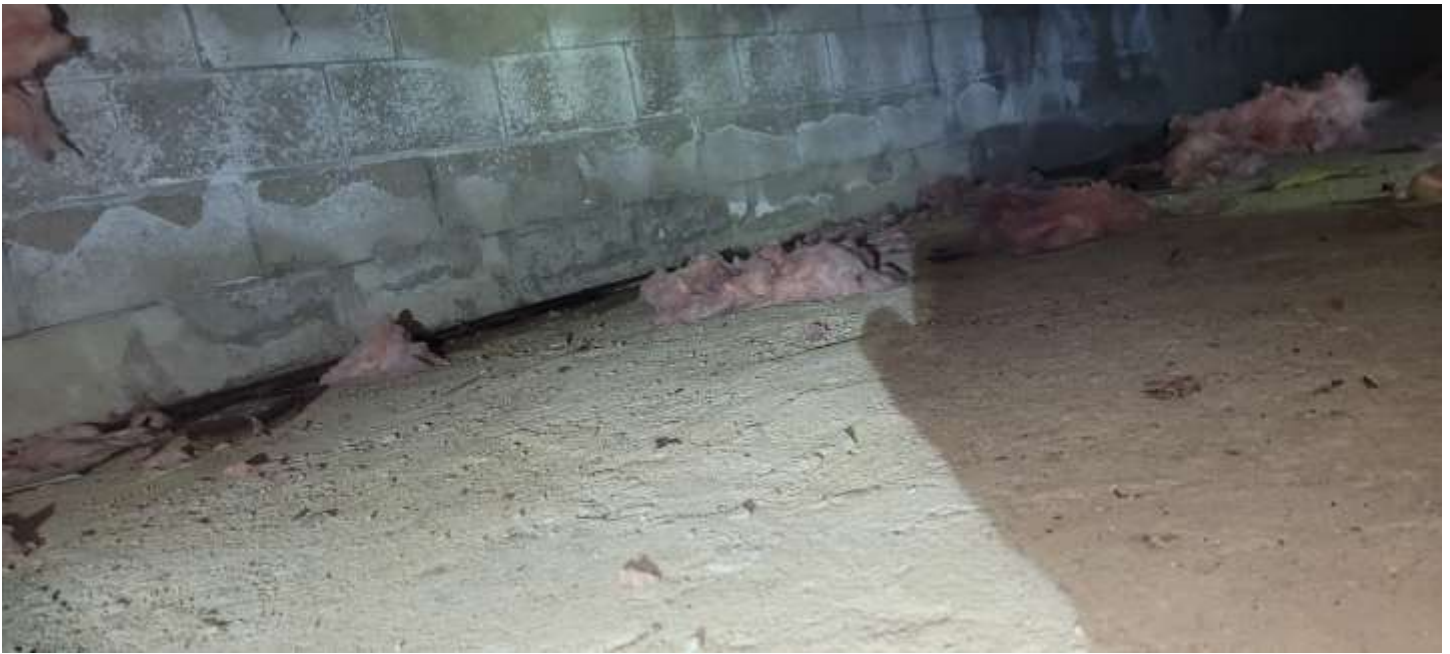
The main foundation of the house looks very good here. I suspect you had animals in this basement that ripped up the fiber glass insulation. There is effluorescence, which indicates the presence of water. This seems to be consistent with some kind of water flow under and around the foundation of this house.

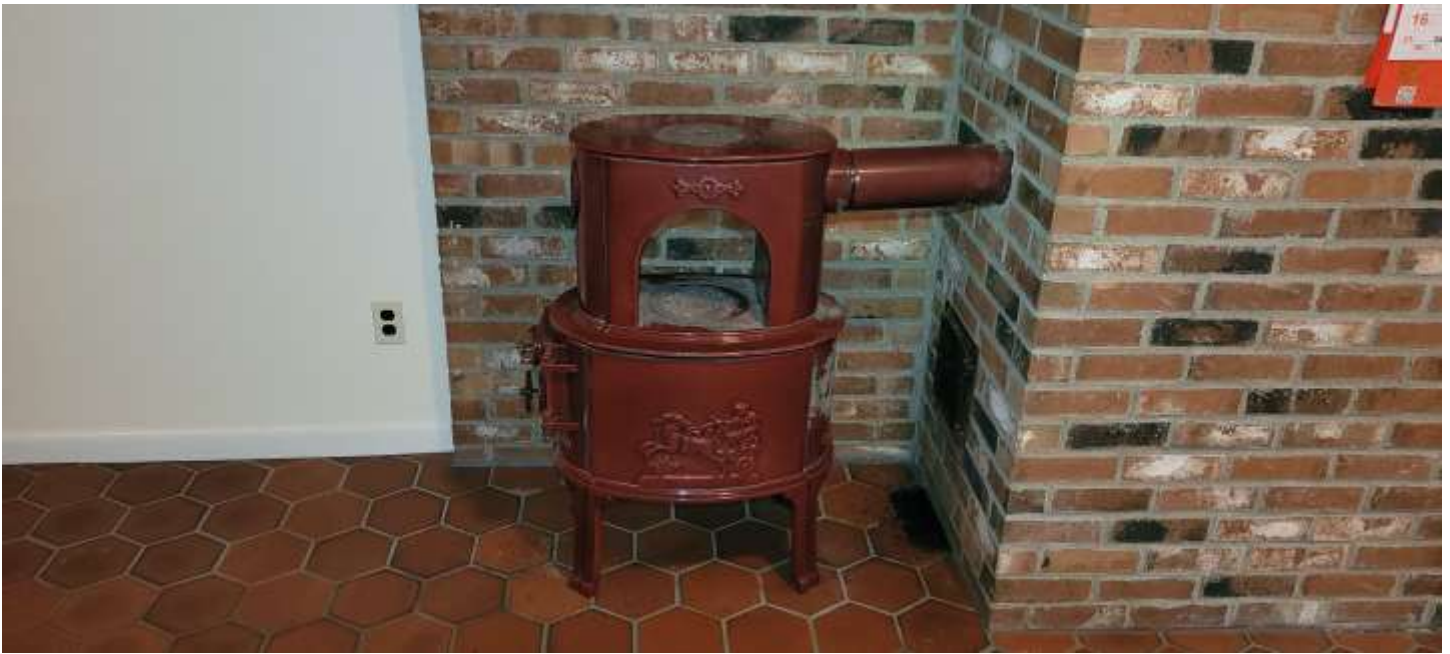
Fireplace clean out needs to be cleaned out.

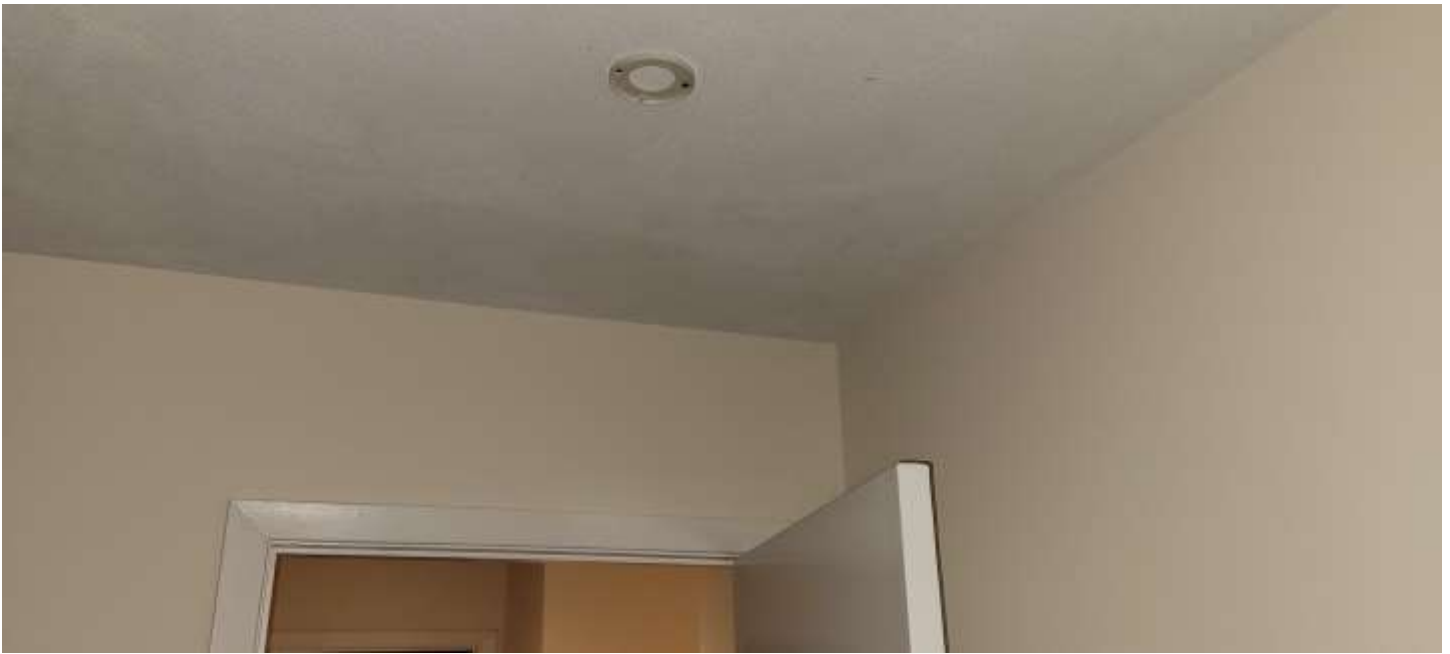
No smoke and carbon monoxide detector in the garage, which is also the mechanical room.

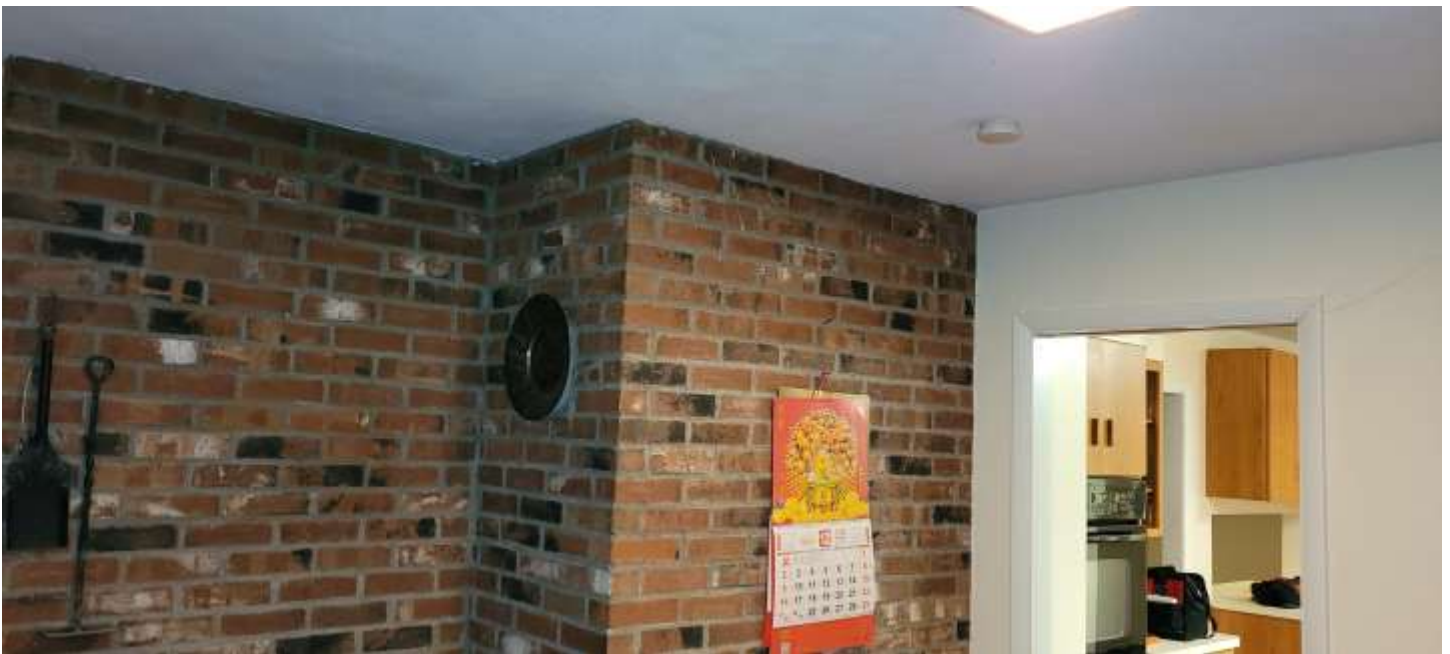
Missing detector.

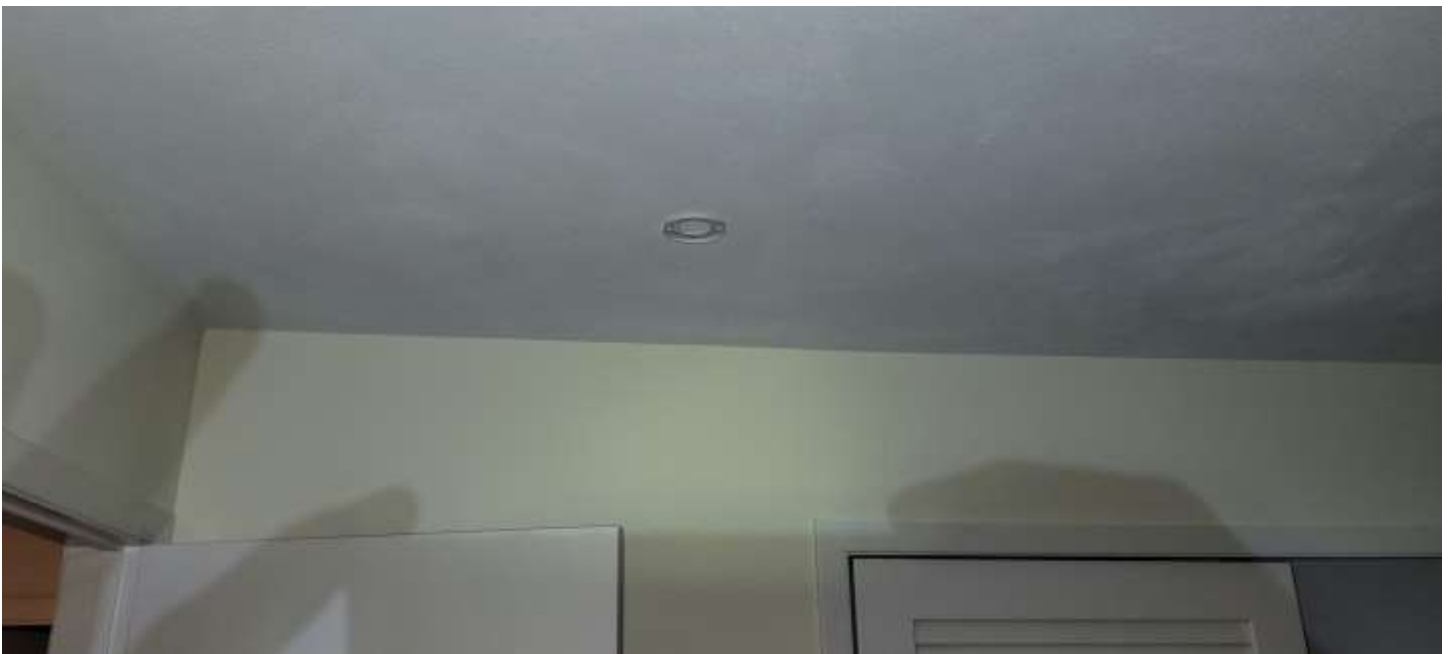
Missing detector.

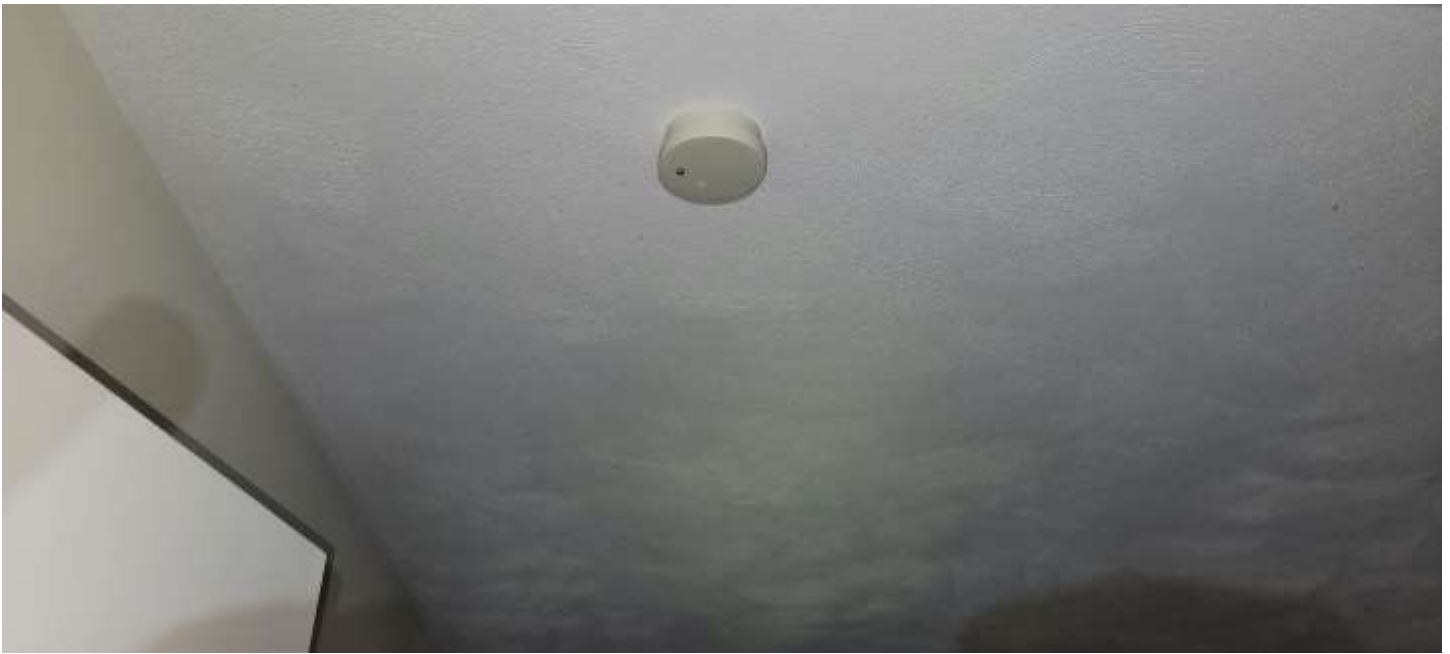
Missing detector.

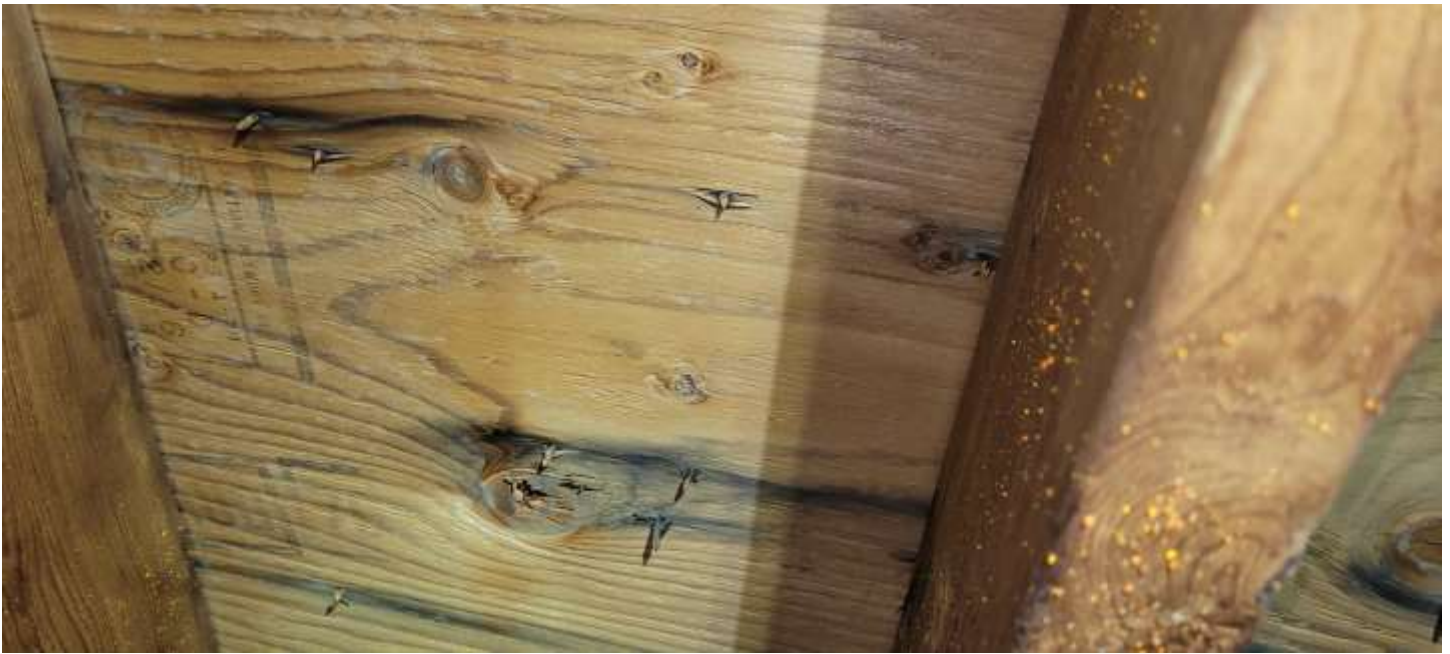
I think if you add more collar ties, you will extend the life of these shingles.

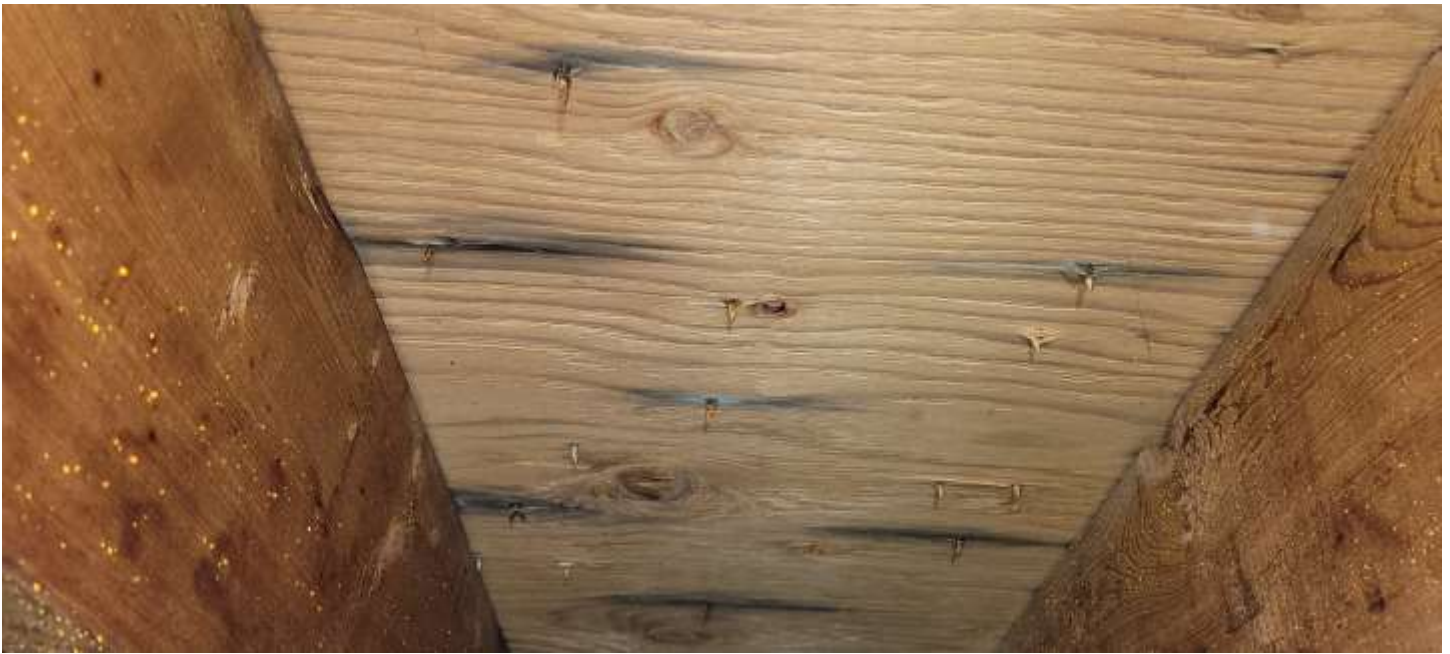
I couldn't tell if this was an old, or current leak. Given the roof is supposed to be only from 2011, hopefully this is old water.

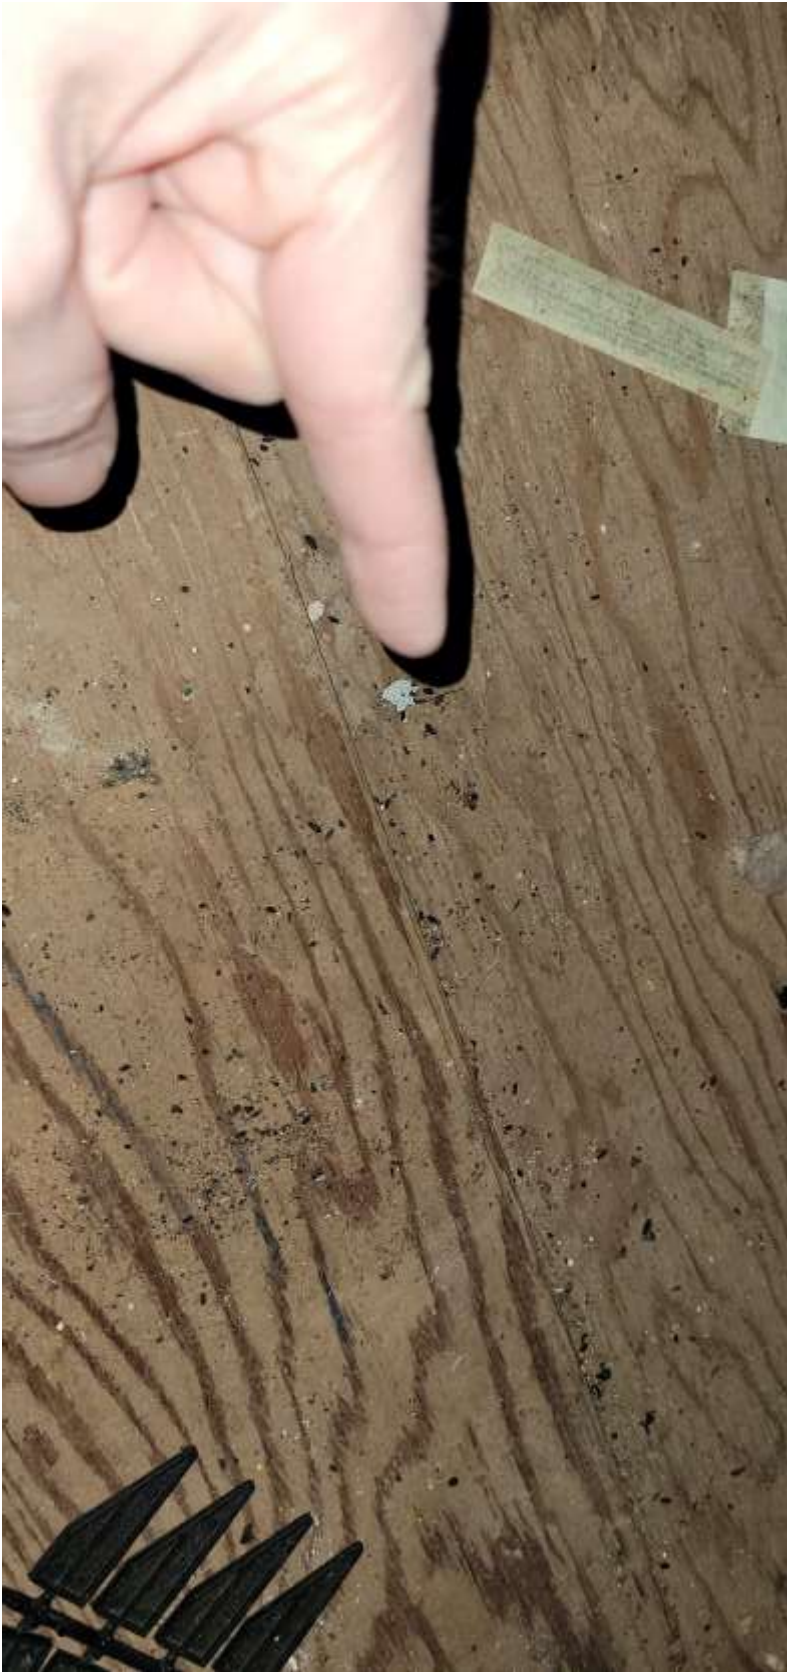
I couldn't tell if this was an old, or current leak. Given the roof is supposed to be only from 2011, hopefully this is old water.

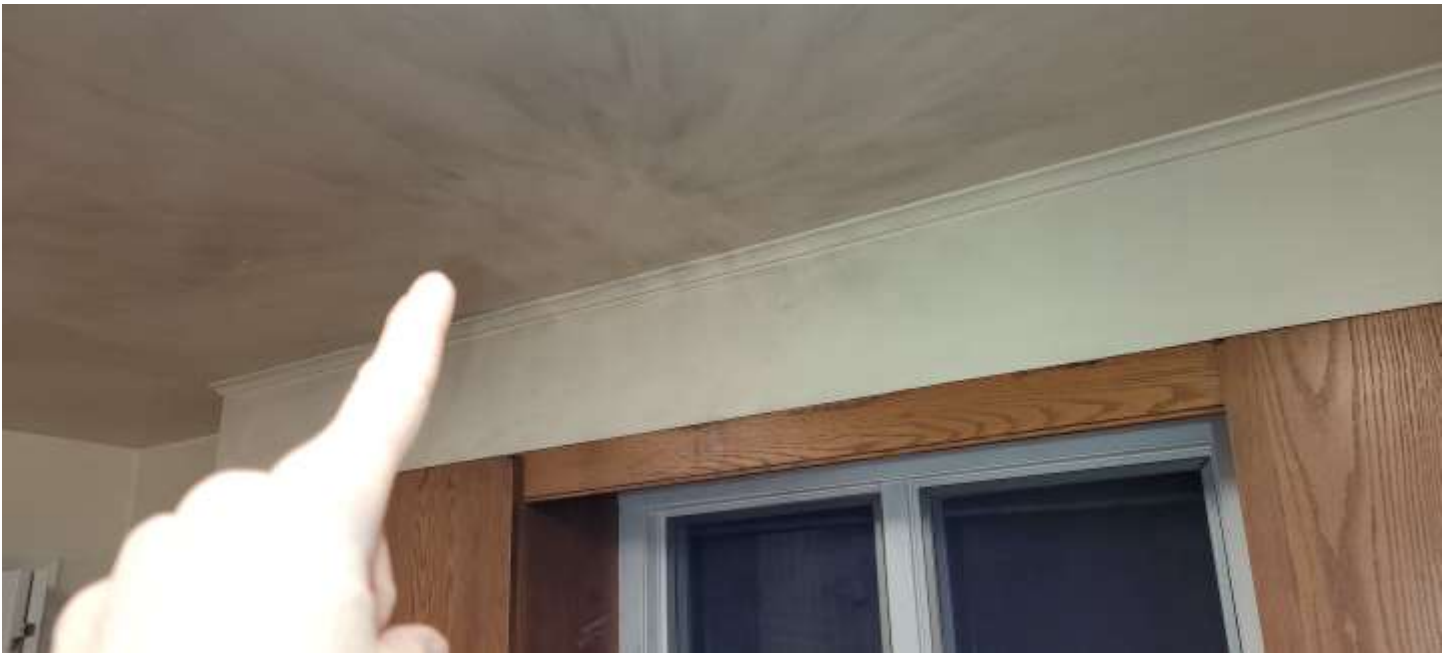
Kitchen ceiling. I don't think that crack is structural.

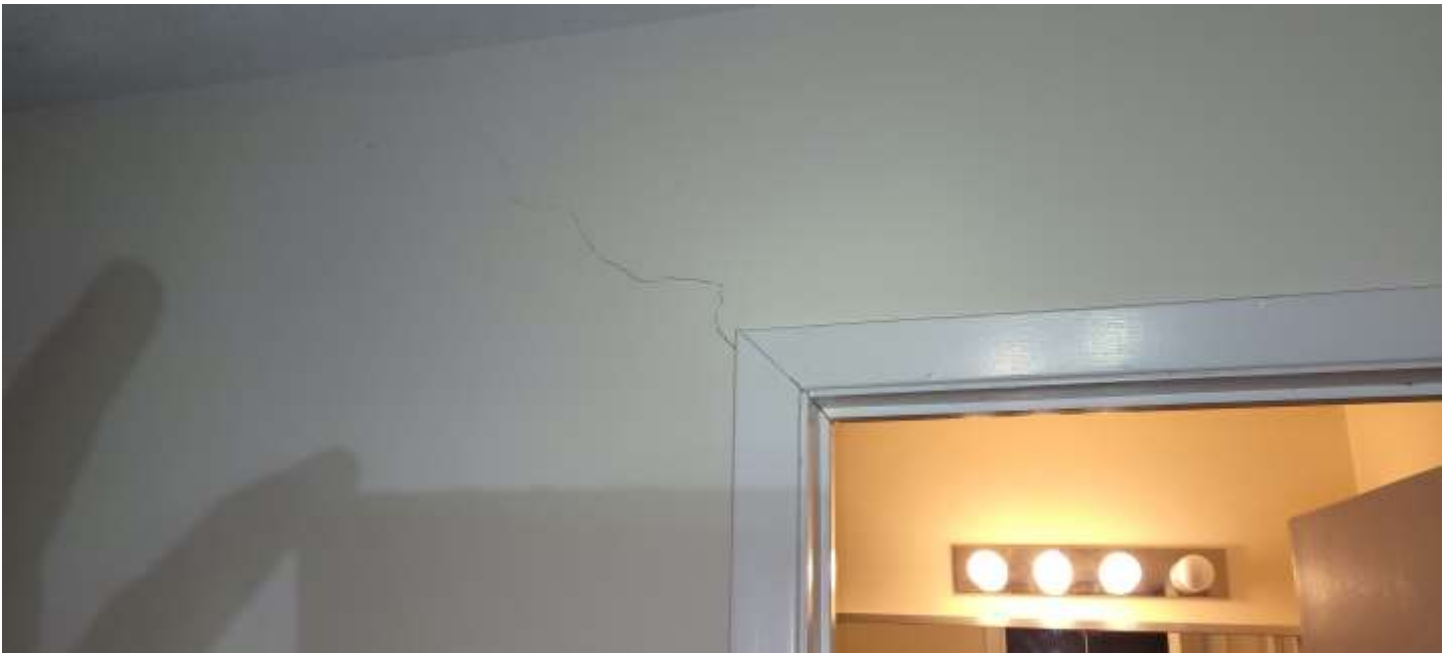
Crack in the wall between the master bedroom and master bathroom. I don't think this is a structural issue. There was also no translation of this crack to motion of the foundation directly underneath this in the foundation area.

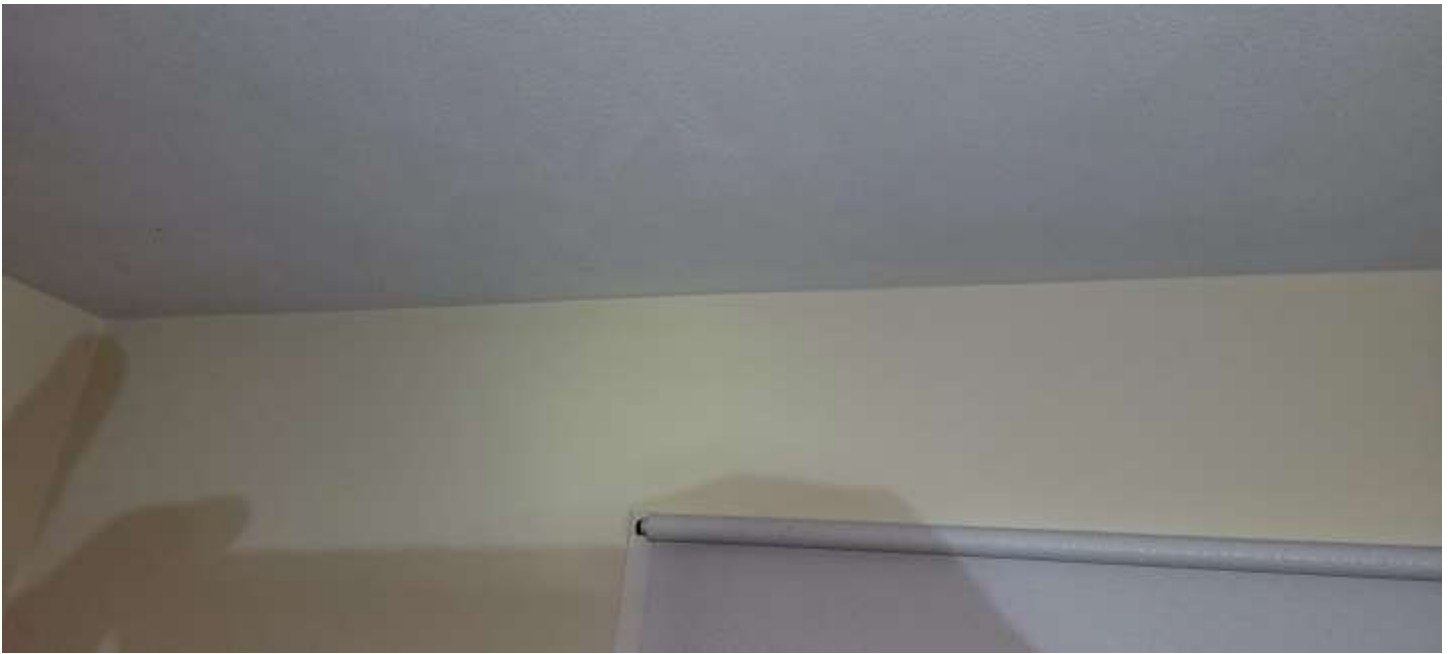
I think this crack in the kitchen is due to workmanship and age.

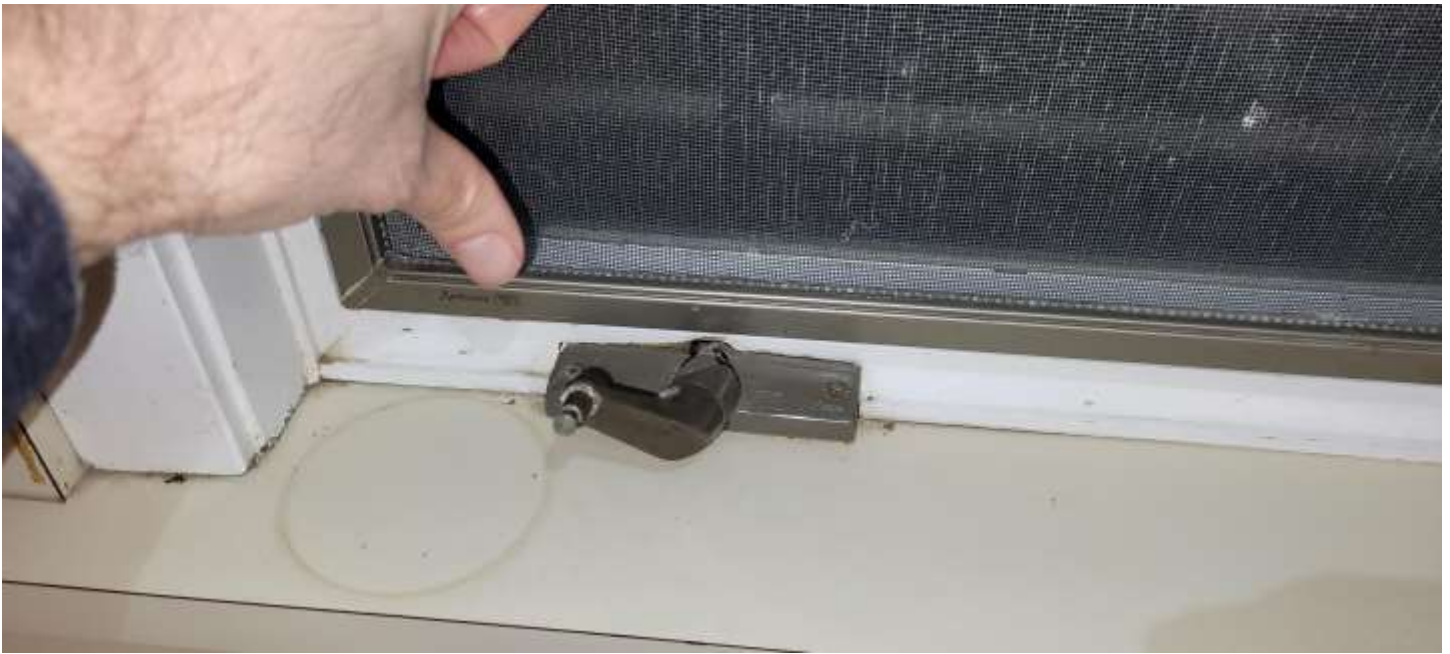
But the lock does not.

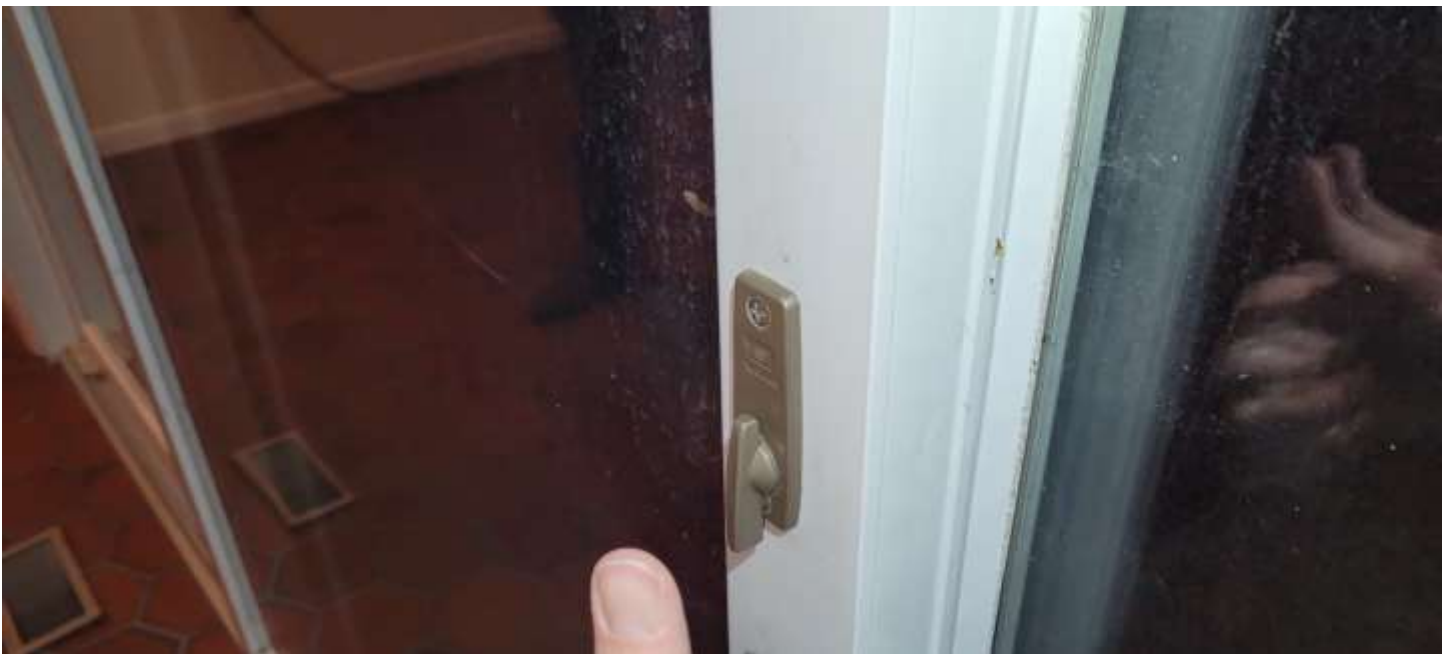
The lock from this screen door is missing.

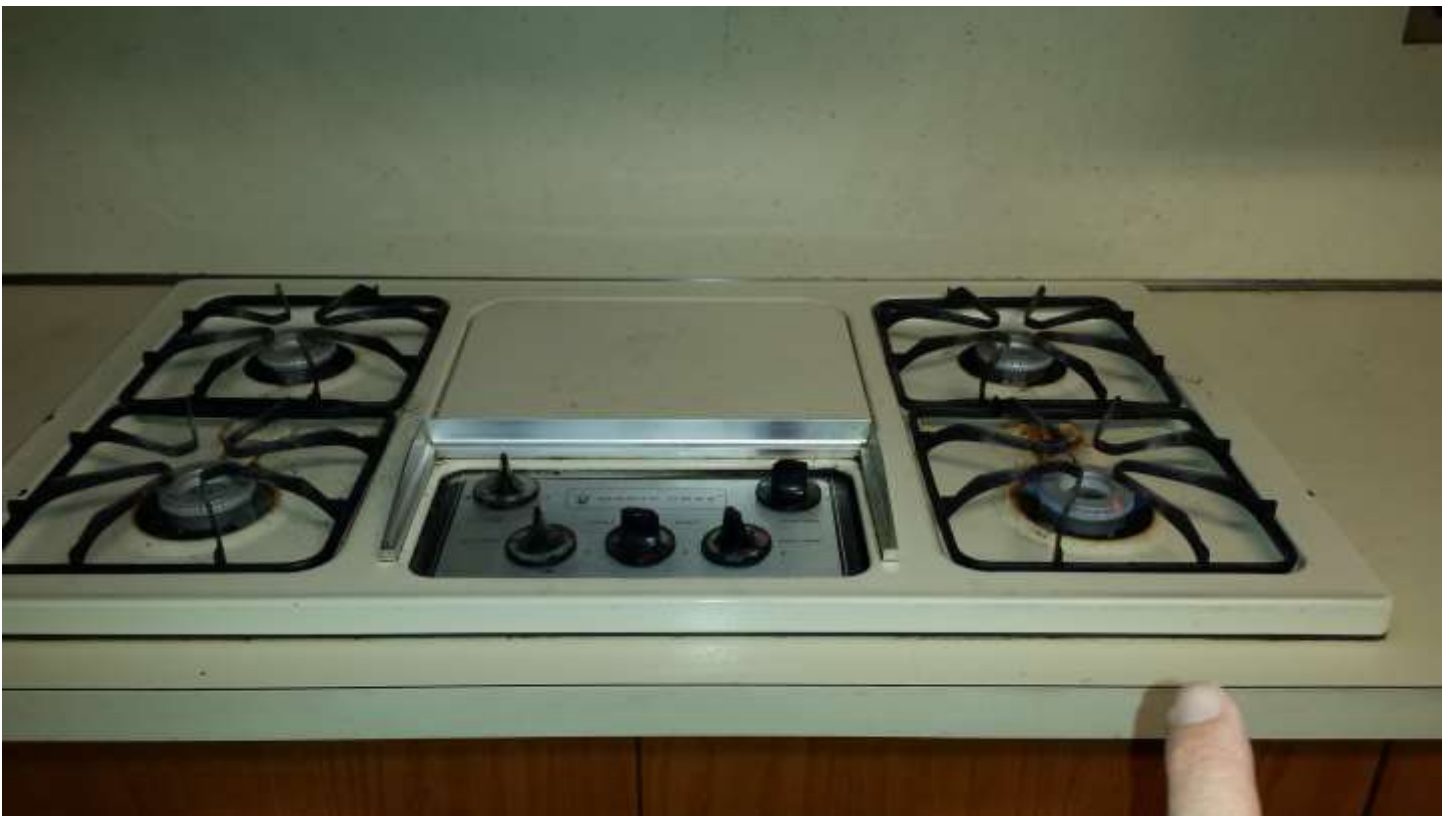
The feeder valve to the main range was flipped off. The burners on the range did not turn on.
