Property: 123 Main Street, Anytown, NY  
Date: 15Jan2021  
Present: Louis Csak, insp.; ####, buyer; ### agent.  
Conditions: 40's, overcast

**Executive summary:** (details in report)

The house was not well maintained, and the garage foundation is beginning to show serious issues, and very likely there is a regular water occurrence that will eventually affect the main foundation badly.

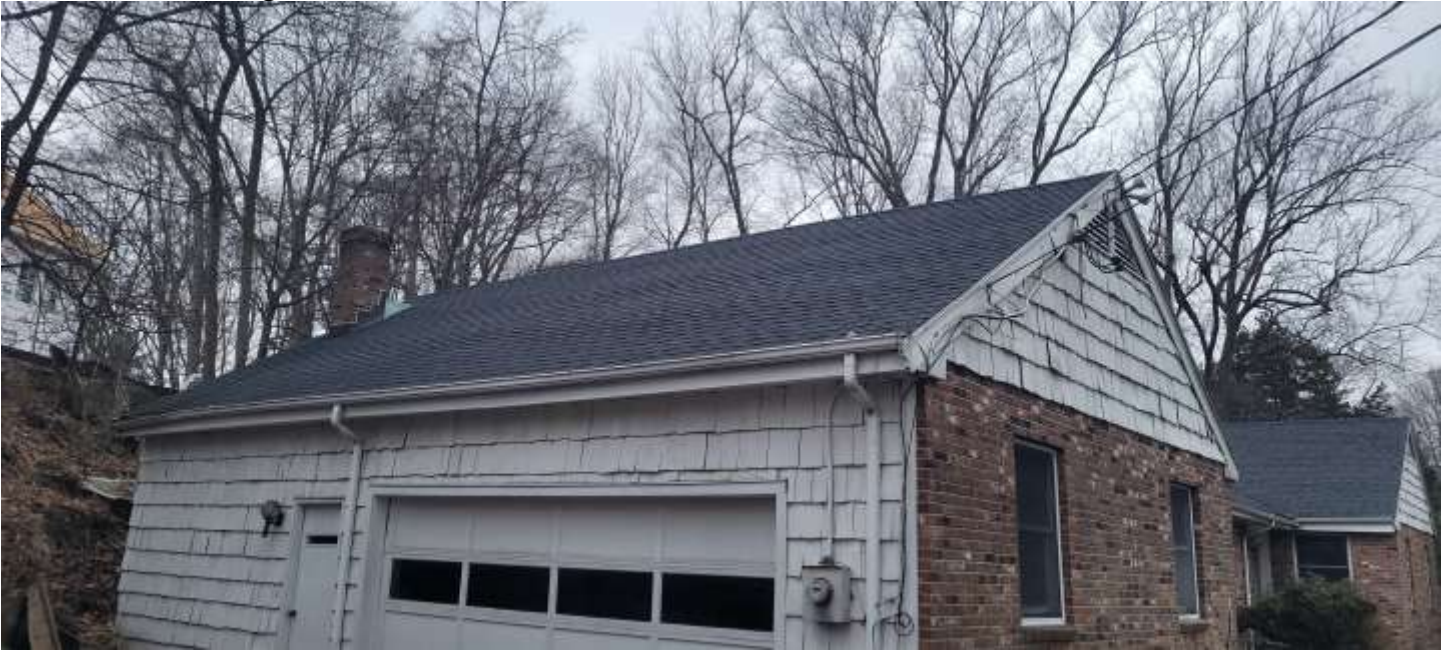
Shingles in good visual condition.

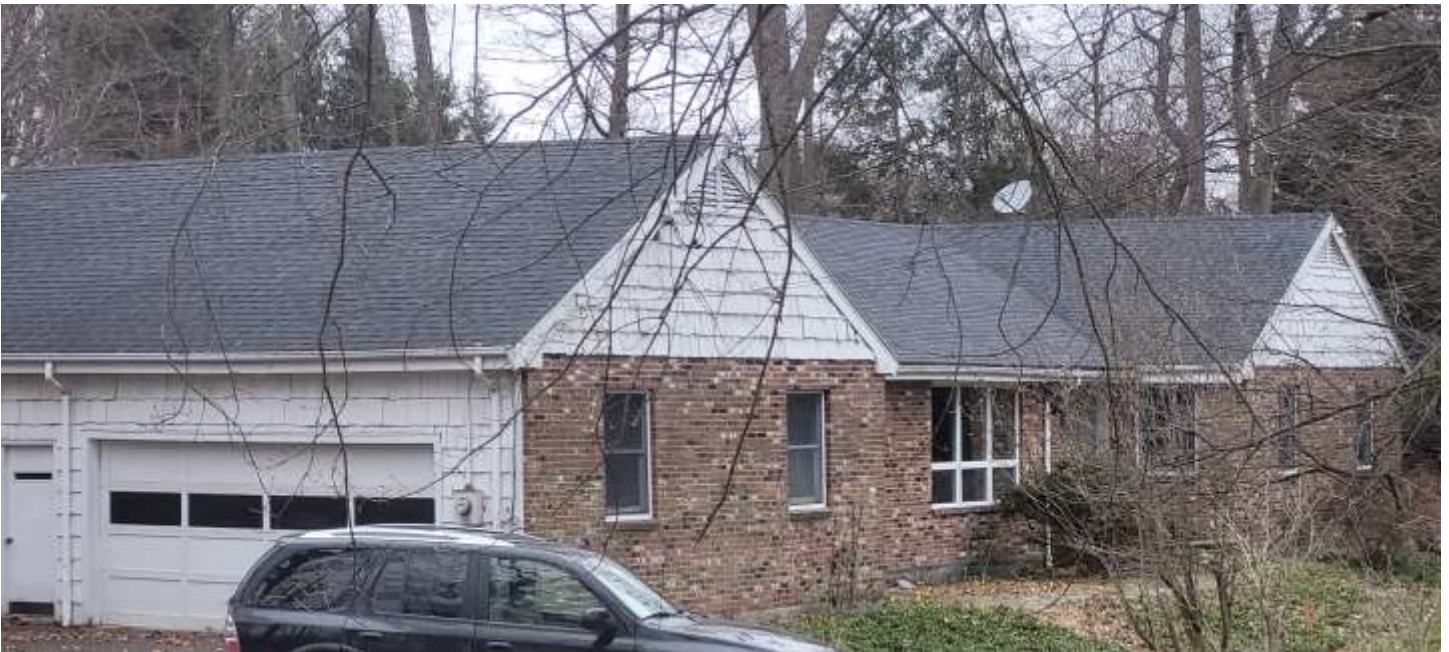
Shingles in good visual condition.

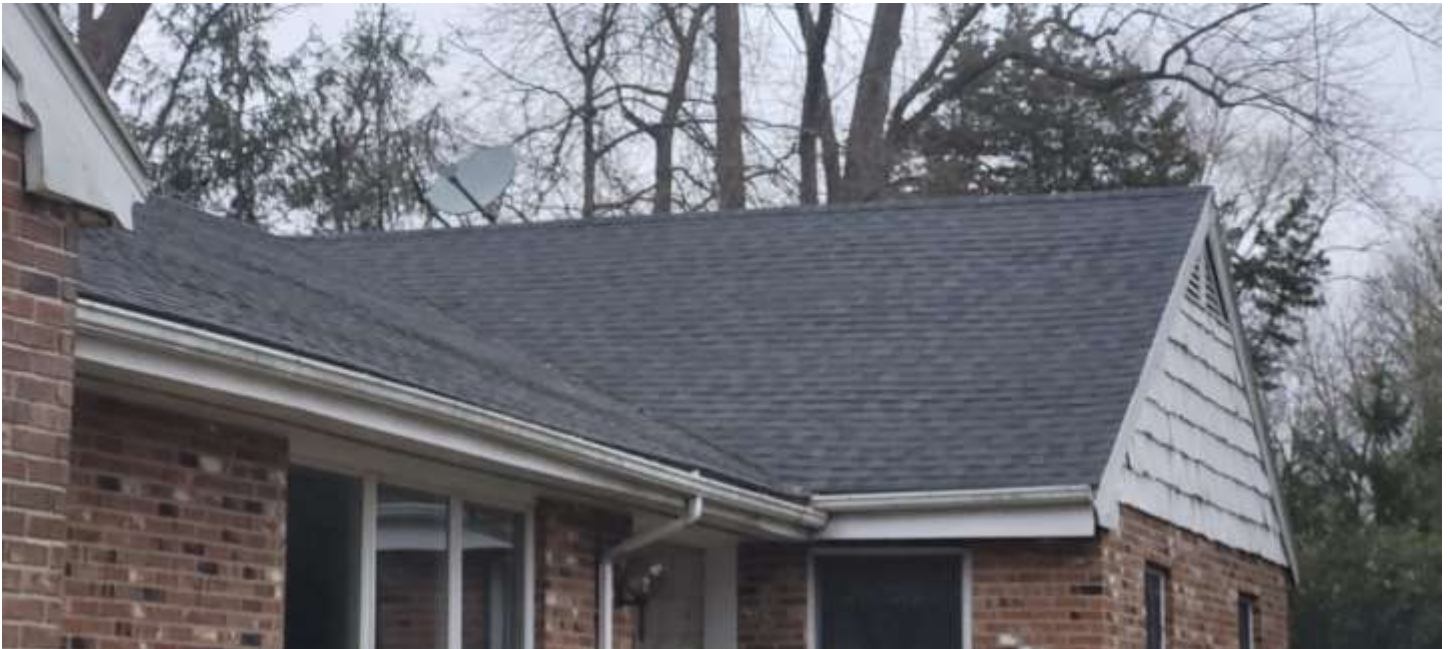
Soffits show some wear here. Gutters are showing signs of being clogged. Shingles in good visual condition. I suggest these gutters be cleaned, and repaired.

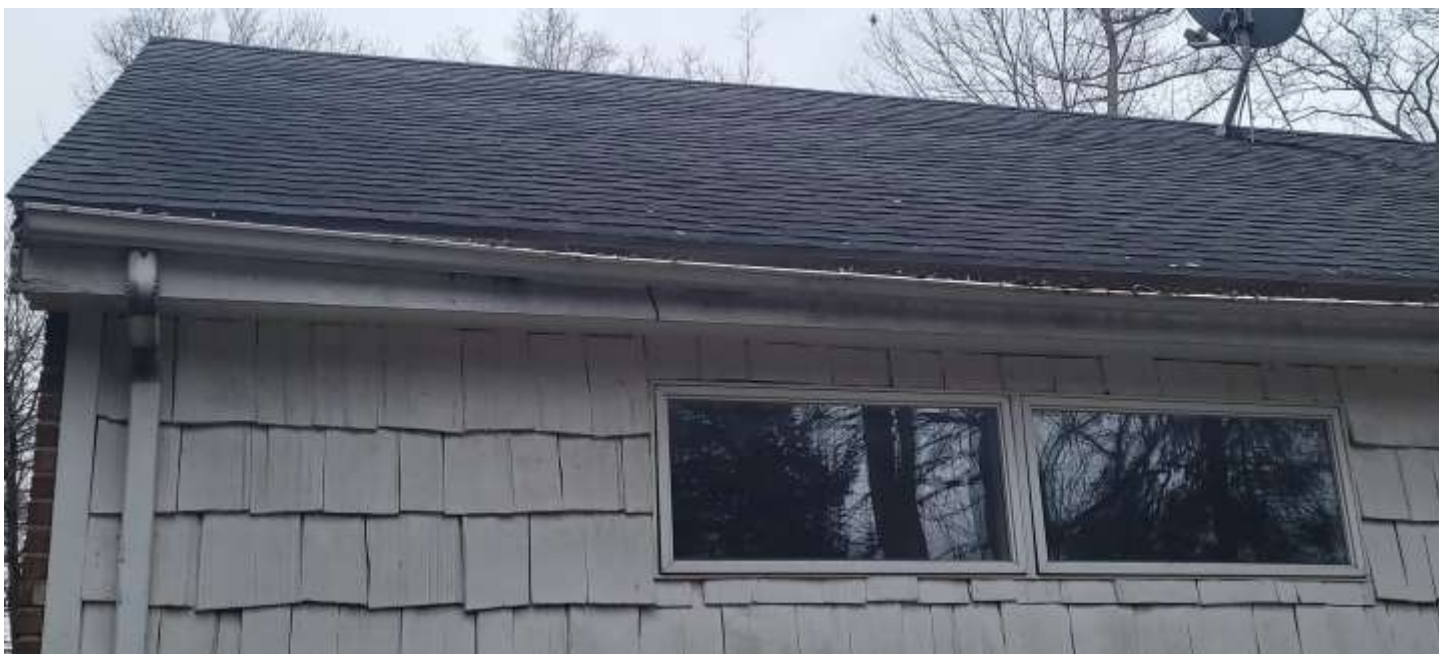
Soffits show some wear here. Gutters are showing signs of being clogged. Shingles in good visual condition. I suggest these gutters be cleaned, and repaired. Downspouts in good condition.

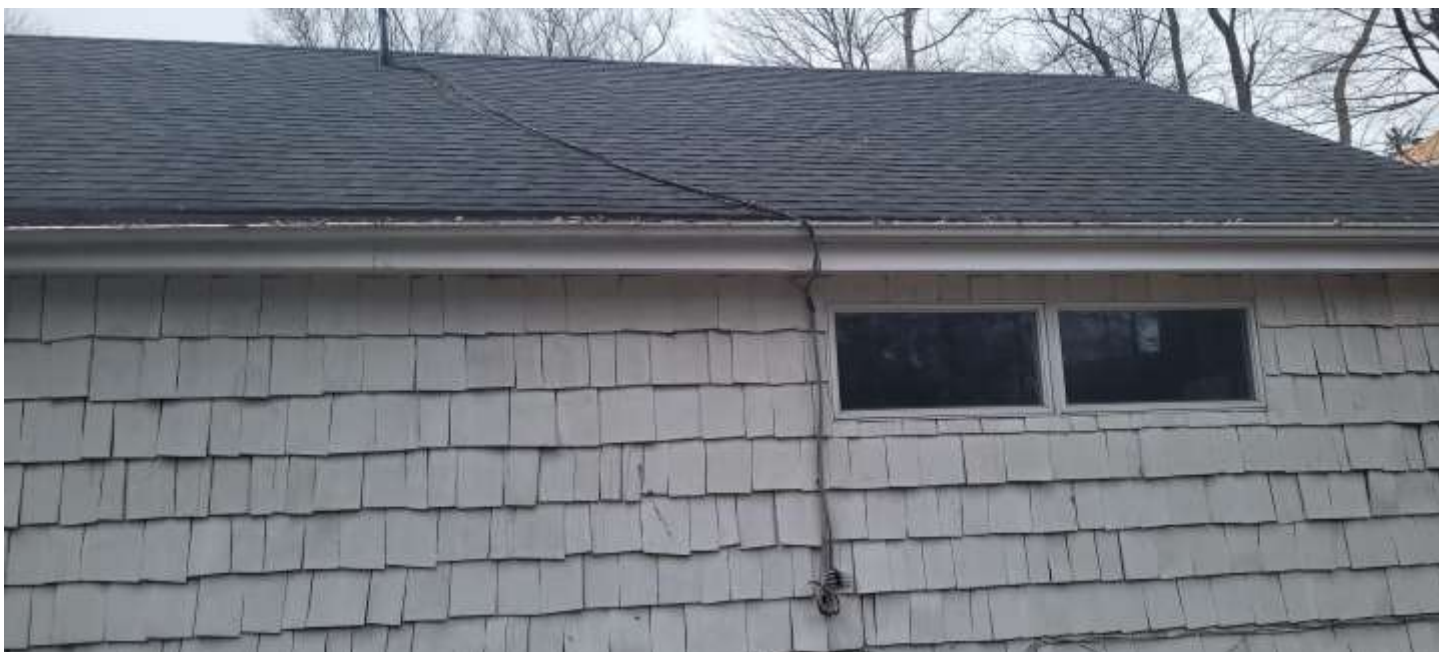
Soffits show some wear here. Gutters are showing signs of being clogged. Shingles in good visual condition. I suggest these gutters be cleaned, and repaired.

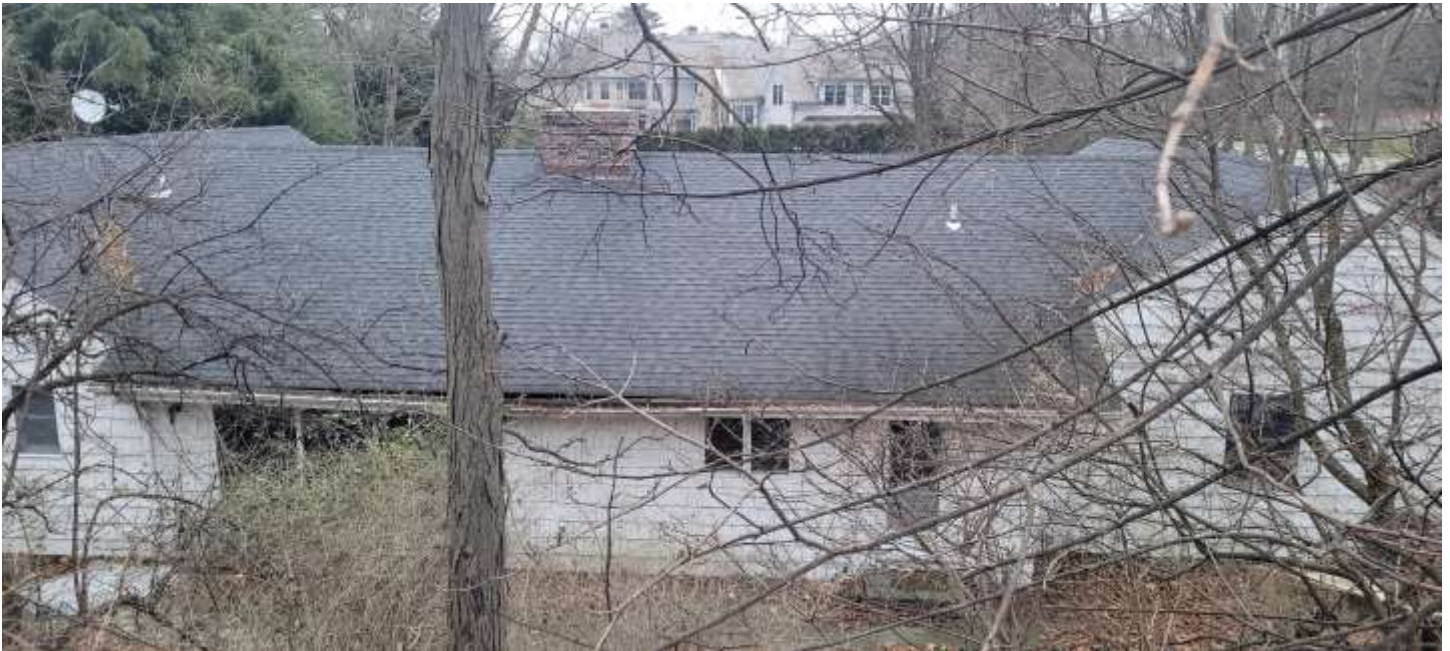
Shingles in good visual condition. Chimney in good visual condition. That gutter at the bottom center is clearly broken.

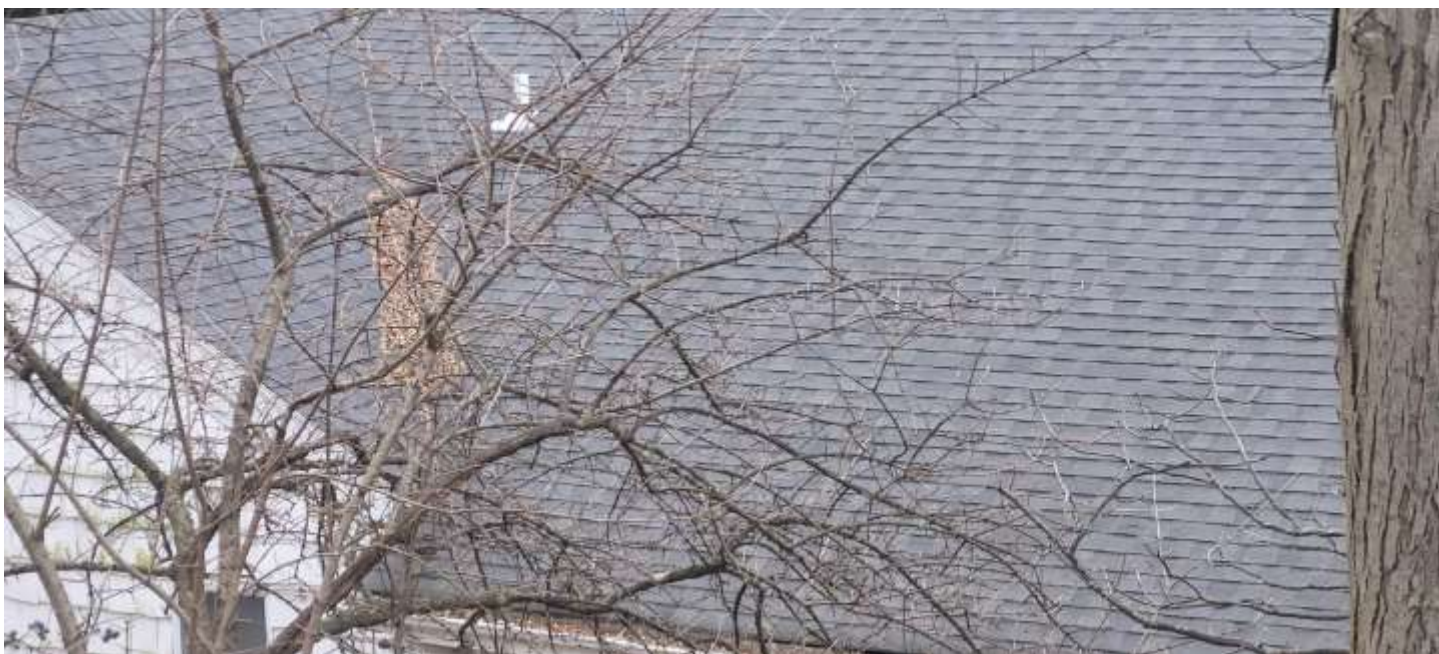
Get those leaves off the roof.

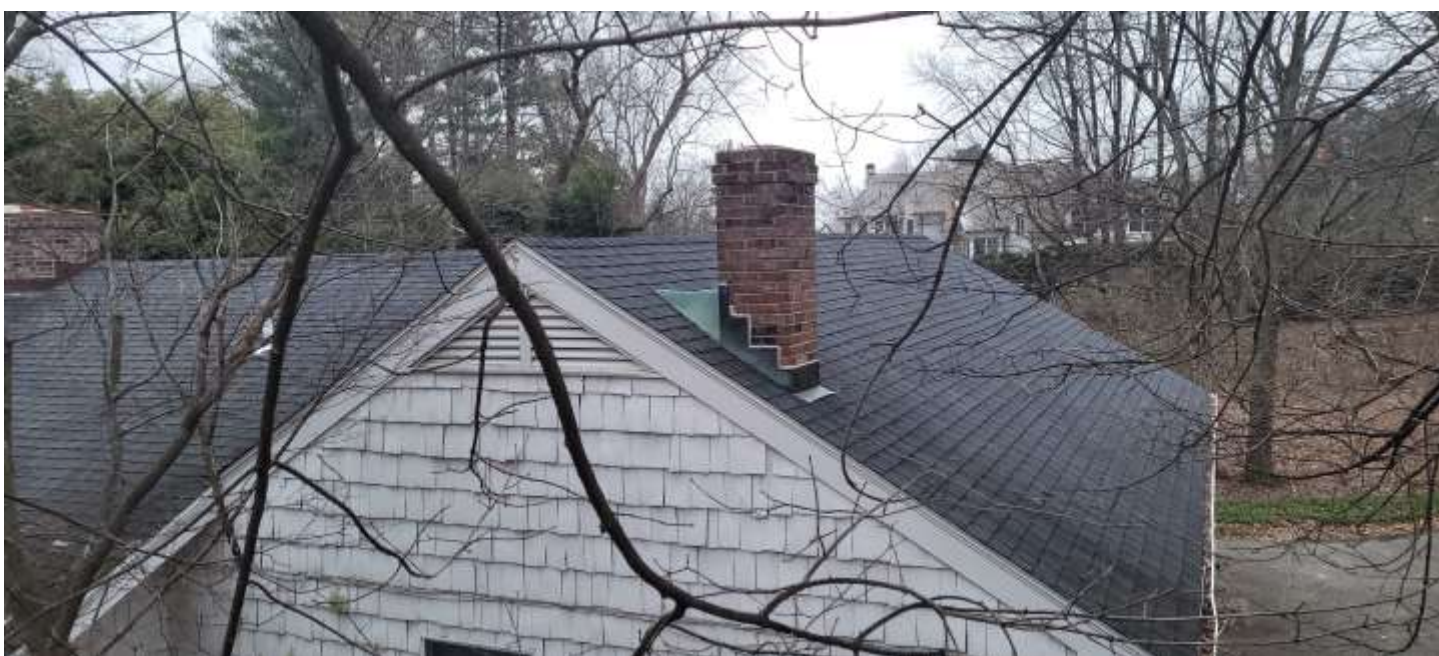
Chimney in good visual condition.

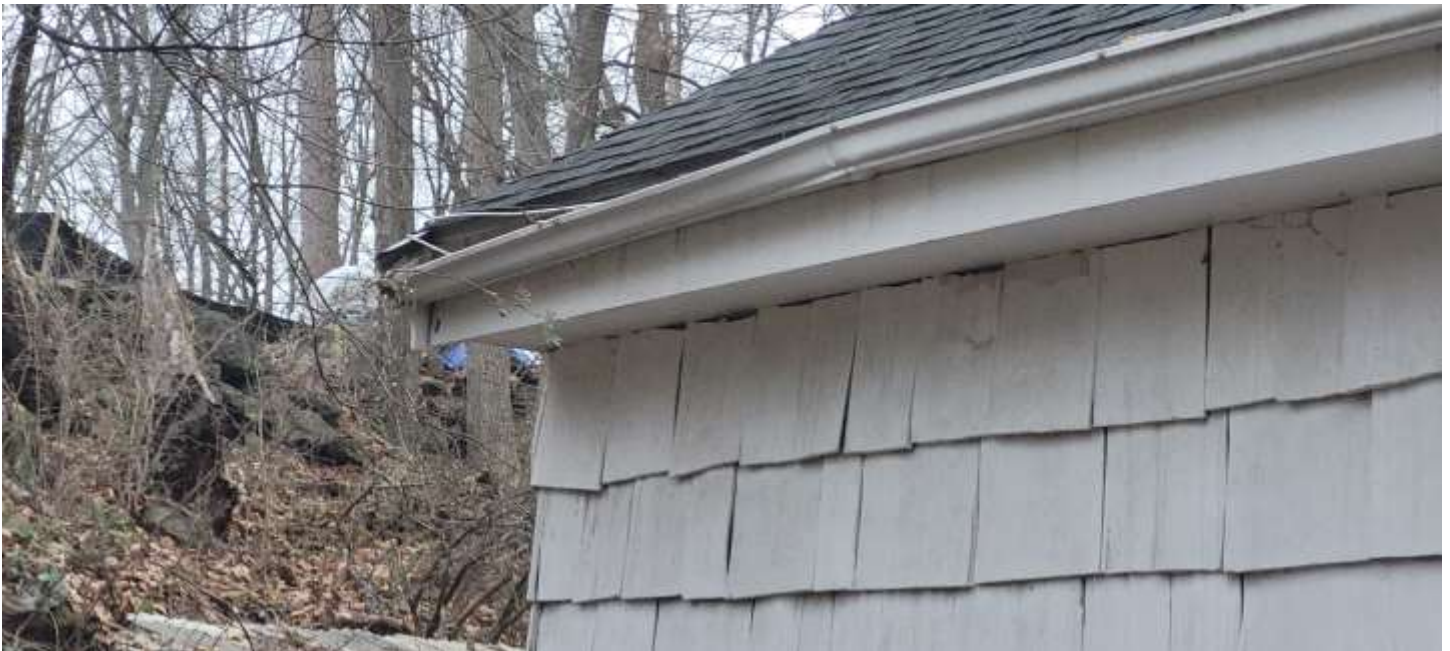
That gutter is broken, and should be repaired.

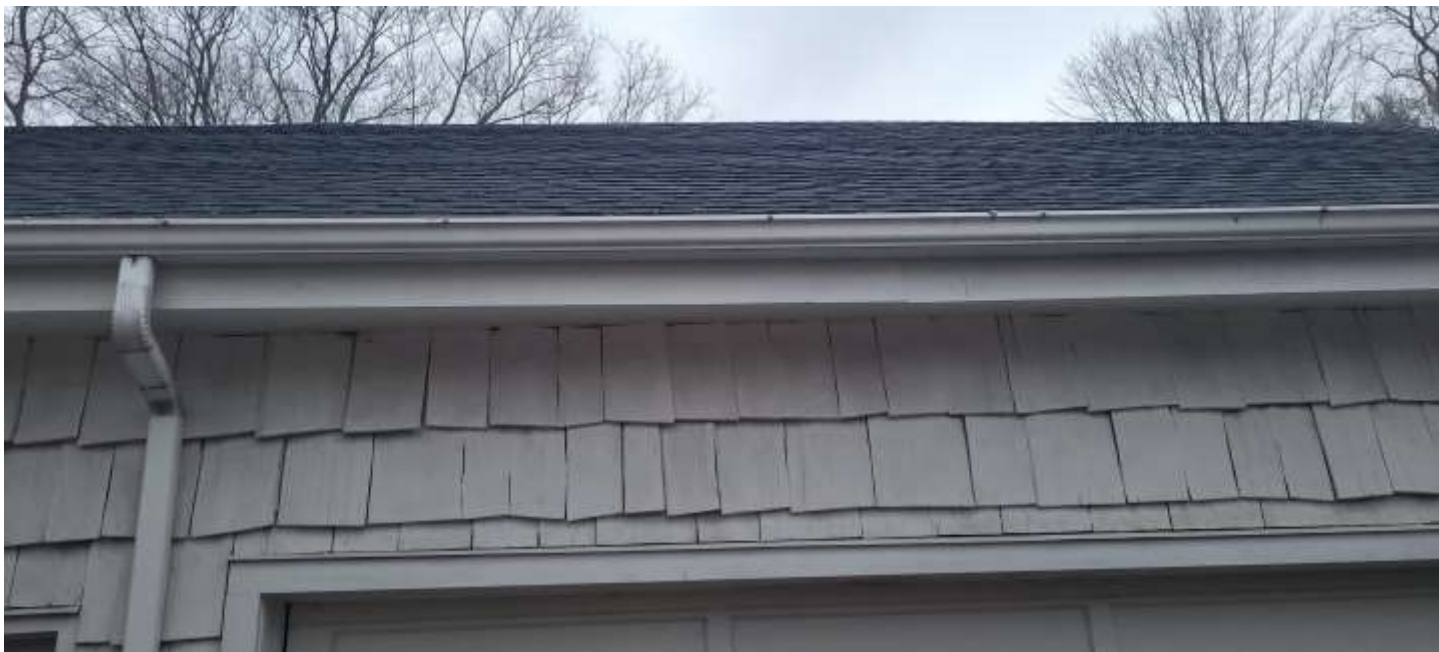
Gutter and soffits here look OK. Downspout in good visual condition.

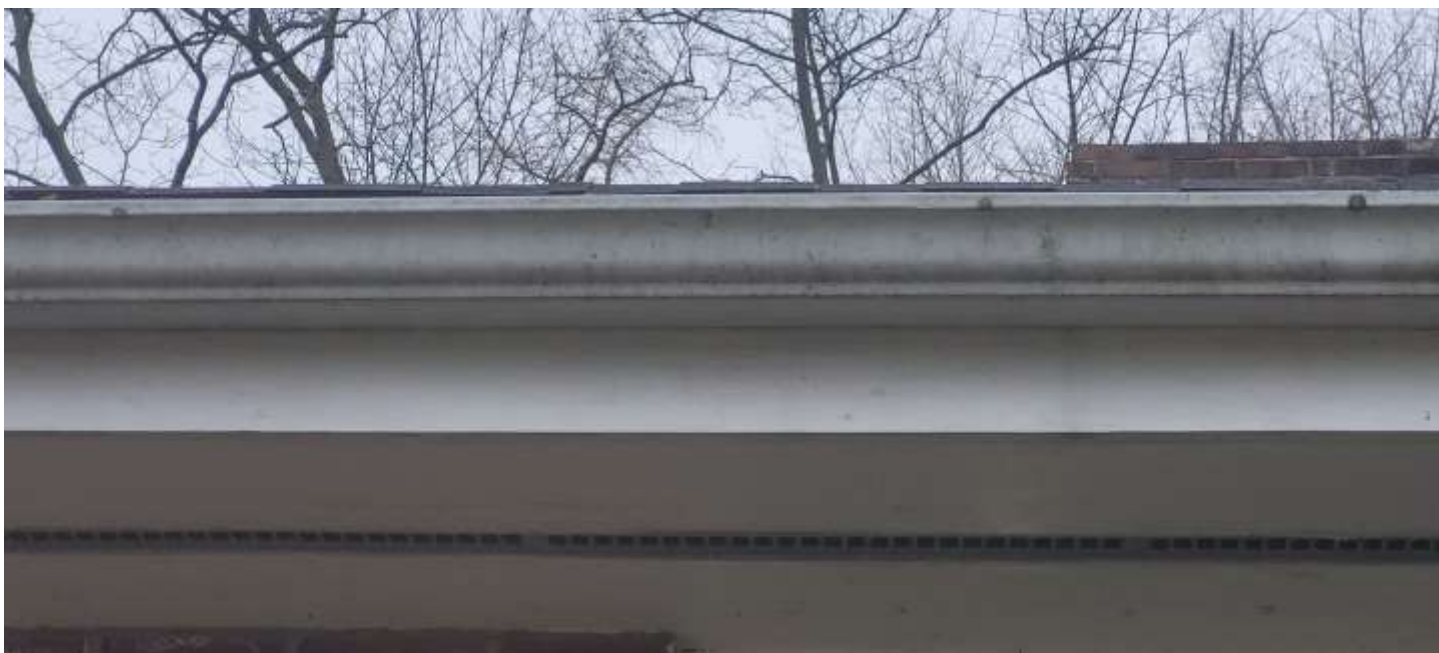
Gutter and soffits in good visual condition. Chimney in good visual condition.

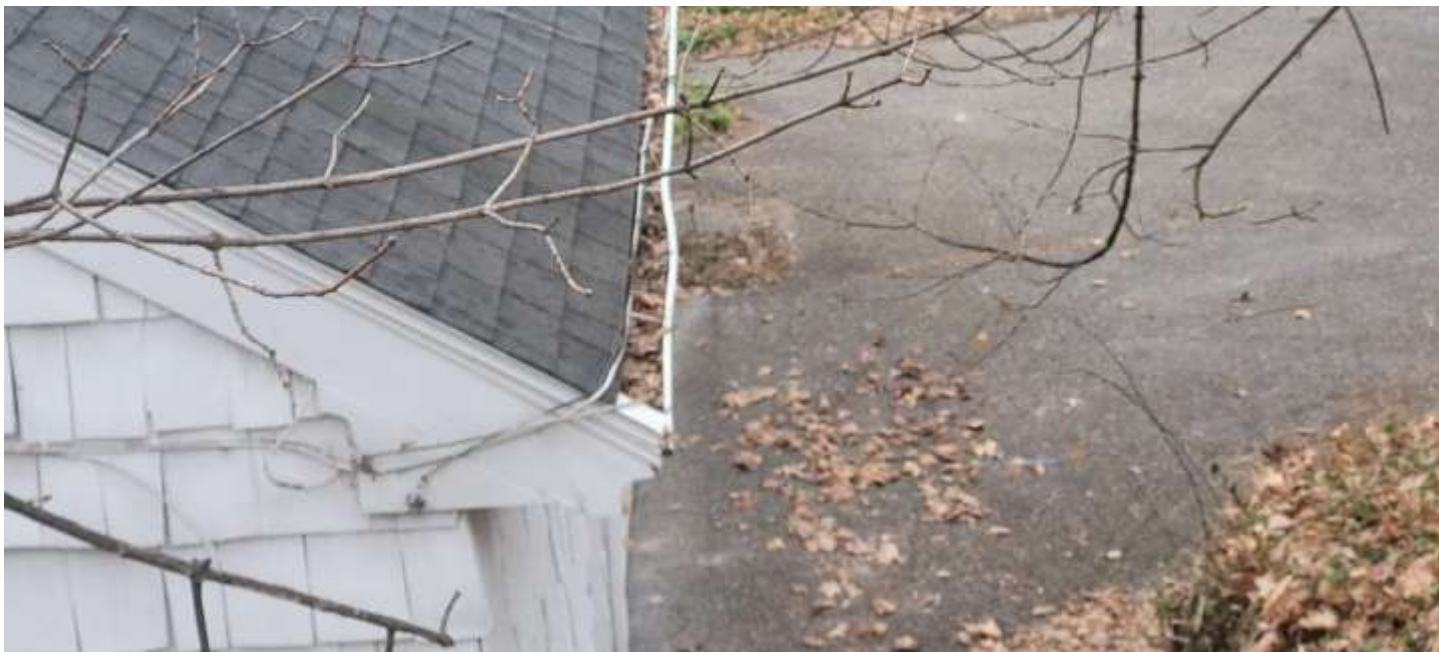
And clearly that gutter is clogged.

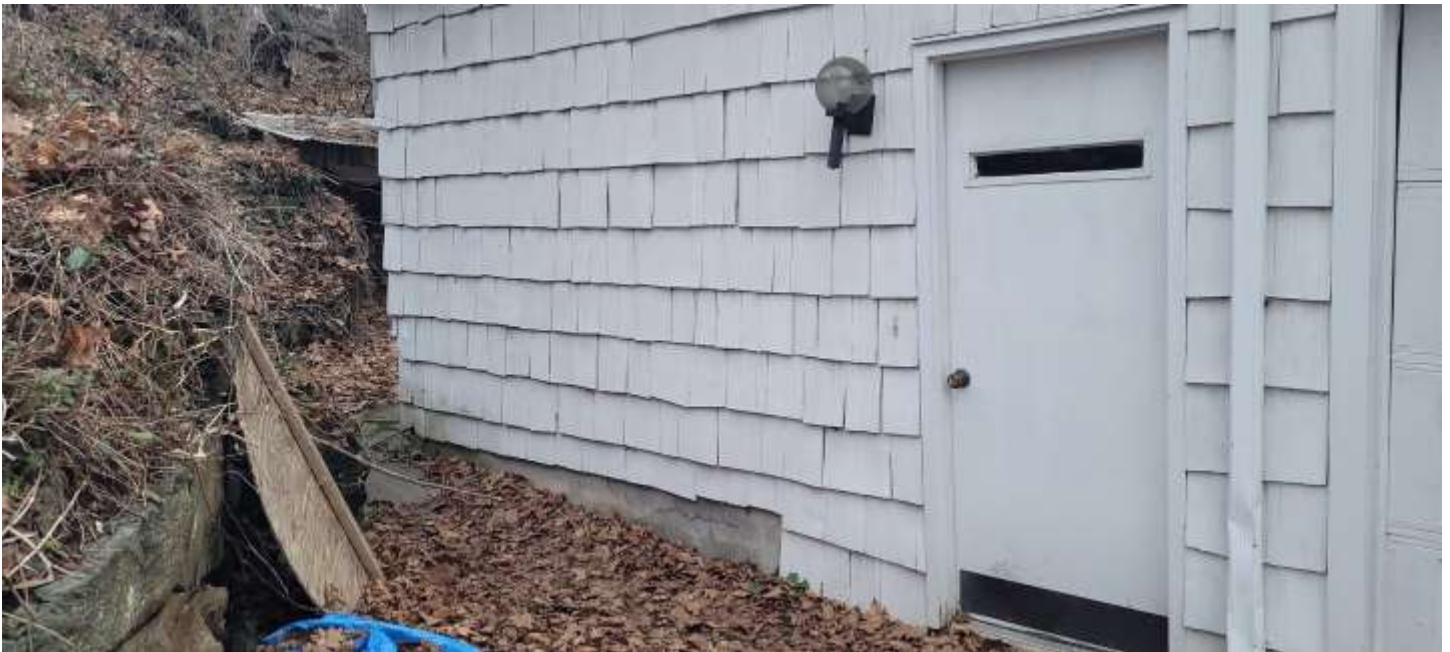
Painted wood generally well maintained and in good condition. I could not lock this door.

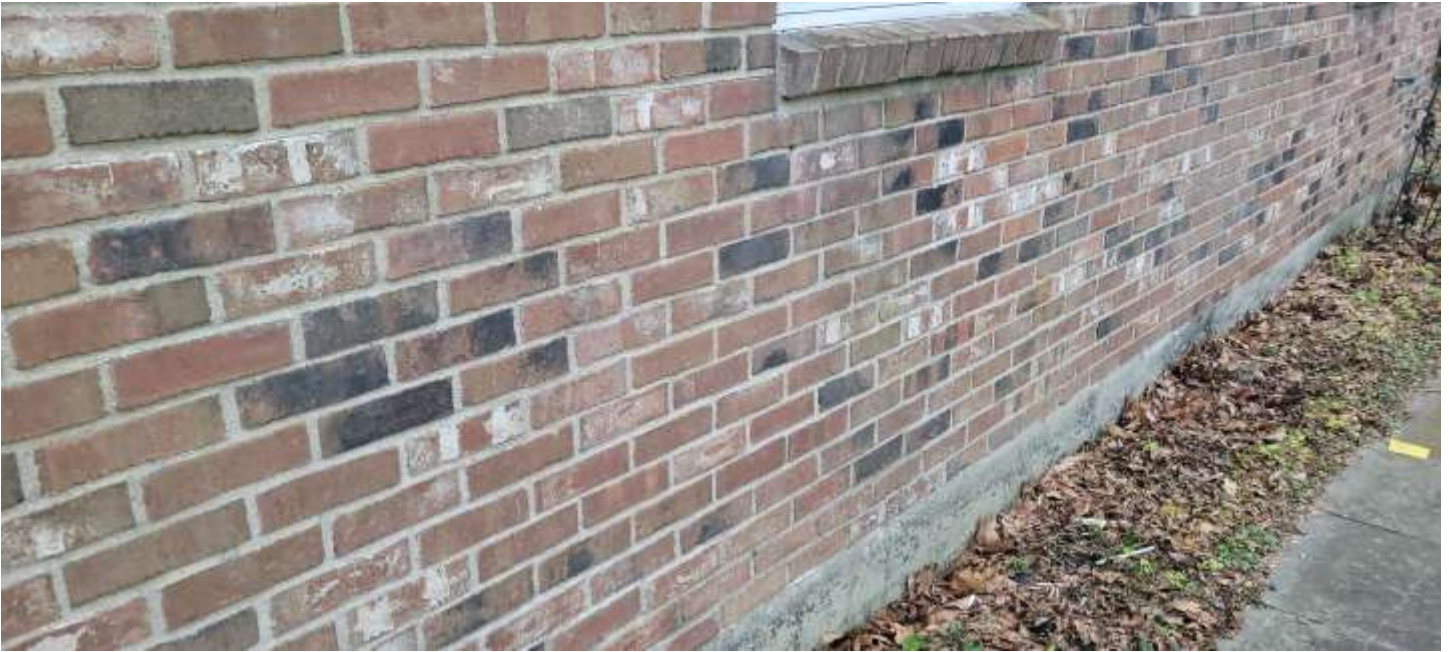
Where the brick was not cracked due to the ground moving, it was in very good visual condition.

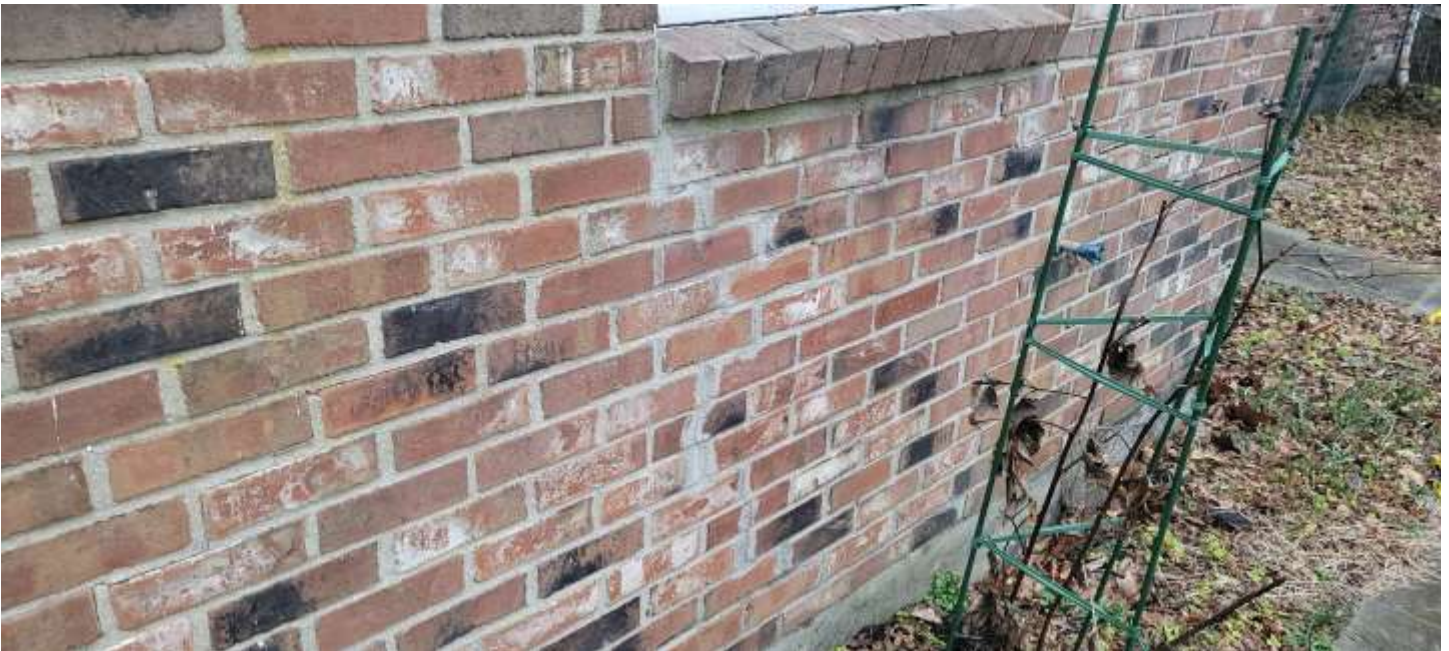
Where the brick was not cracked due to the ground moving, it was in very good visual condition.

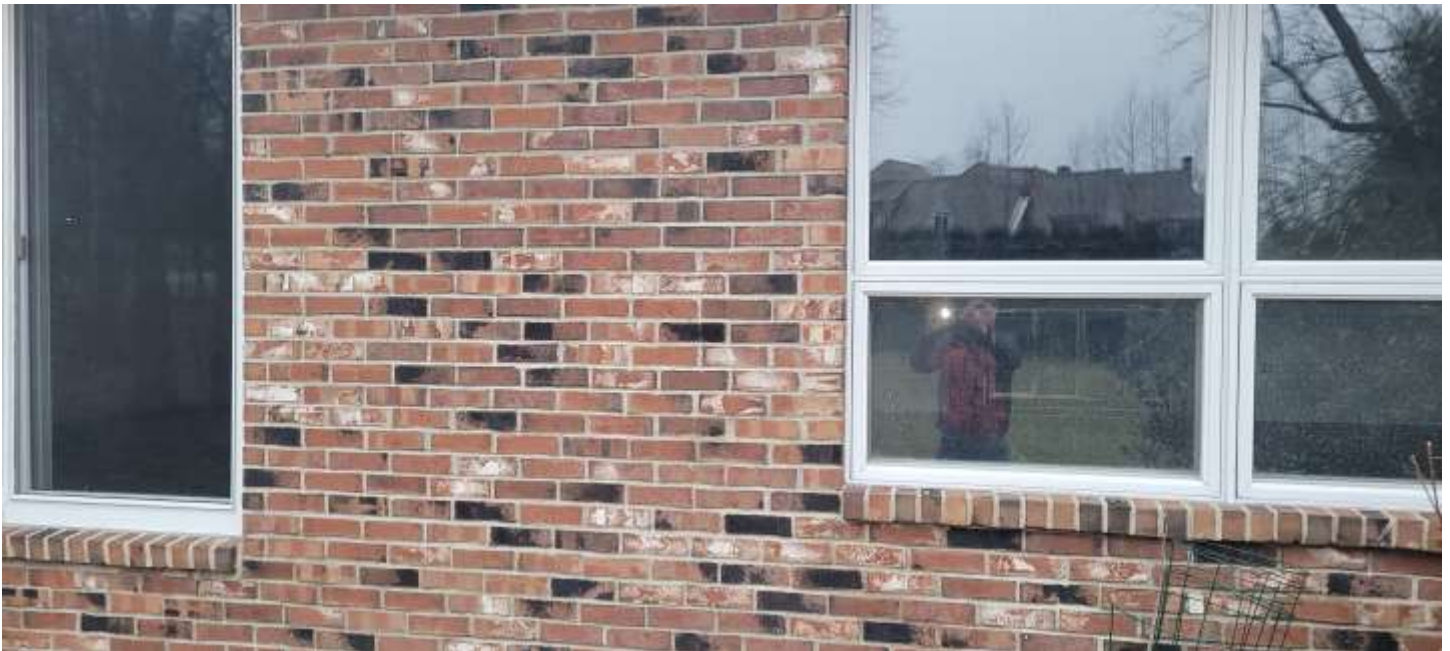
Where the brick was not cracked due to the ground moving, it was in very good visual condition.

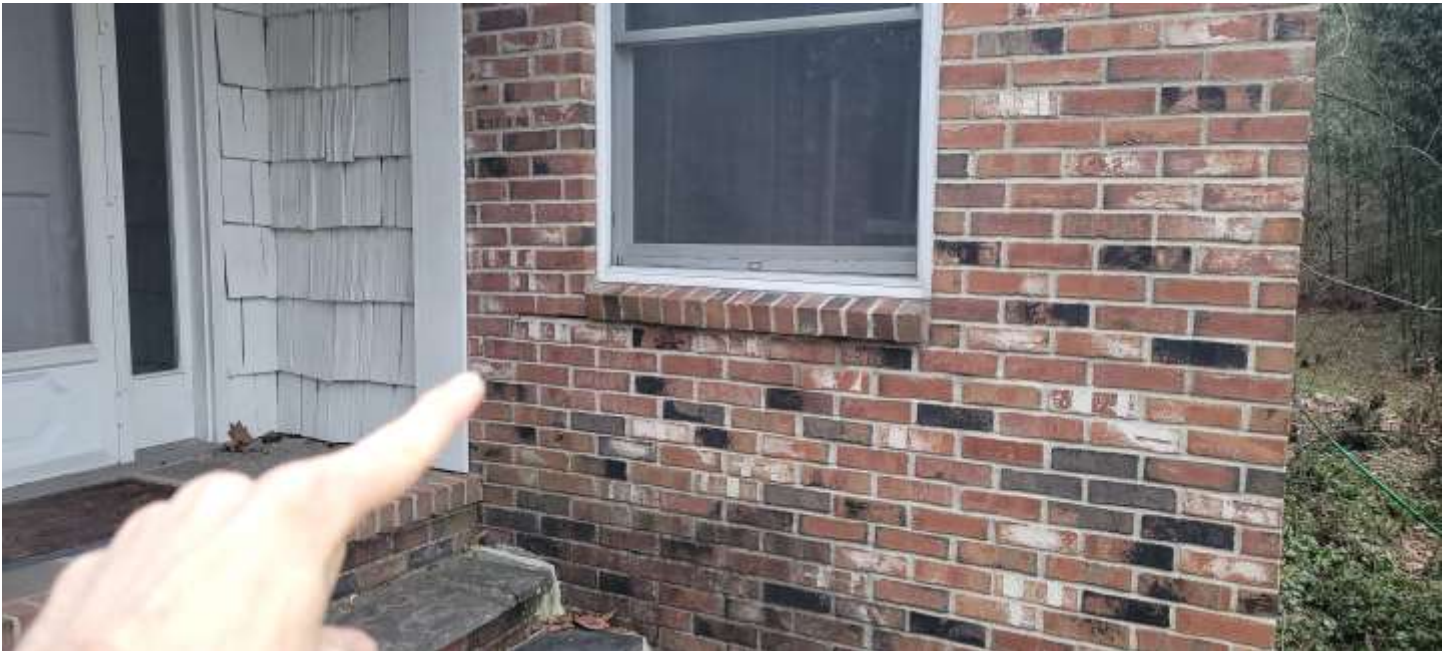
There's one spot here that's indicative of the foundation moving just a bit under this section of house. That should be re sealed.

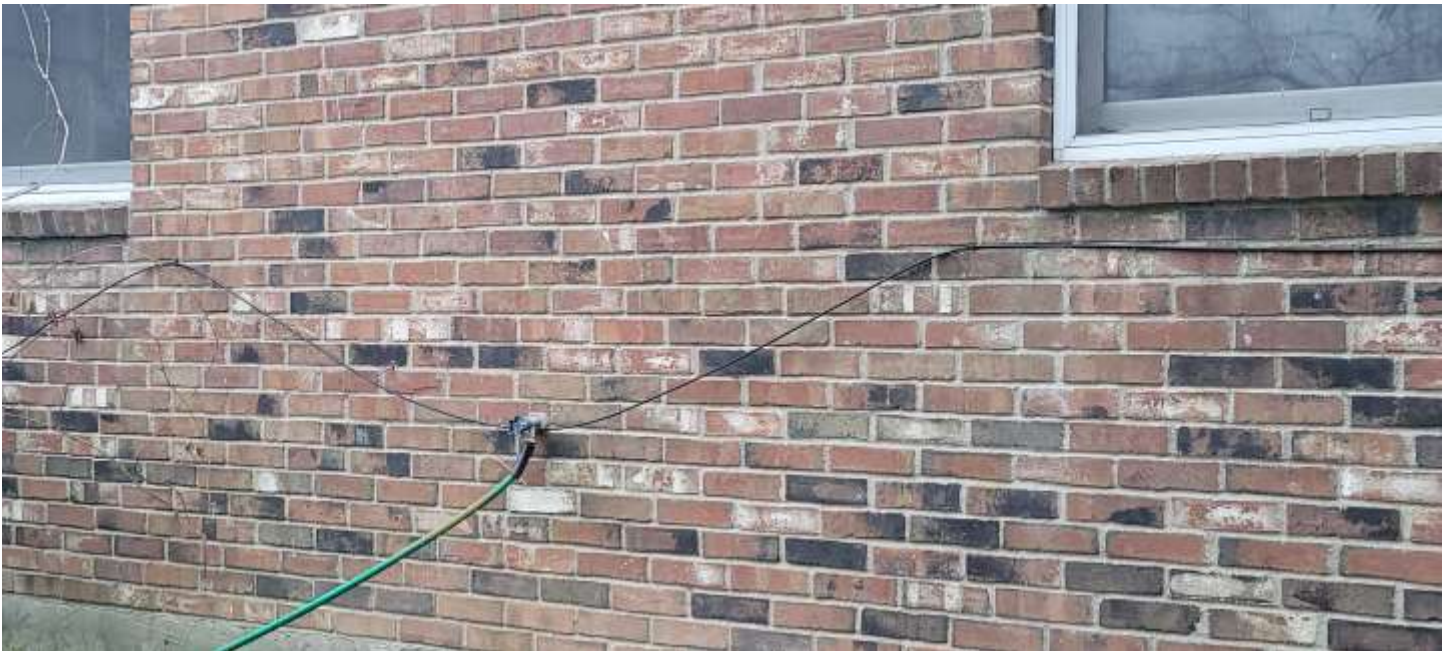
Where the brick was not cracked due to the ground moving, it was in very good visual condition.

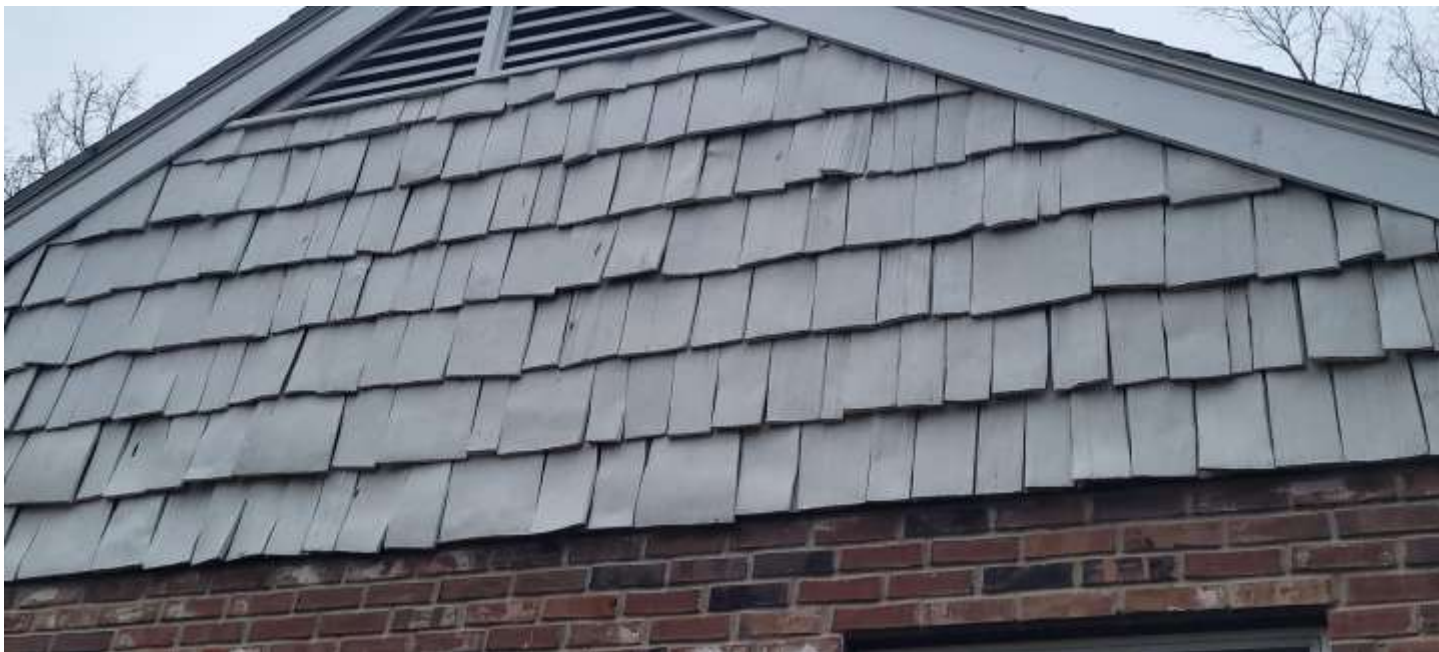
Painted wood generally well maintained and in good condition.

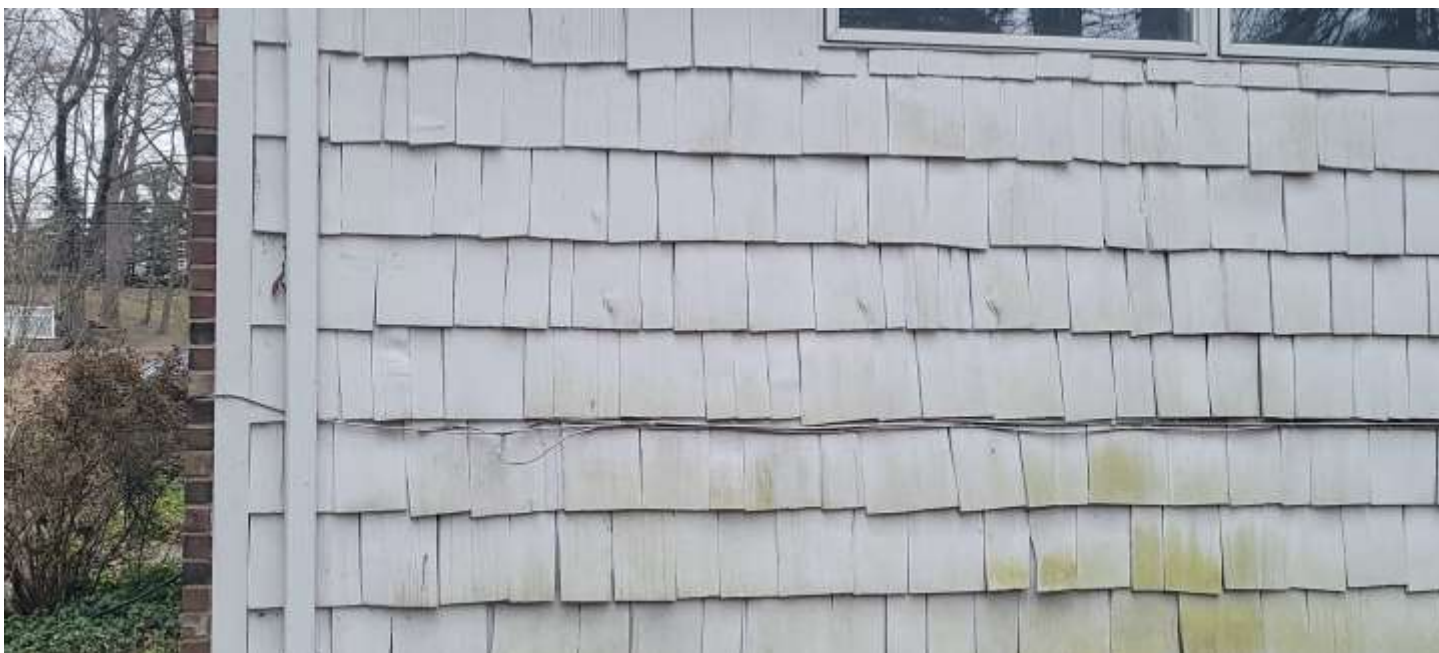
Painted wood generally well maintained and in good condition.

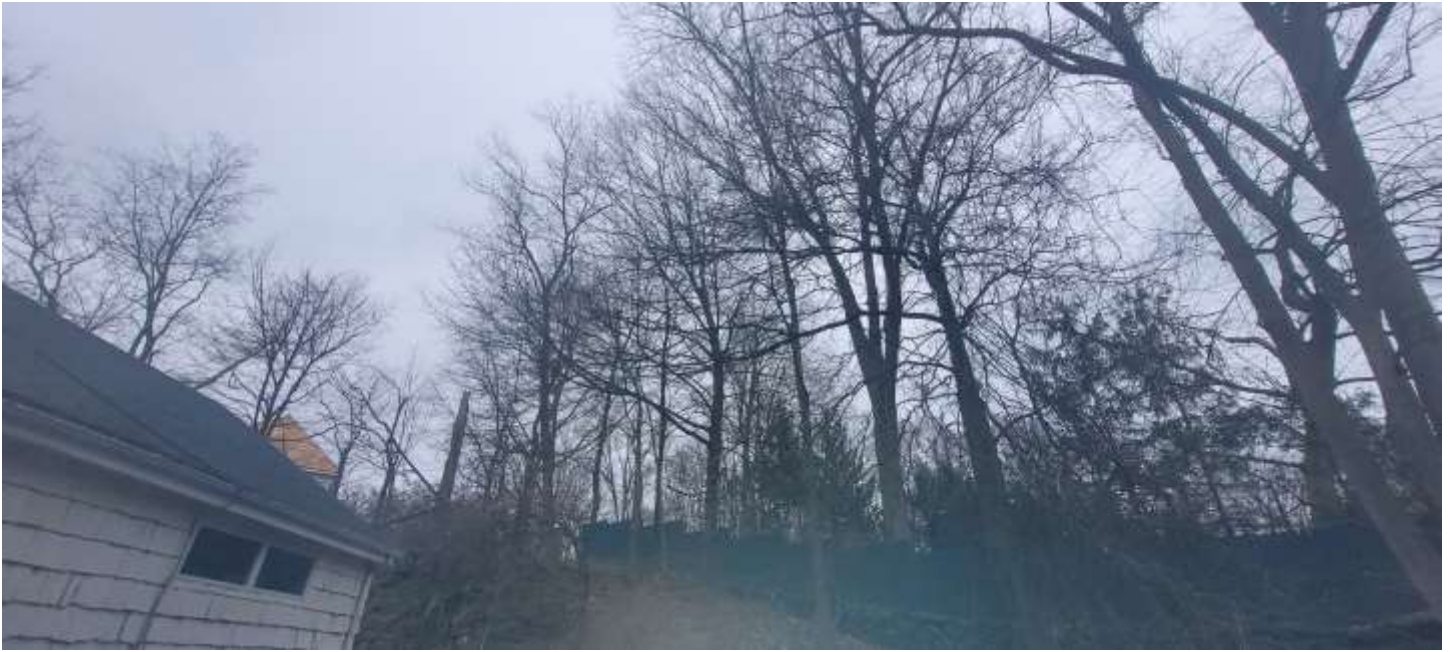
Some of those trees are fall hazards. Trim them or better yet remove them if you can.

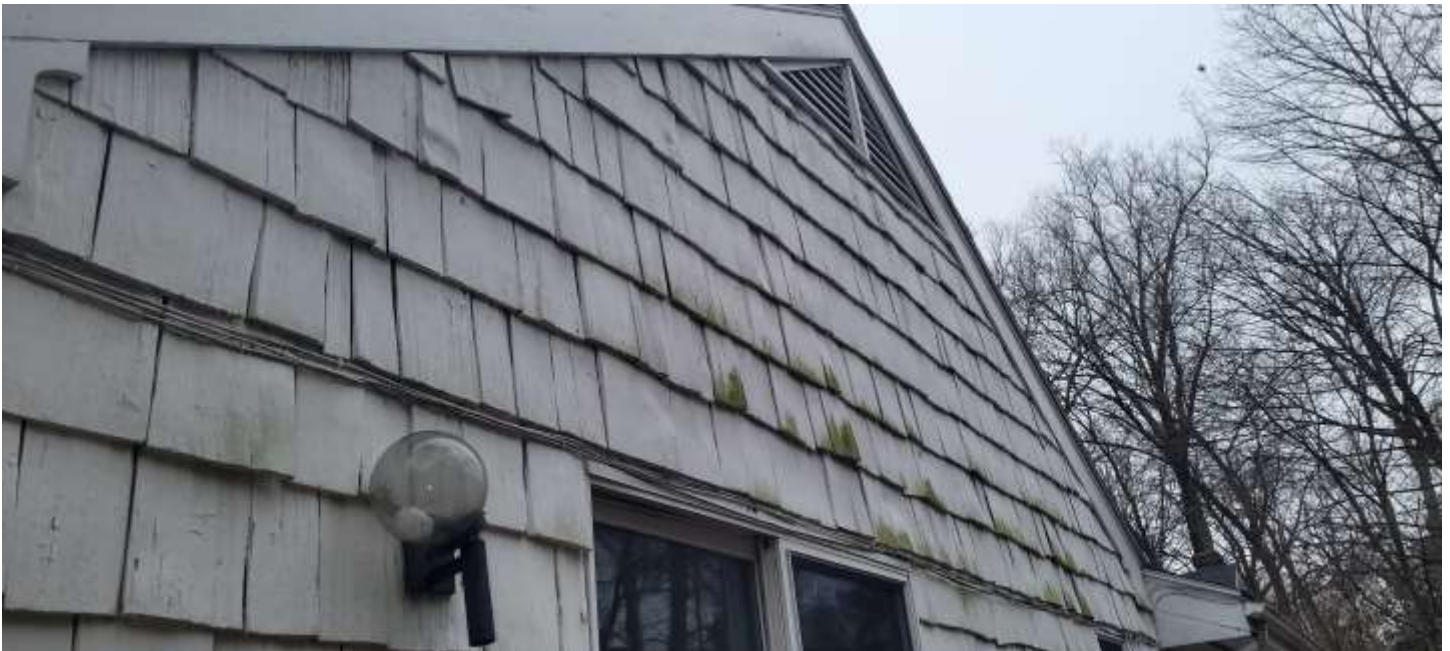
Painted wood generally well maintained and in very good condition.

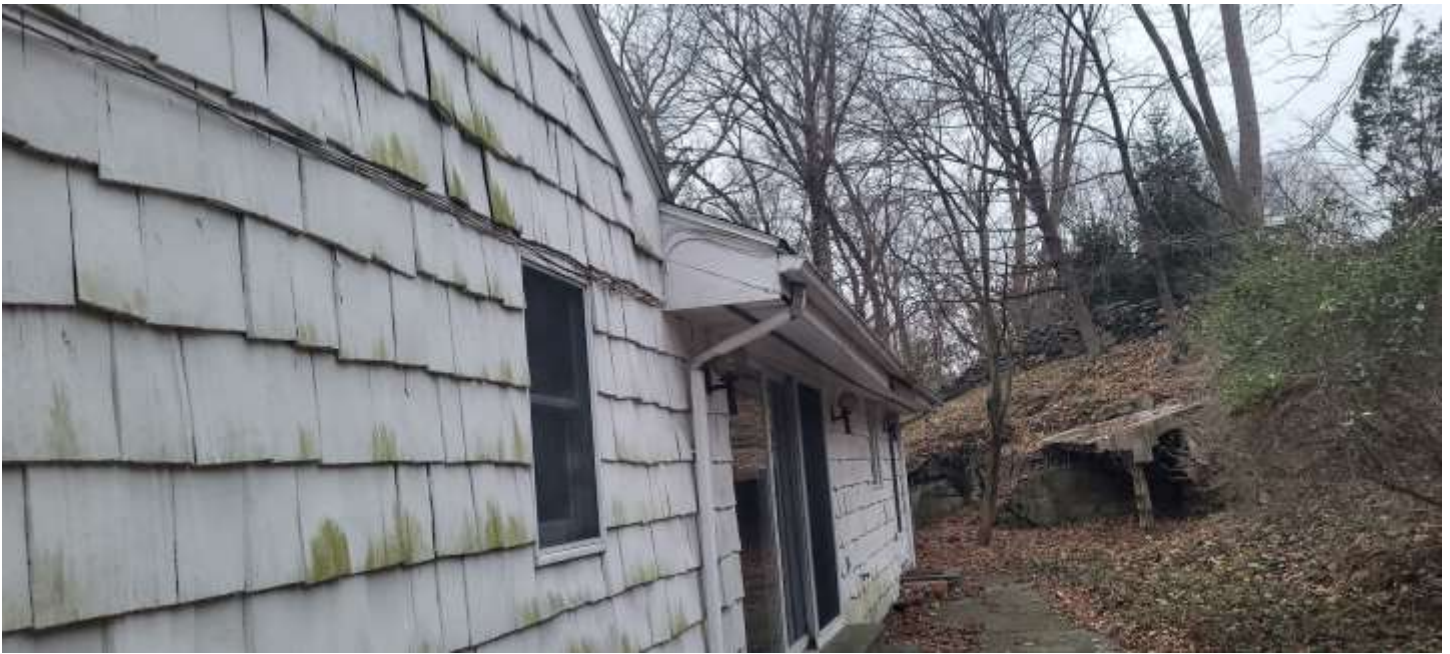
Painted wood generally well maintained and in very good condition.

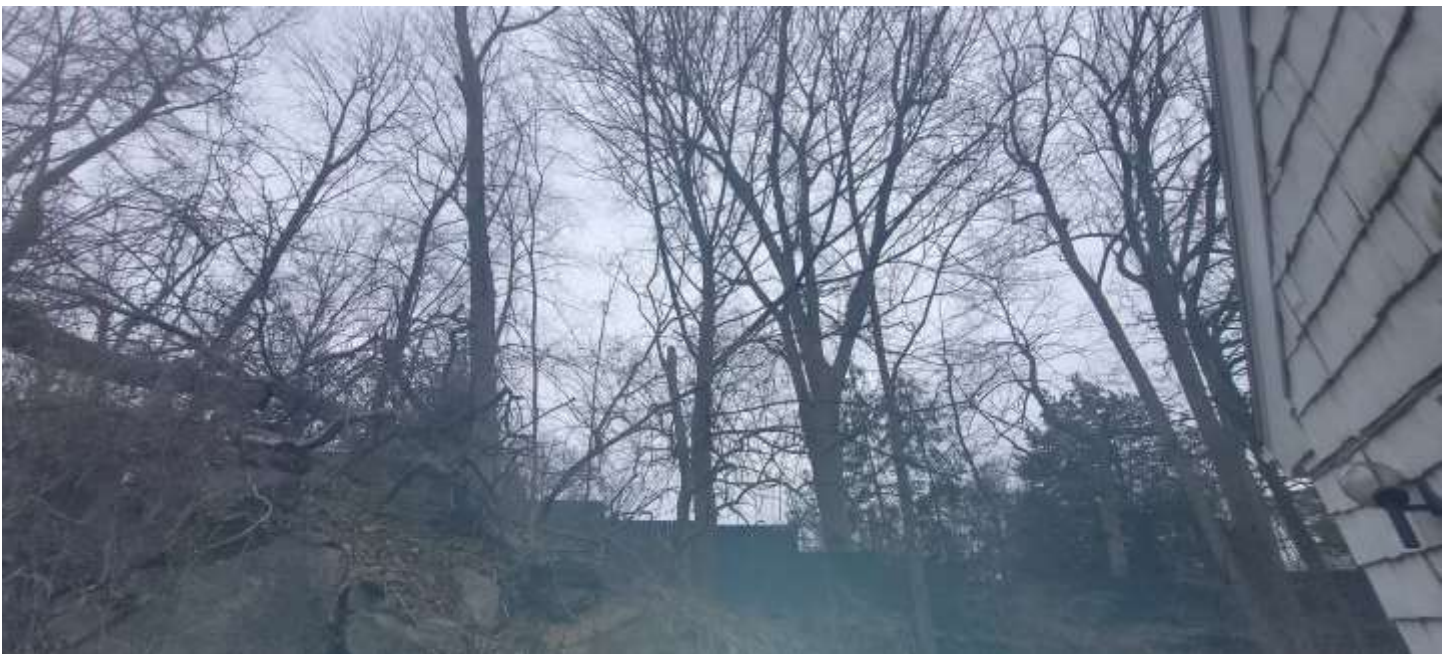
I think those trees could also be potential fall hazards. Consider trimming them, or better yet remove them.
