Property: 123 Main Street, Anytown, NY  
Date: 15Jan2021  
Present: Louis Csak, insp.; ####, buyer; ### agent.  
Conditions: 40's, overcast

**Executive summary:** (details in report)

The house was not well maintained, and the garage foundation is beginning to show serious issues, and very likely there is a regular water occurrence that will eventually affect the main foundation badly.

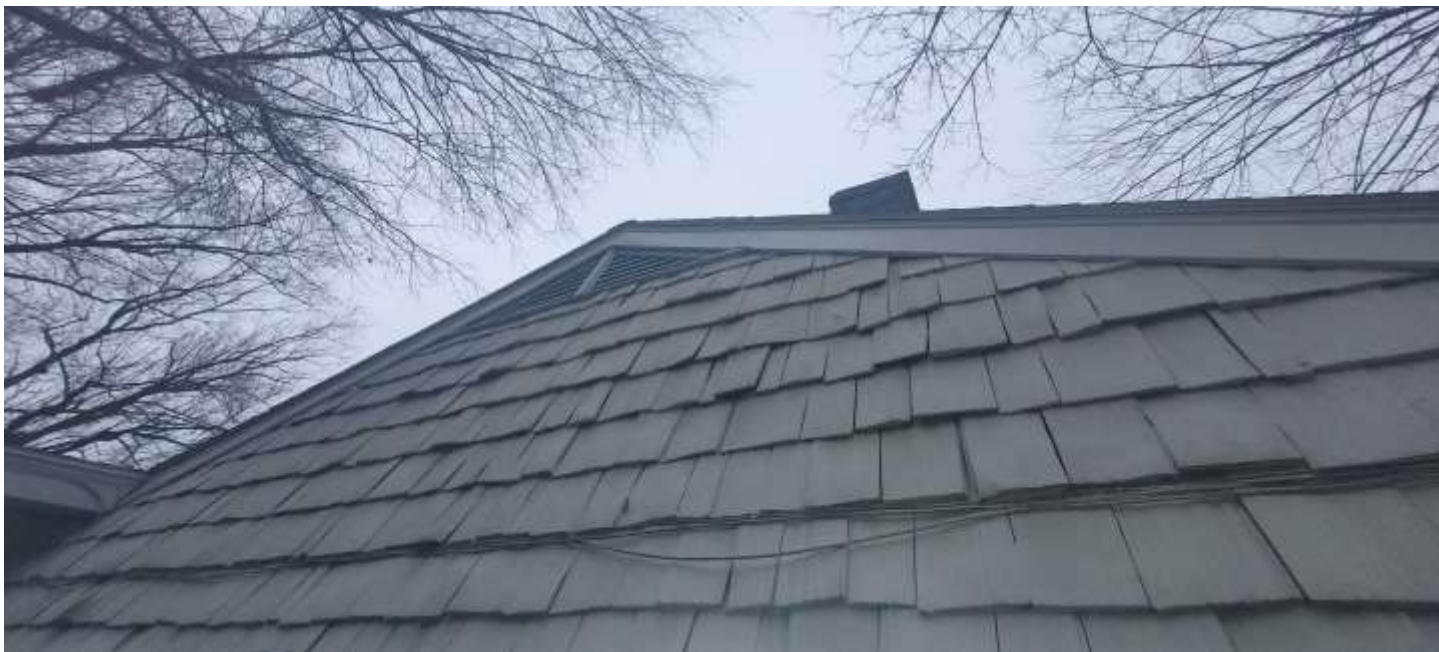
Painted wood generally well maintained and in very good condition.

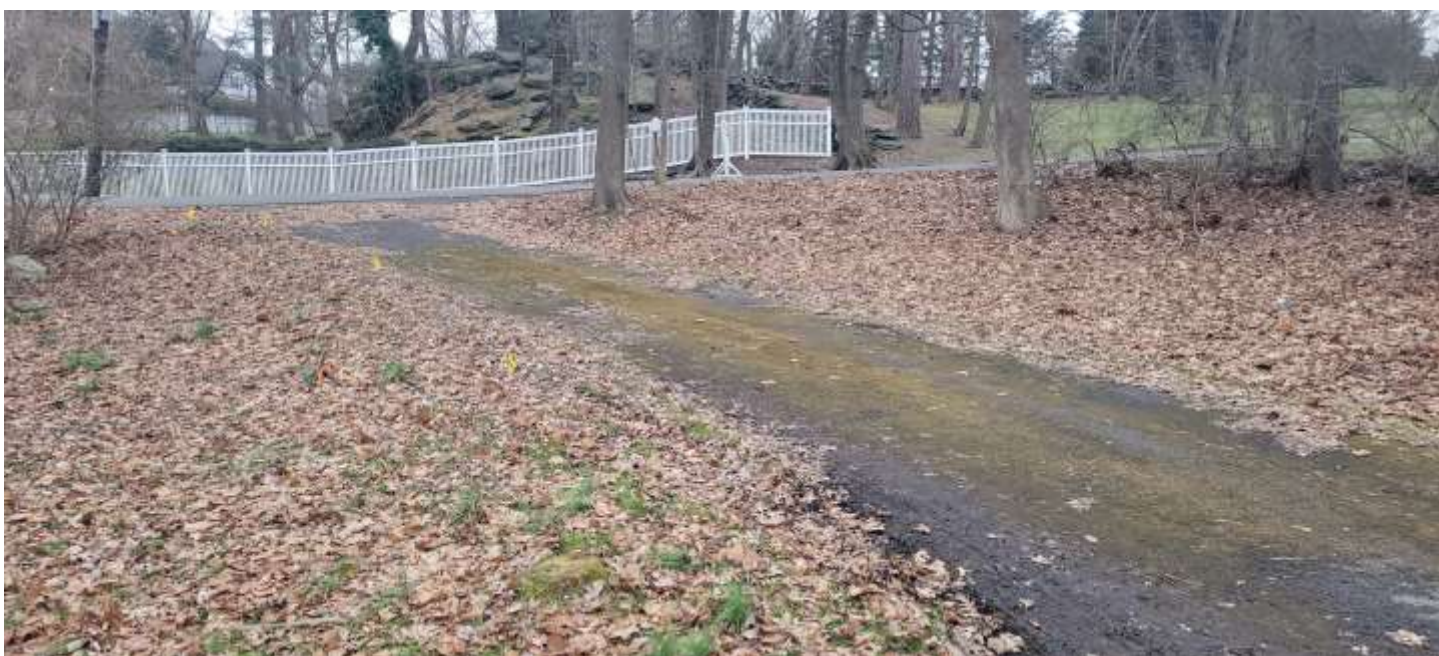
The asphalt driveway is passable. It could use to be re-sealed.

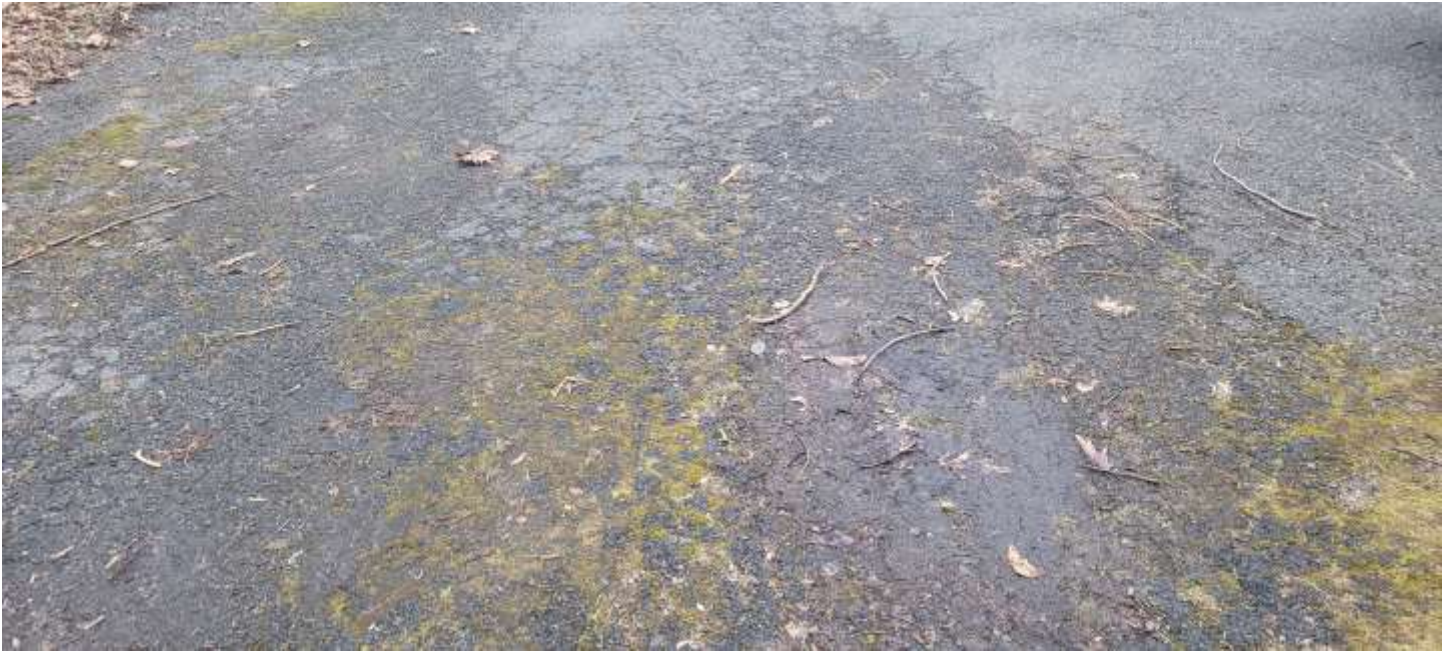
The asphalt driveway is passable. It could use to be re-sealed.

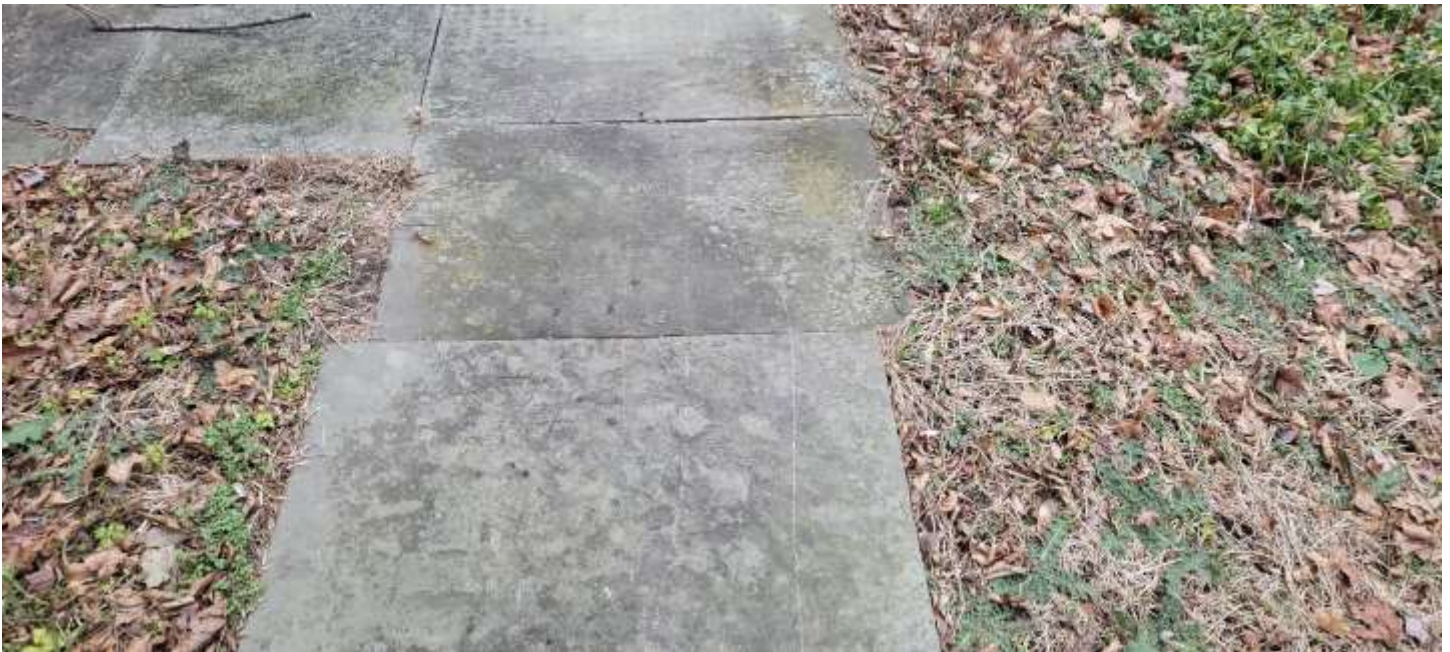
The walkway here is passable. But it showed signs of the underground eroding. And it was unlevel and moving in many spots.

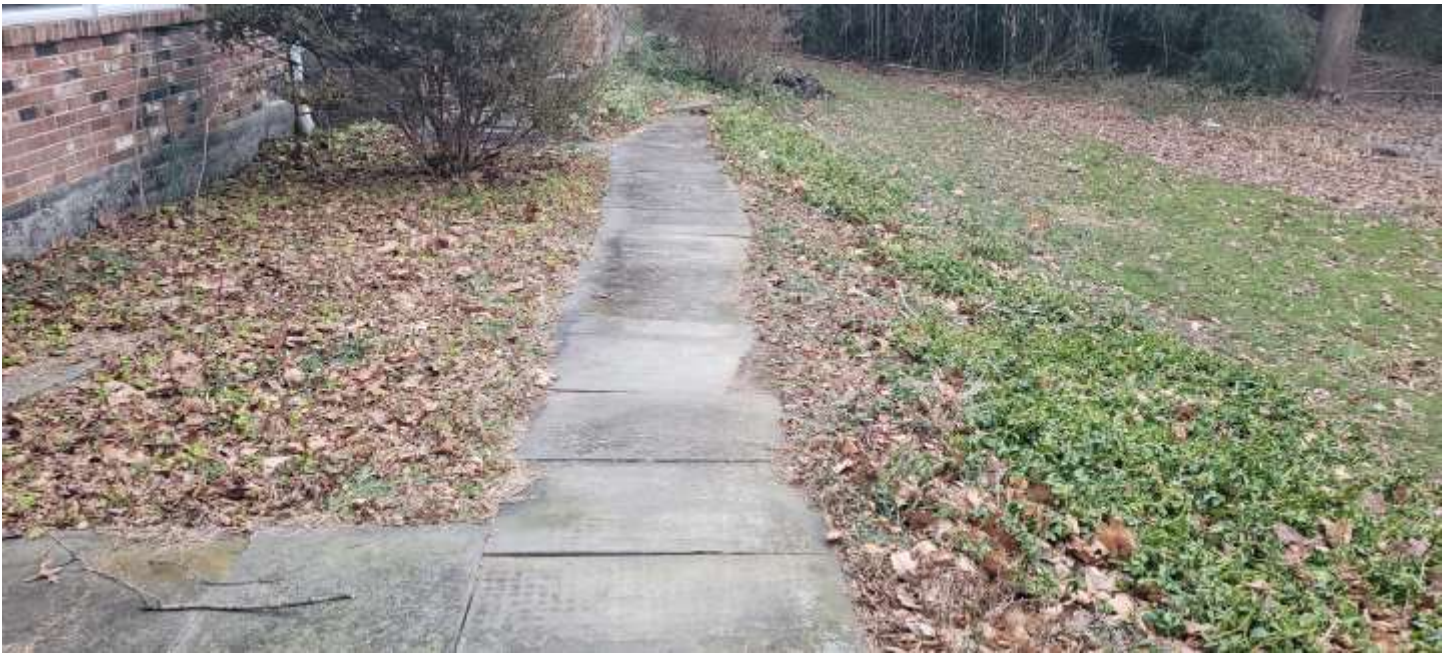
The walkway here is passable. But it showed signs of the underground eroding. And it was unlevel and moving in many spots.

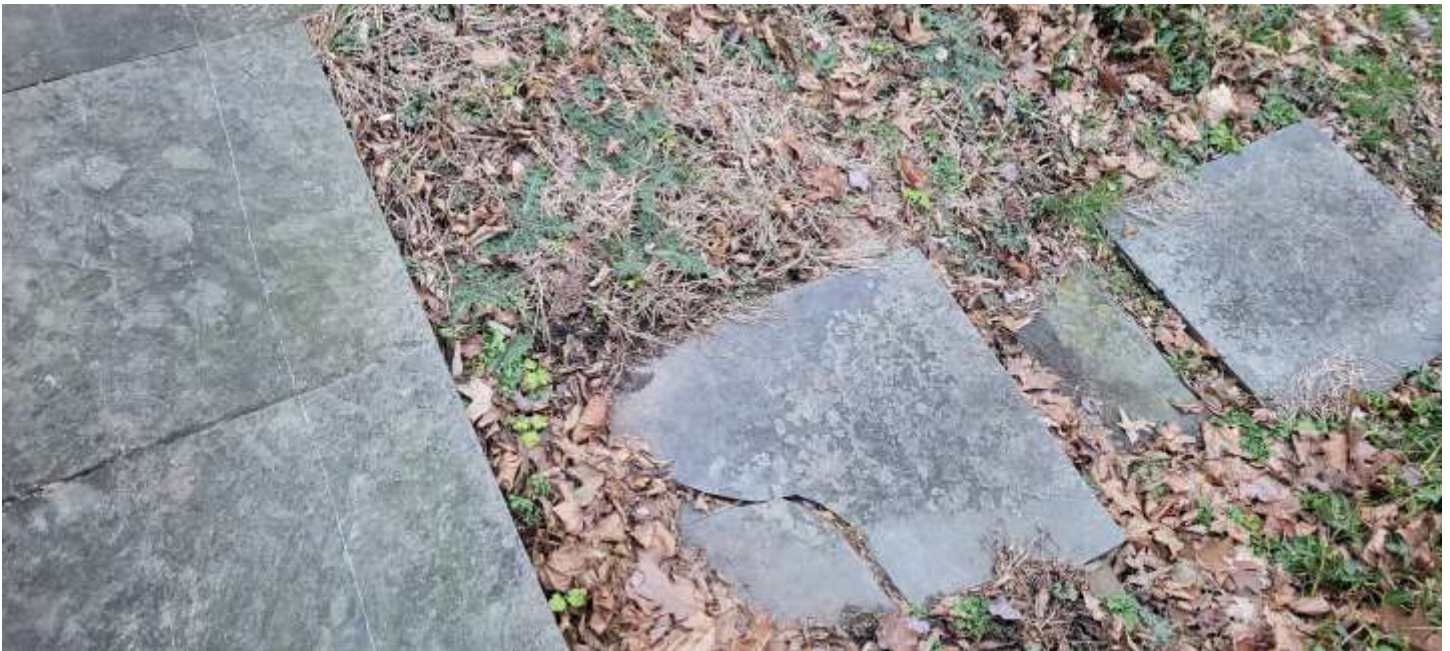
The walkway here is passable. But it showed signs of the underground eroding. And it was unlevel and moving in many spots.

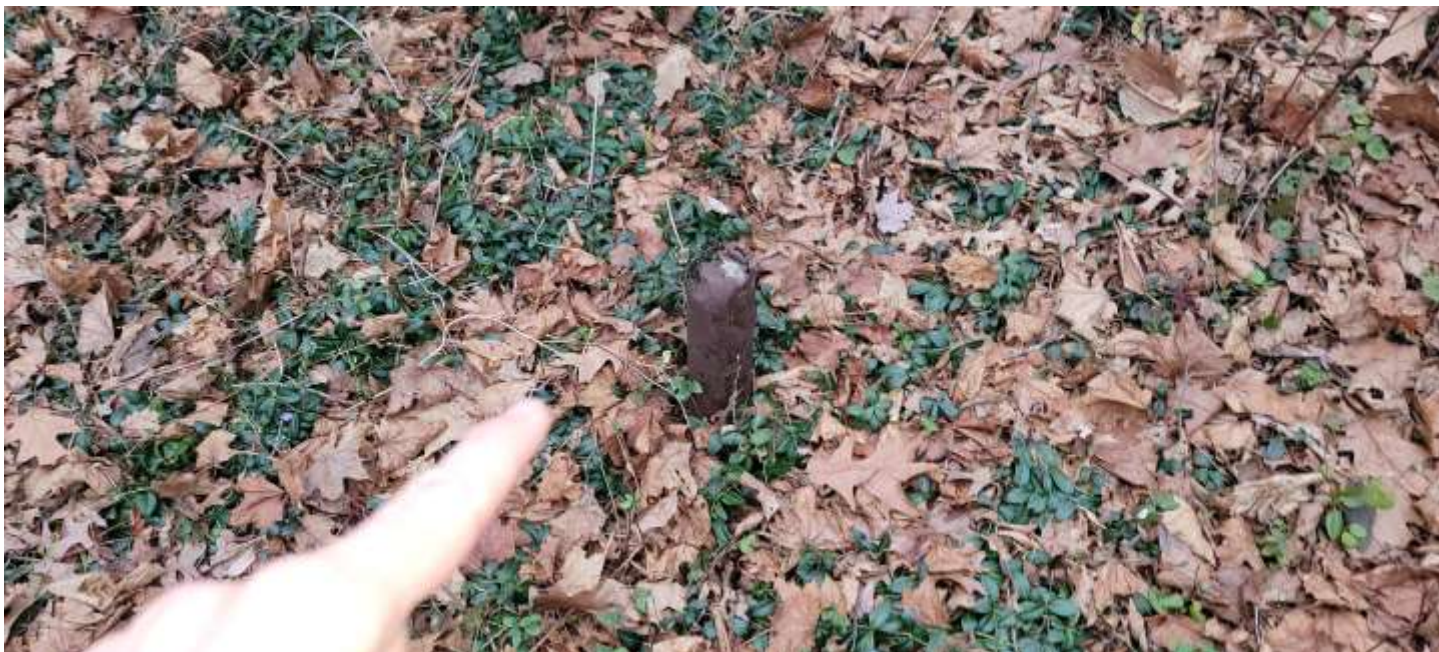
I notice this metal post sticking up to the left of the driveway as you approached the garage. If someone falls on this thing, this could be a lawsuit. I suggest you remove this as soon as practical.

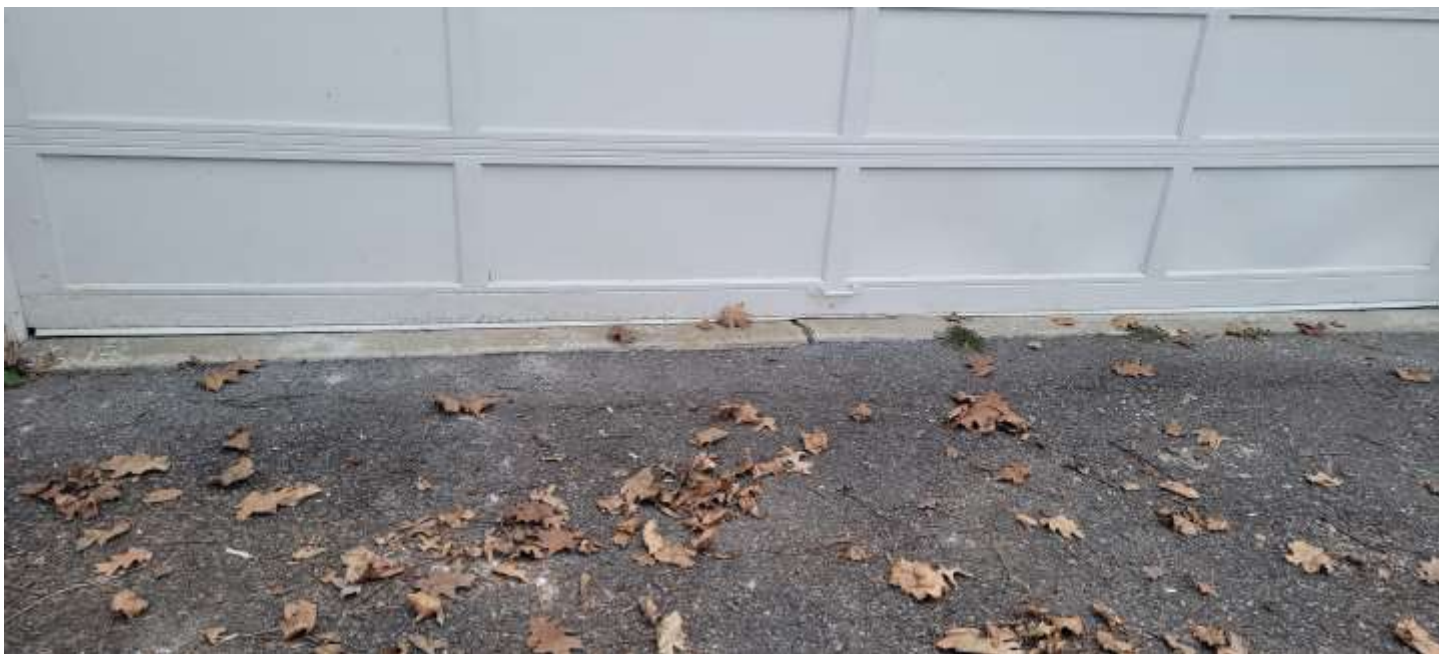
Garage door in good visual condition.

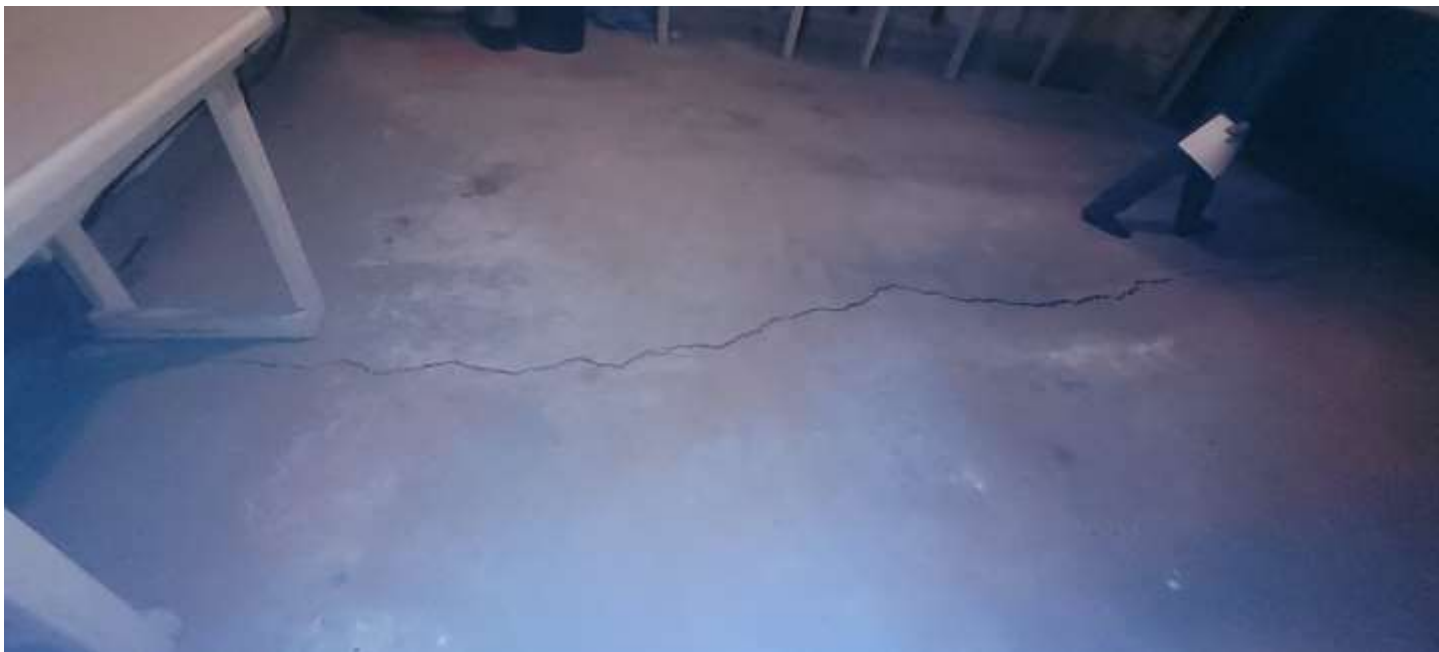
Garage slab had two large cracks.

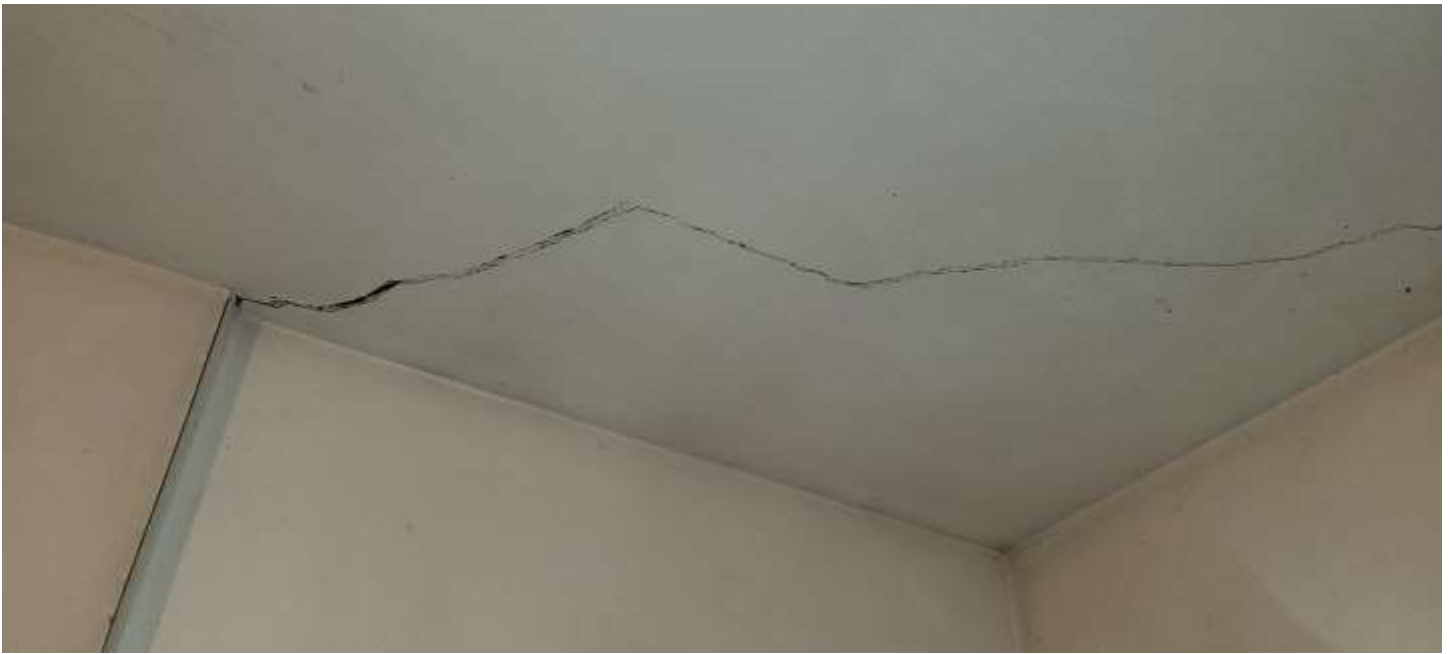
Garage had a crack in the ceiling. This is almost certainly connected to the motion of the bottom slab of the garage, and the walls of the garage.

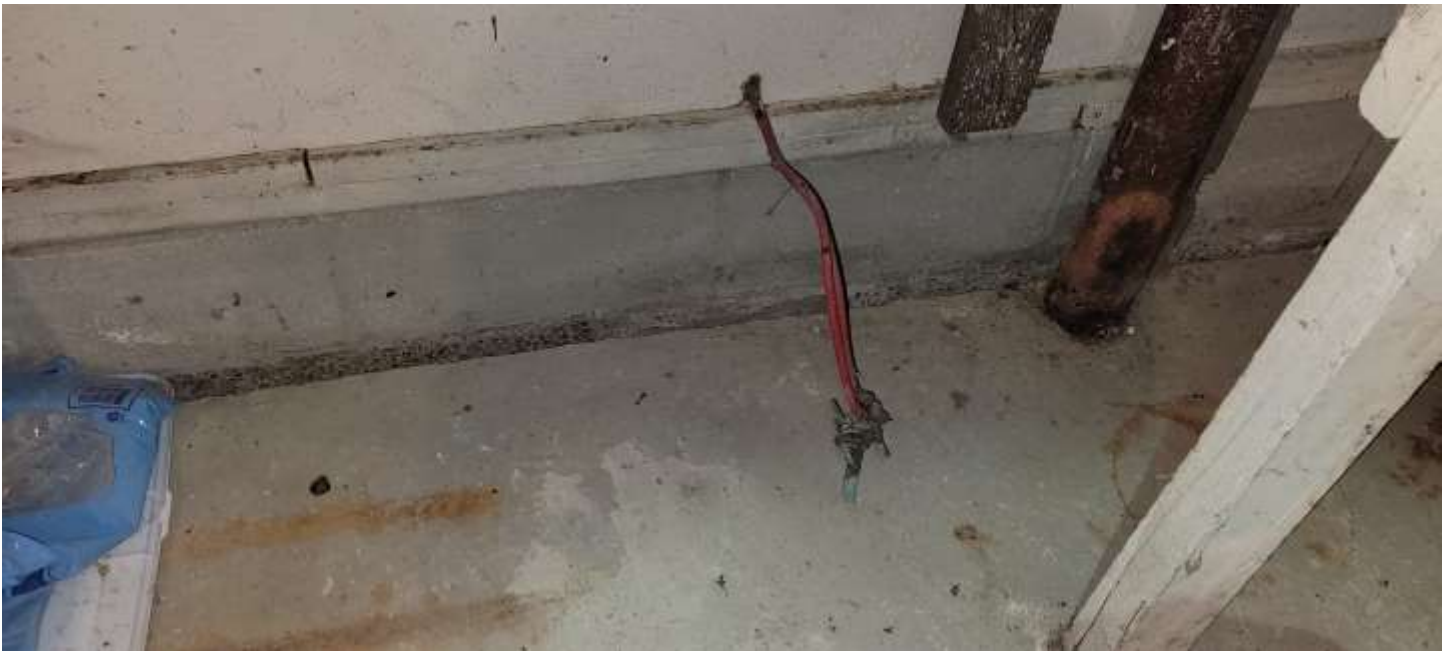
I believe that is a lightning rod.

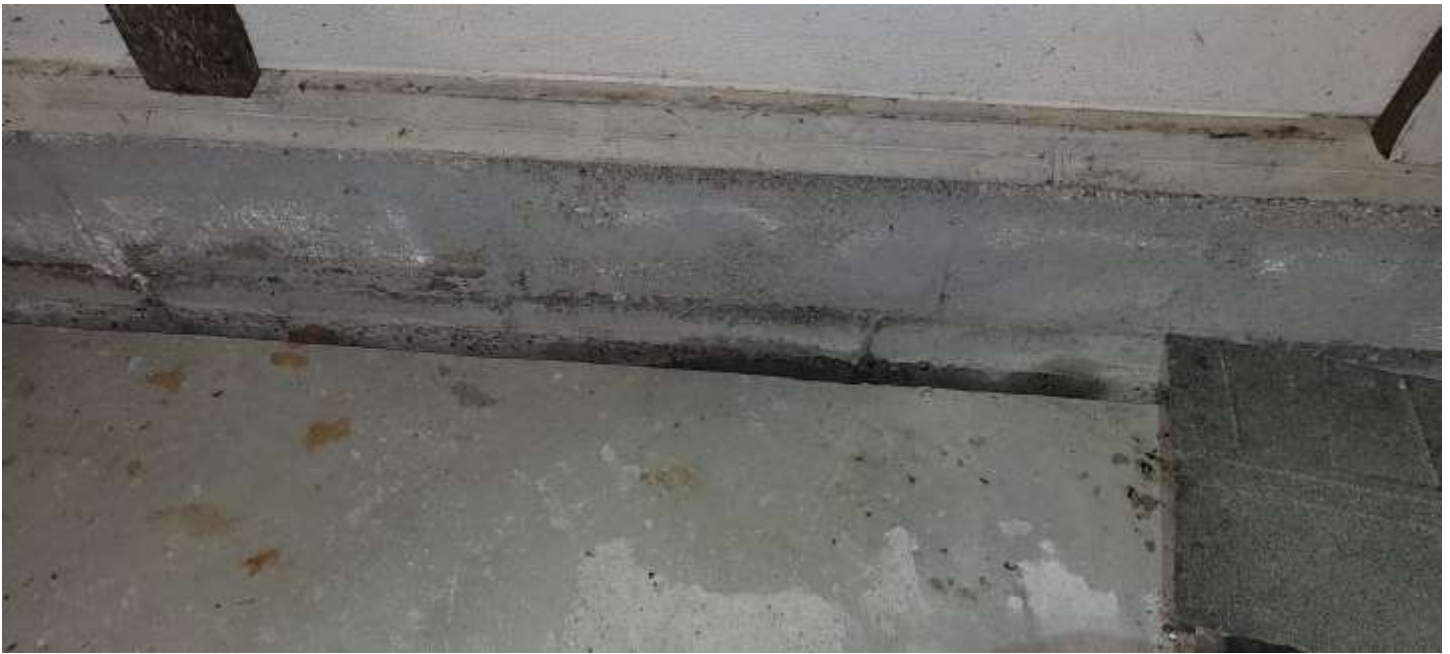
It seems there was some effort made at a drain around the perimeter of this garage.

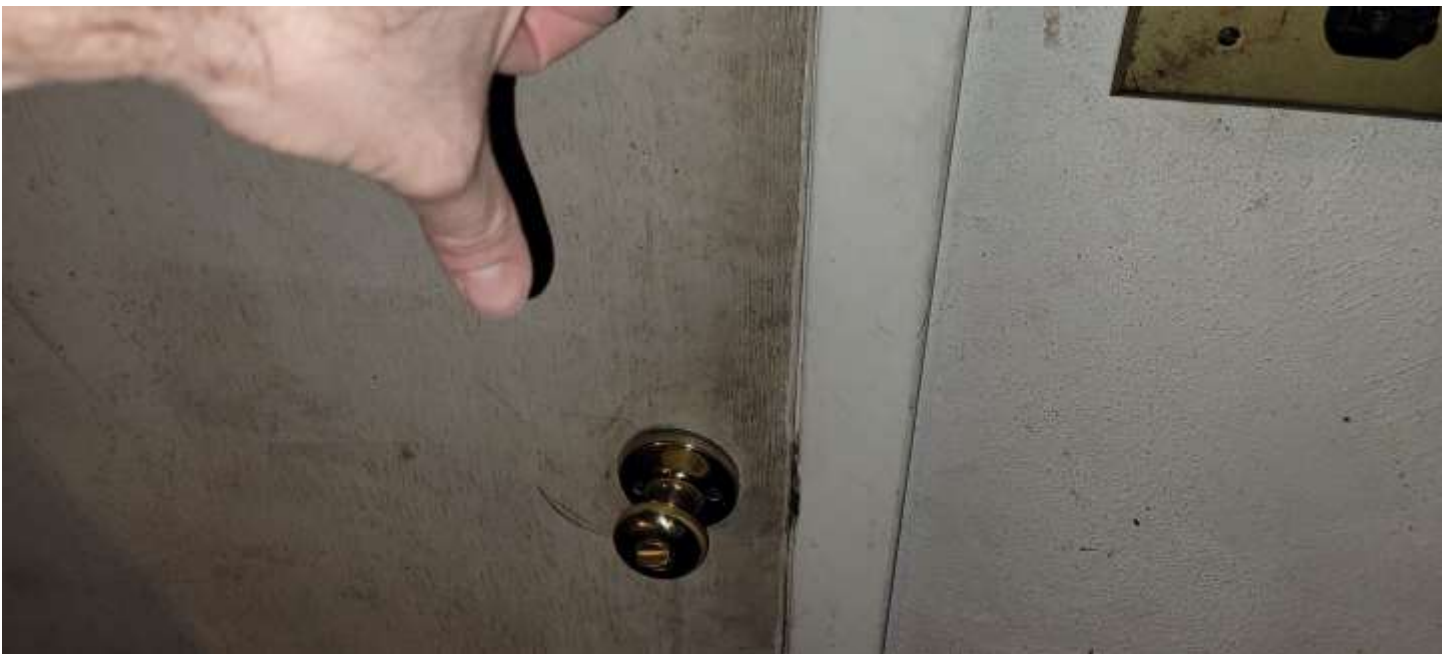
As described earlier, this door did not lock.

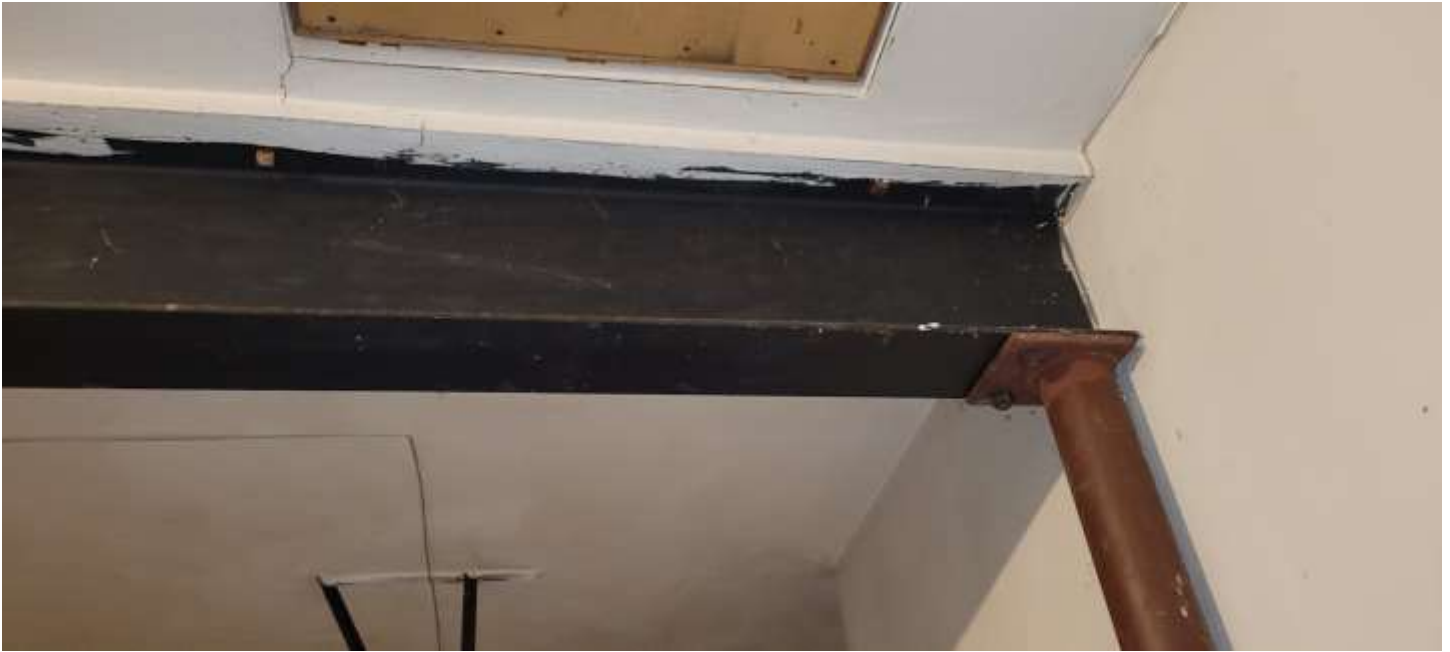
This side of the I-Beam seemed secure.

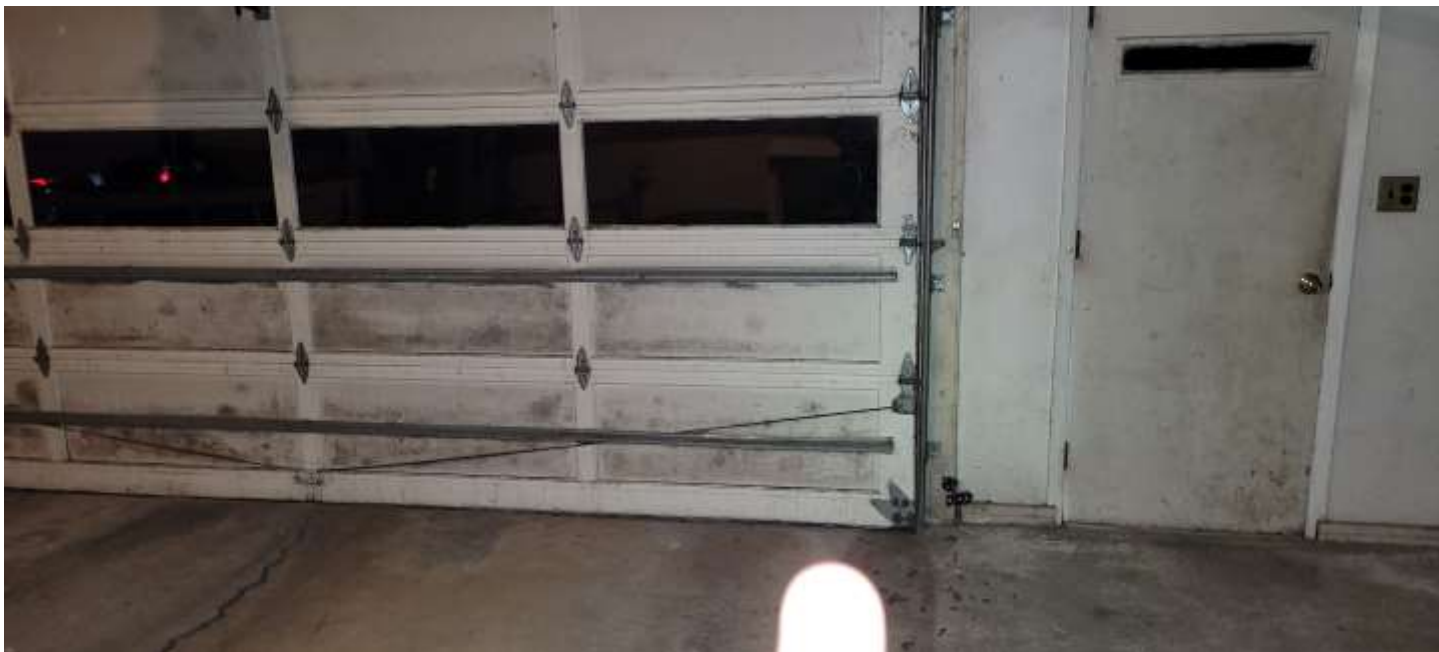
Garage door opened and closed, and the photoelectric safety functioned.

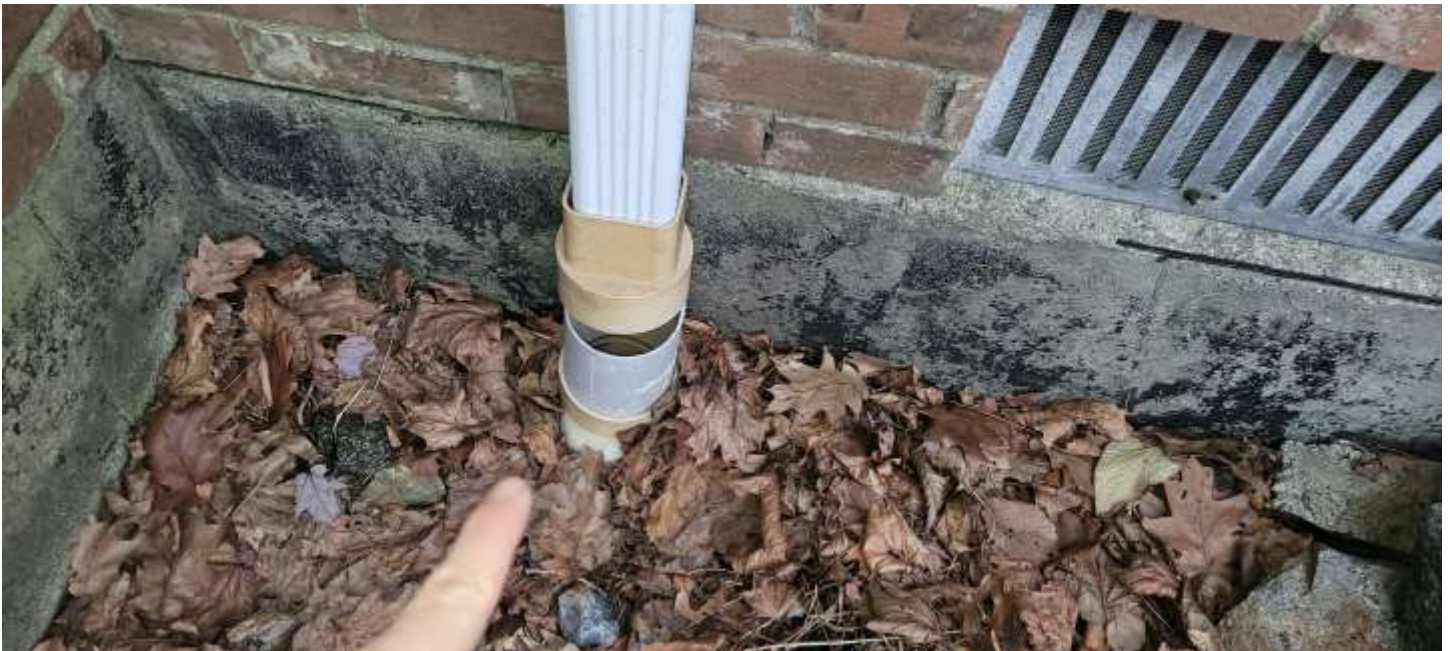
That downspout should be connected. It is dumping water directly on the foundation where there is almost certainly erosion taking place.

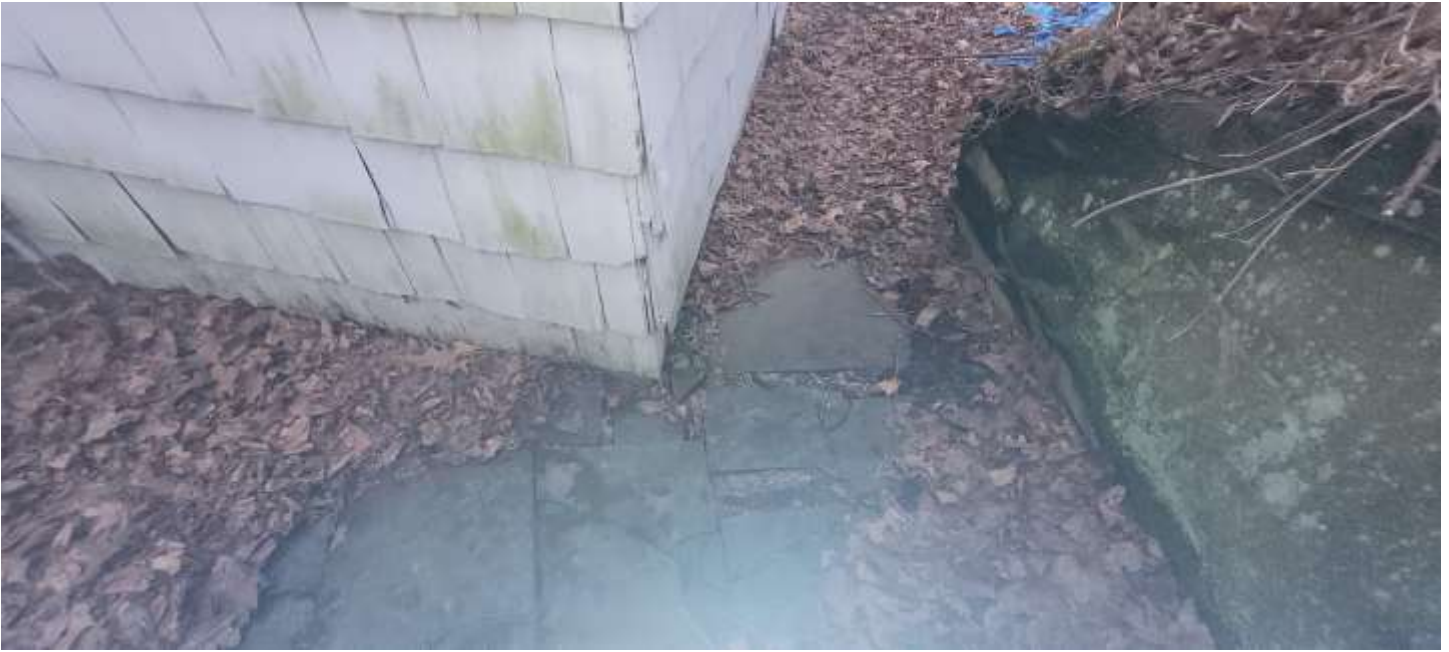
There should be a railing here, is this is a fall hazard. The stairs in the rear are clearly not pulling away.

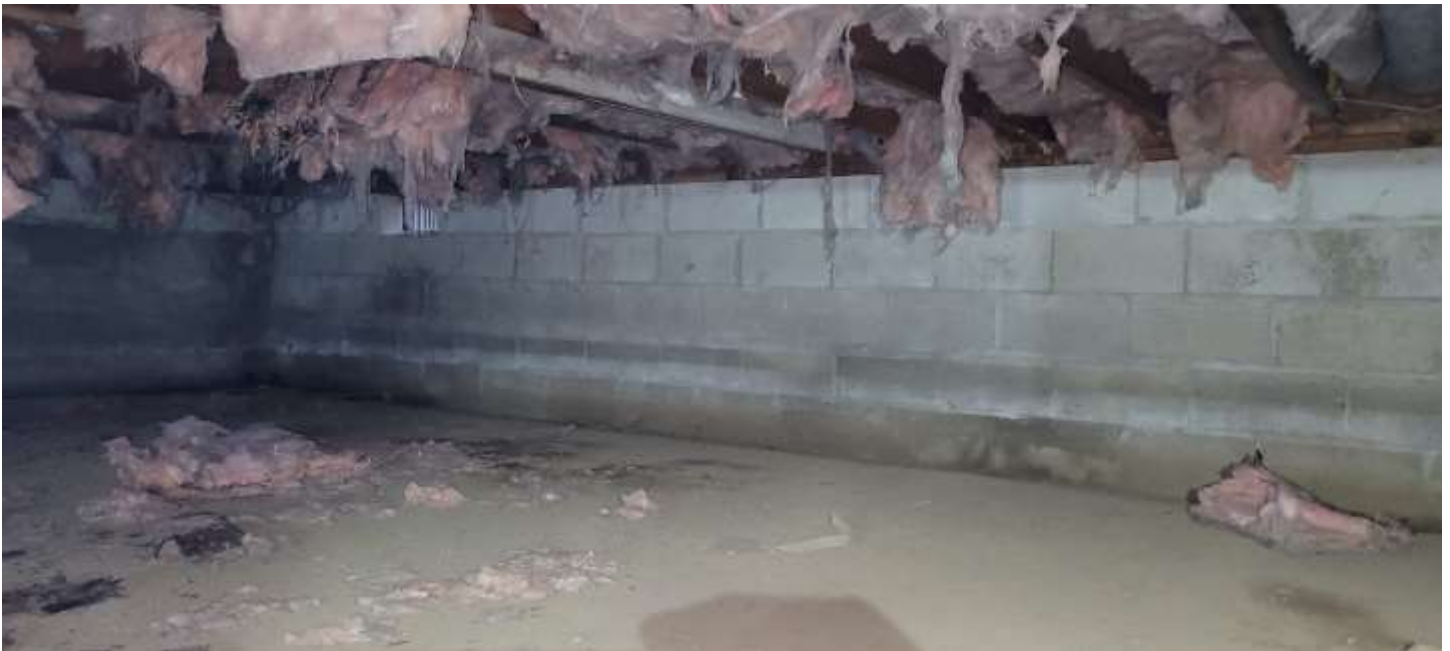
The main foundation of the house looks very good here. I suspect you had animals in this basement that ripped up the fiber glass insulation.

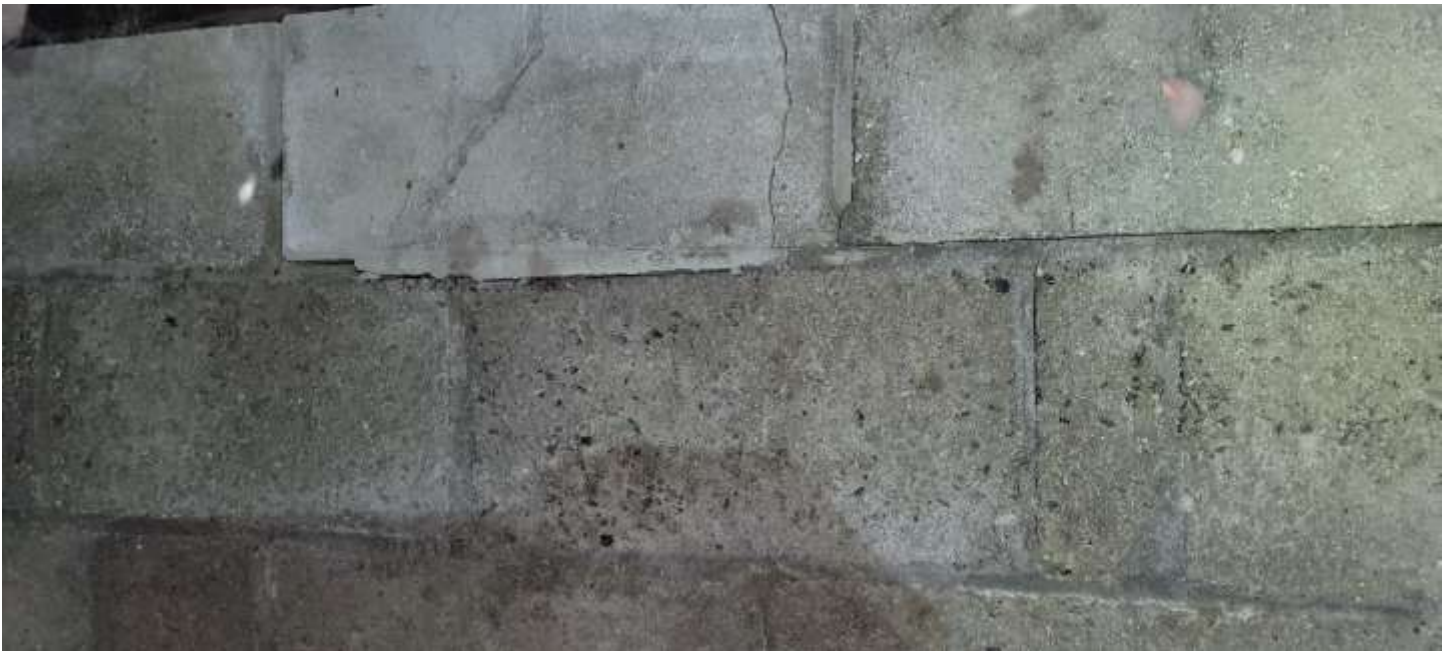
Somewhat larger crack here. This is also reflected in the bedroom above it. This seems to have moved about 1/4"-3/8".

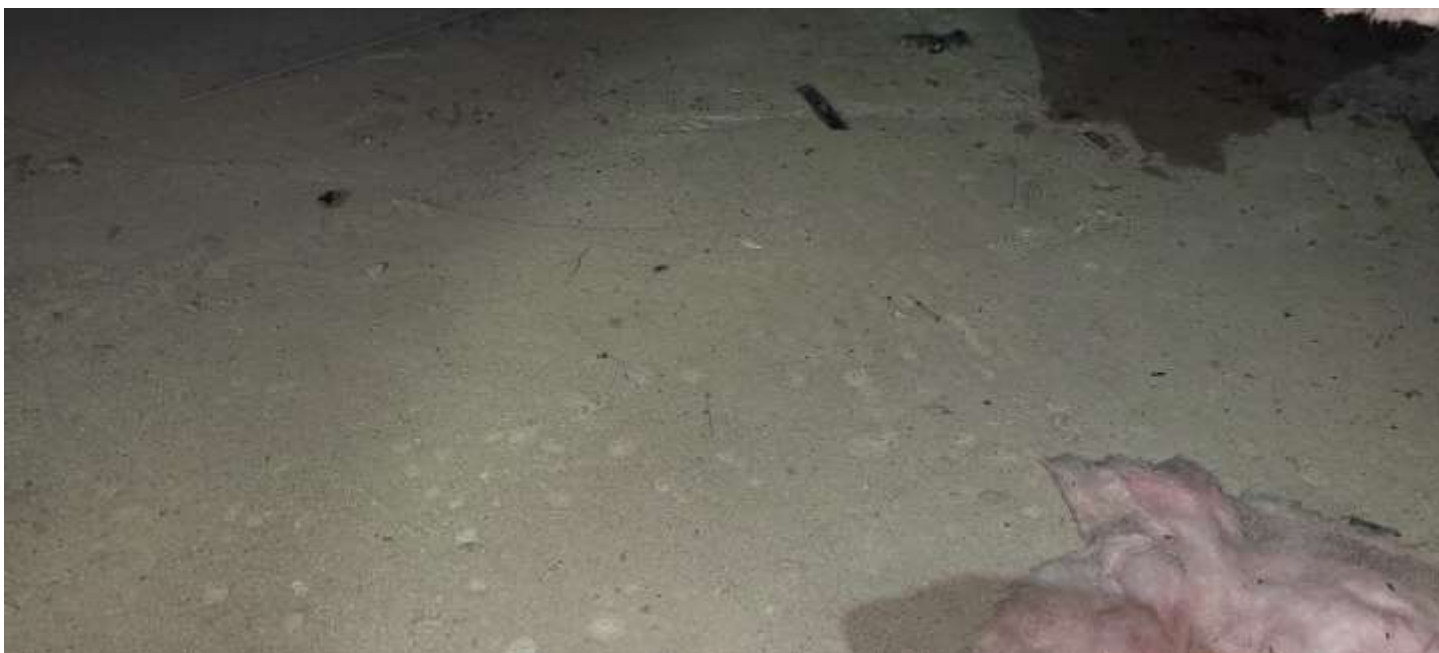
It looks like you had some animals here ripping up the fiberglass.

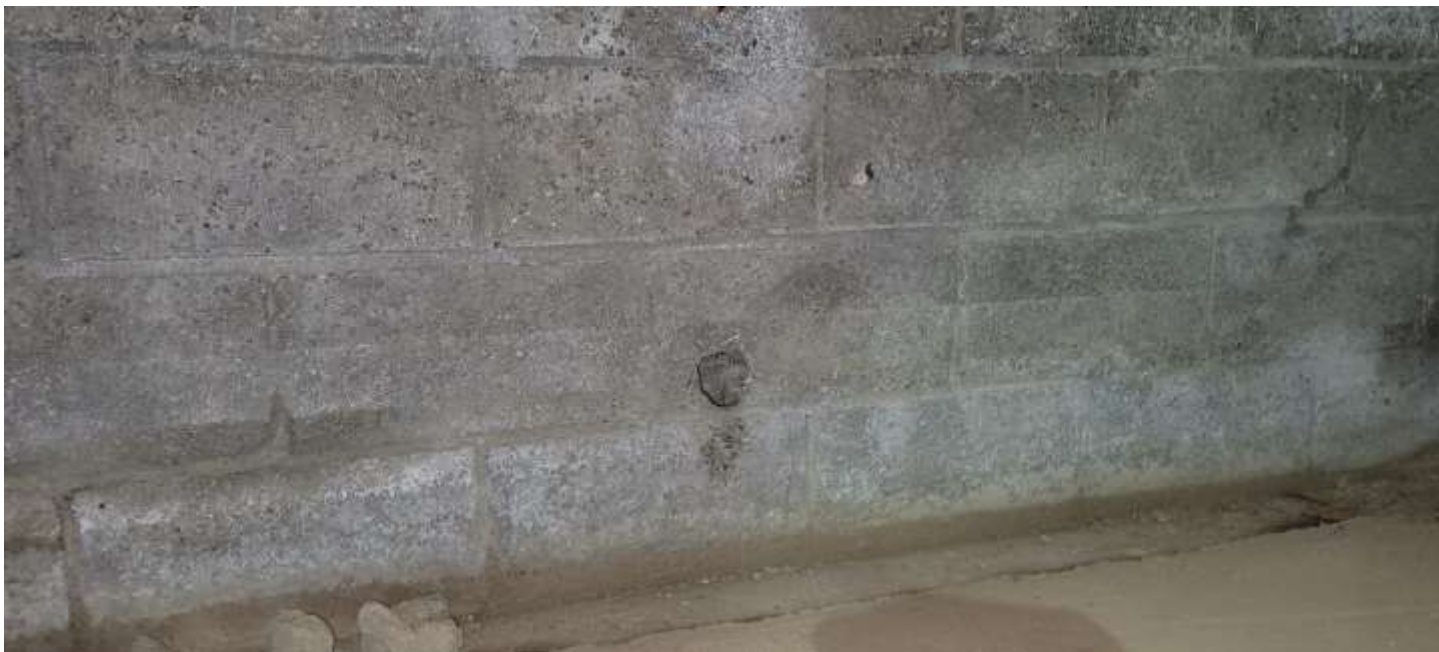
I could not figure out what those dots were in the dust under the foundation.

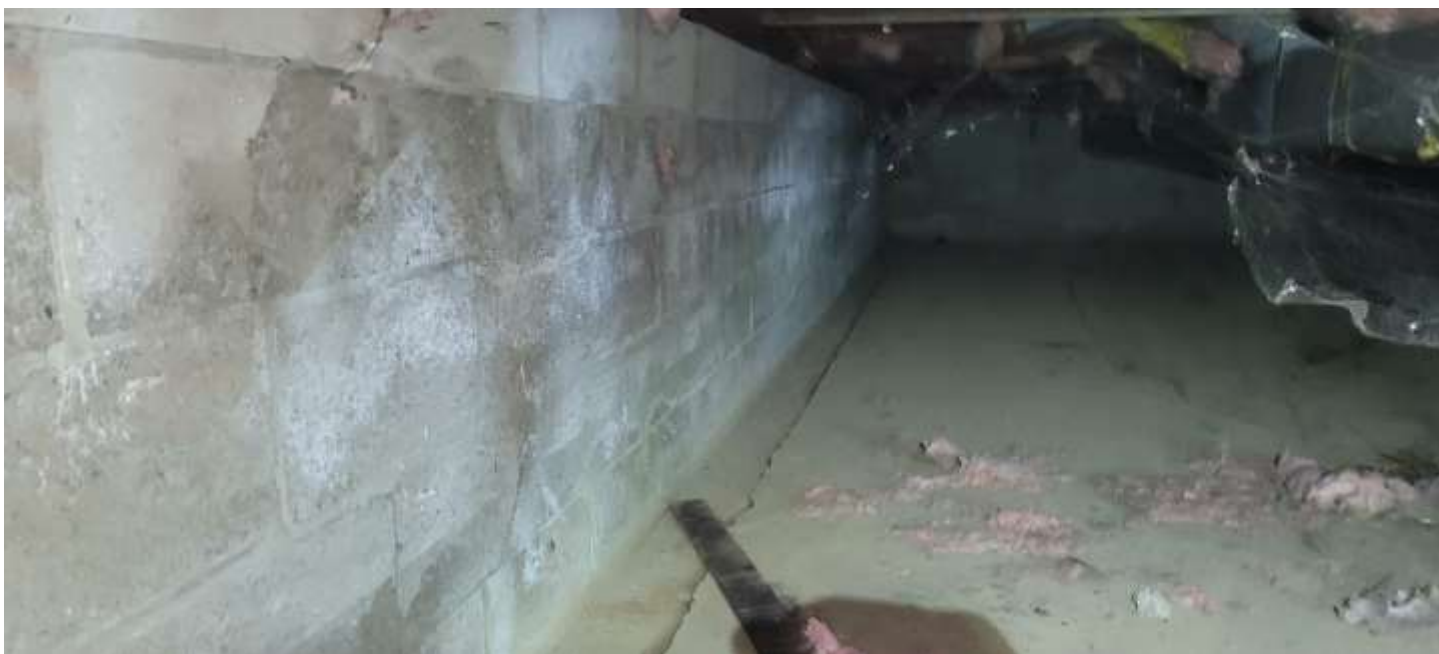
The main foundation of the house looks very good here. There is effluorescence, which indicates the presence of water. This seems to be consistent with some kind of water flow under and around the foundation of this house. I don't know why there is a break in that cement block. It seems inconsequential.

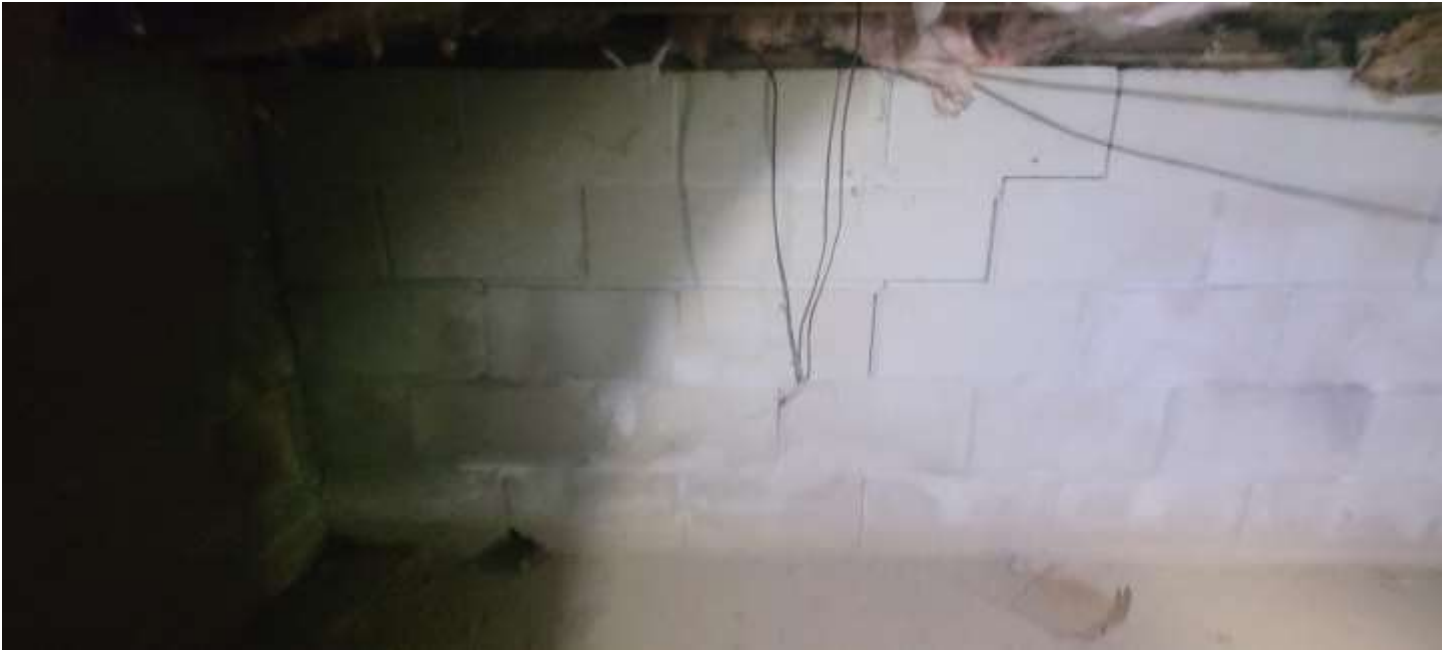
This is the wall that faces the garage. Notice this crack here approaches 1/2". It did it get significantly larger when you look at the slab, and the wall in the garage. I believe this will need to be addressed in the near future.
