Property: 123 Main Street, Anytown, NY  
Date: 15Jan2021  
Present: Louis Csak, insp.; ####, buyer; ### agent.  
Conditions: 40's, overcast

**Executive summary:** (details in report)

The house was not well maintained, and the garage foundation is beginning to show serious issues, and very likely there is a regular water occurrence that will eventually affect the main foundation badly.

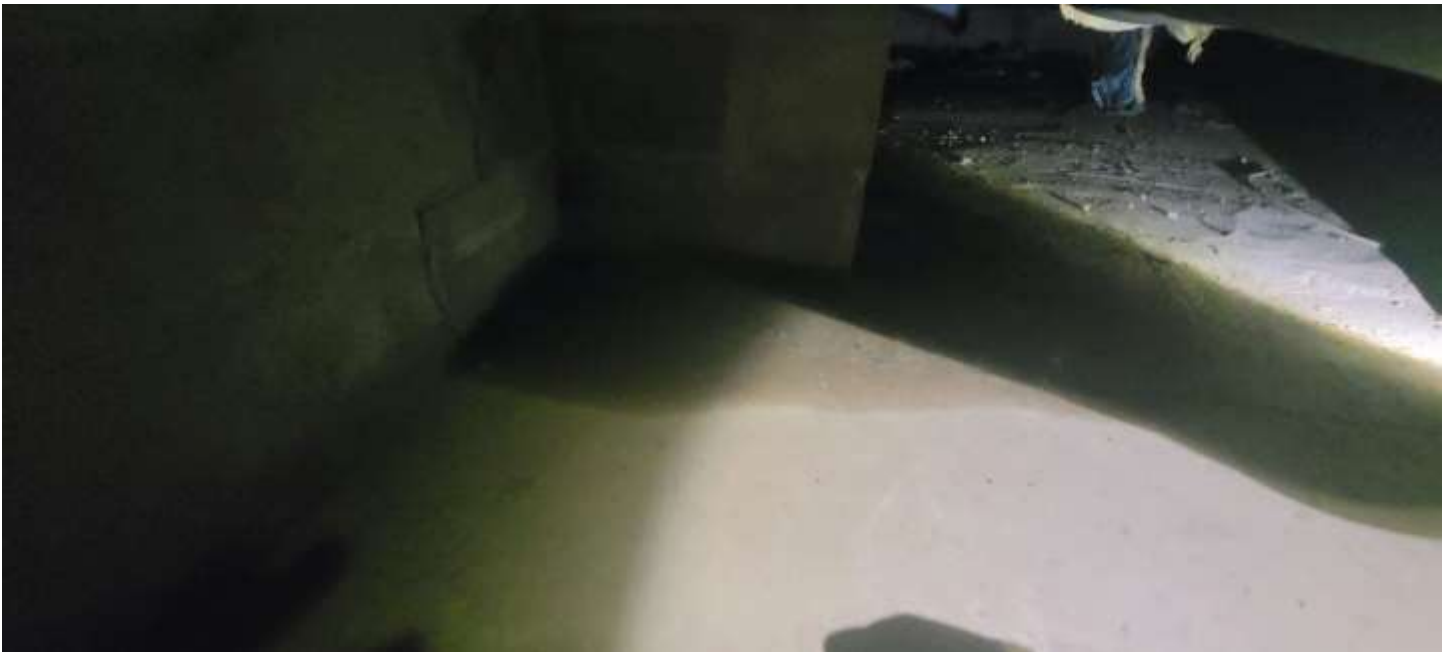
This is the wall that faces the garage. Notice this crack here approaches 1/2 an inch. It did it get significantly larger when you look at the slab, and the wall in the garage. I believe this will need to be addressed in the near future.

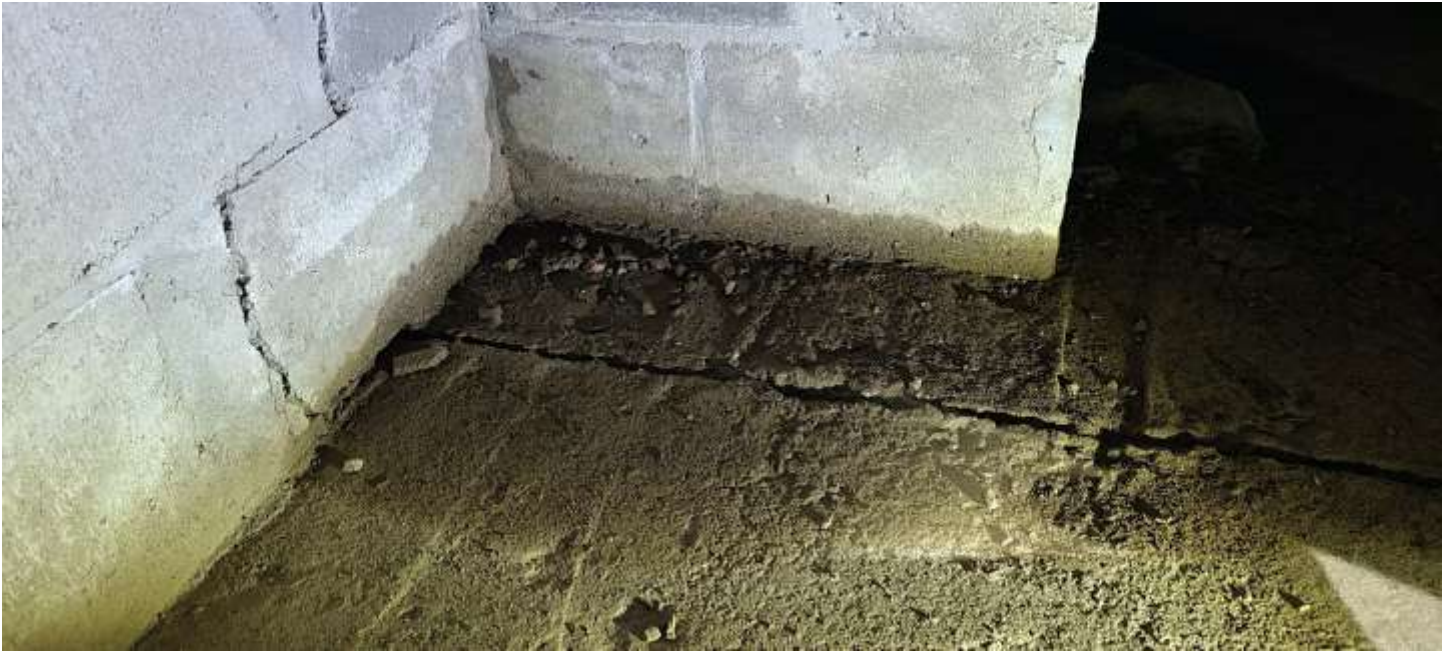
There was quite a bit of water on the garage side of the foundation. This would be consistent with the possibility of some kind of under slab water movement.

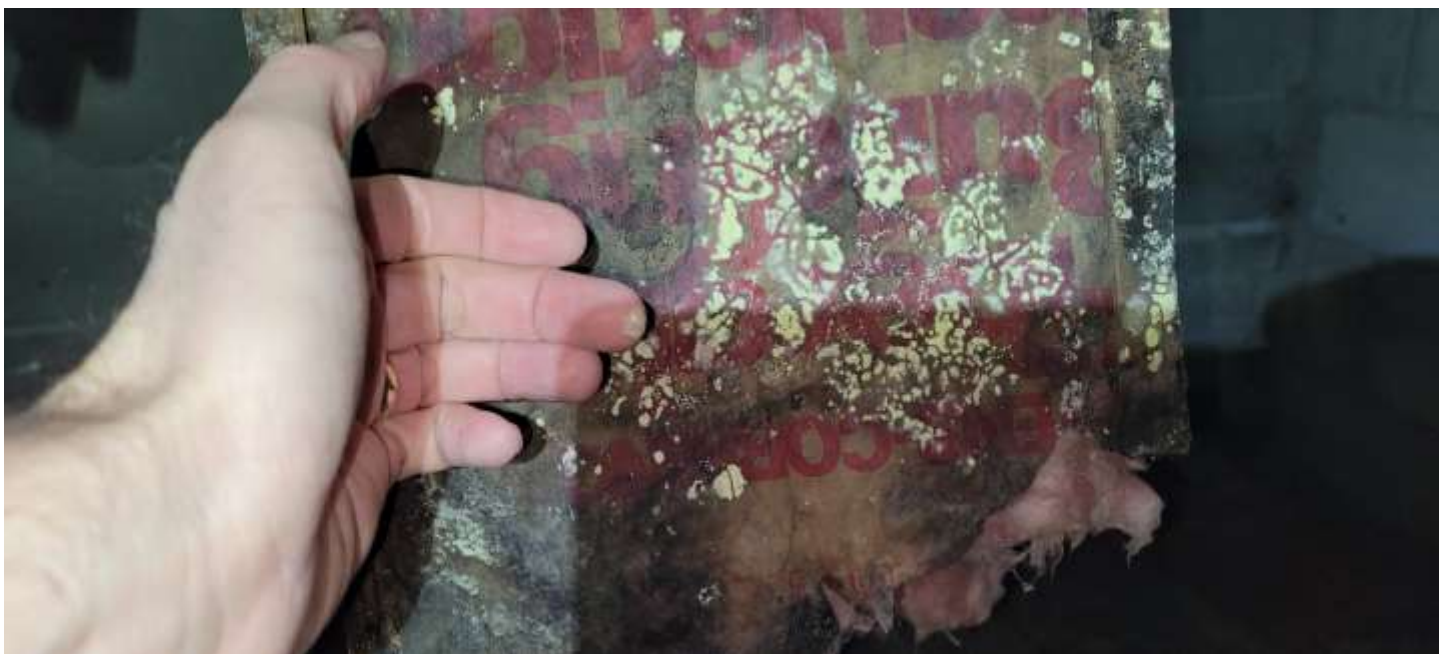
There is some mold in this basement. This is consistent with a very humid basement, and the presence of water.

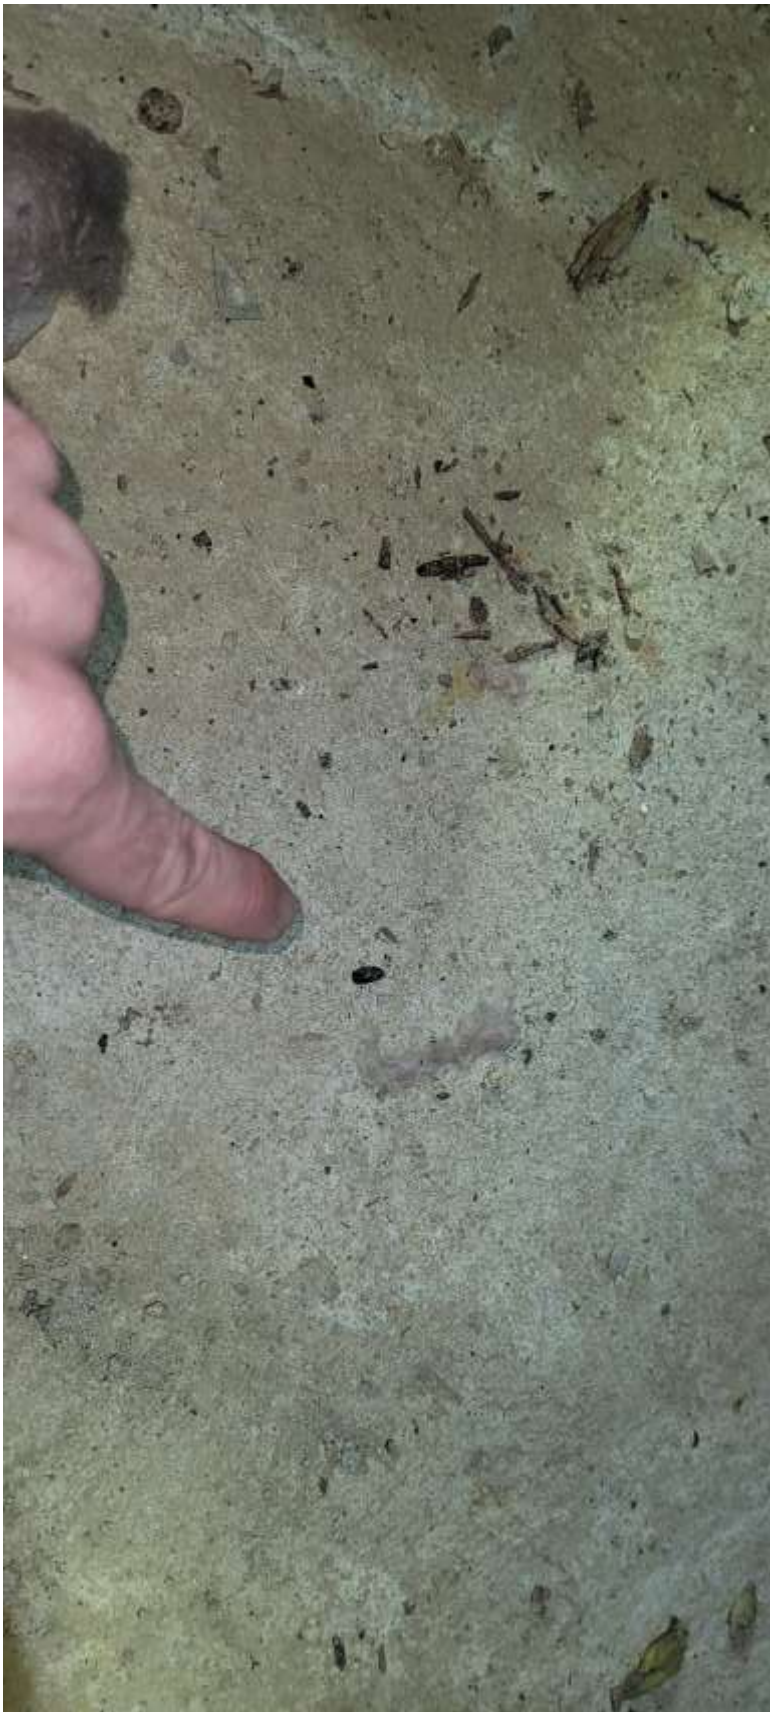
There is some mold in this basement.

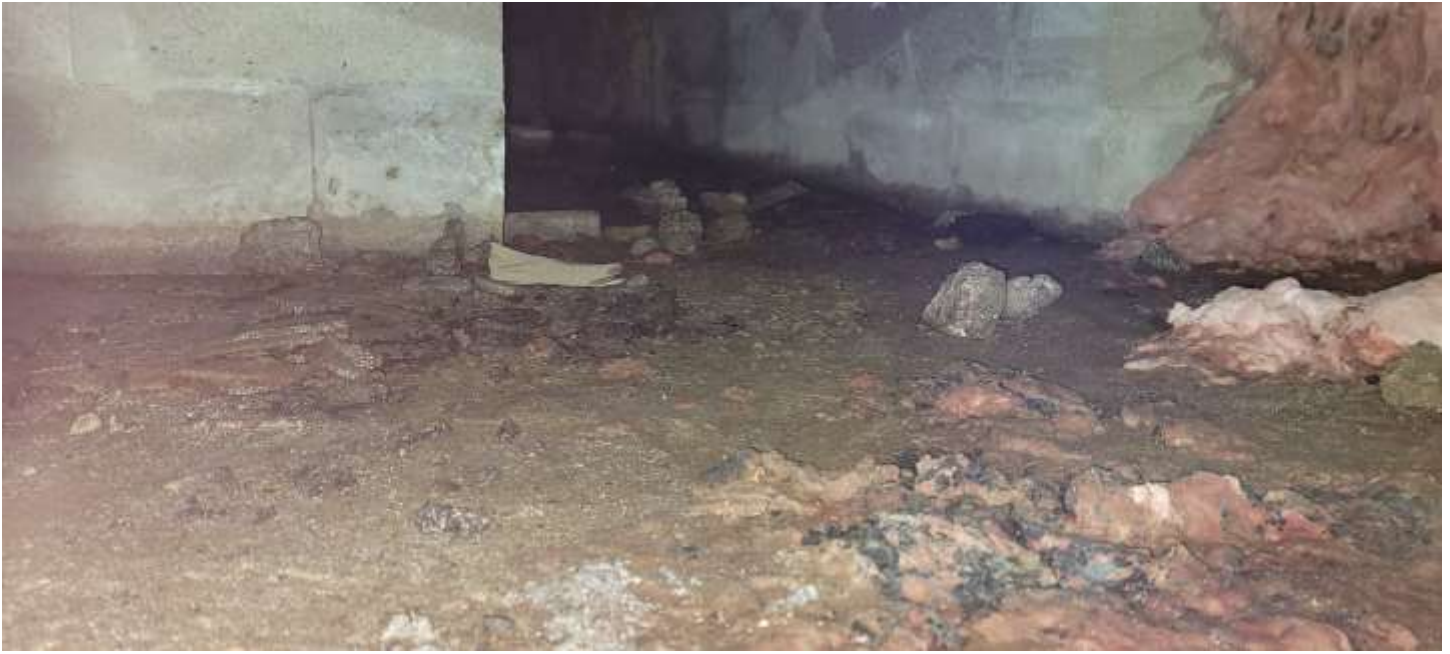
And some feces. I did not see significantly large amounts of feces, or any mice carcasses.

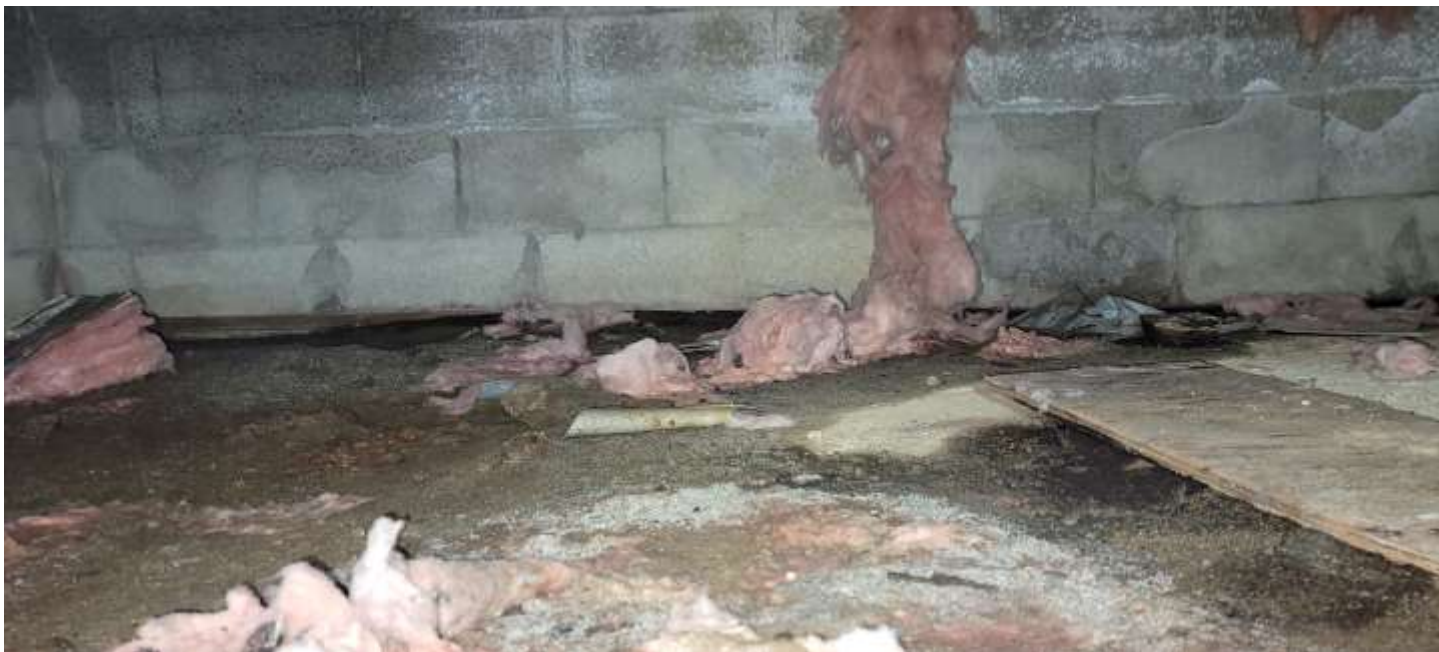
The main foundation of the house looks very good here. I suspect you had animals in this basement that ripped up the fiber glass insulation. There is effluorescence, which indicates the presence of water. This seems to be consistent with some kind of water flow under and around the foundation of this house.

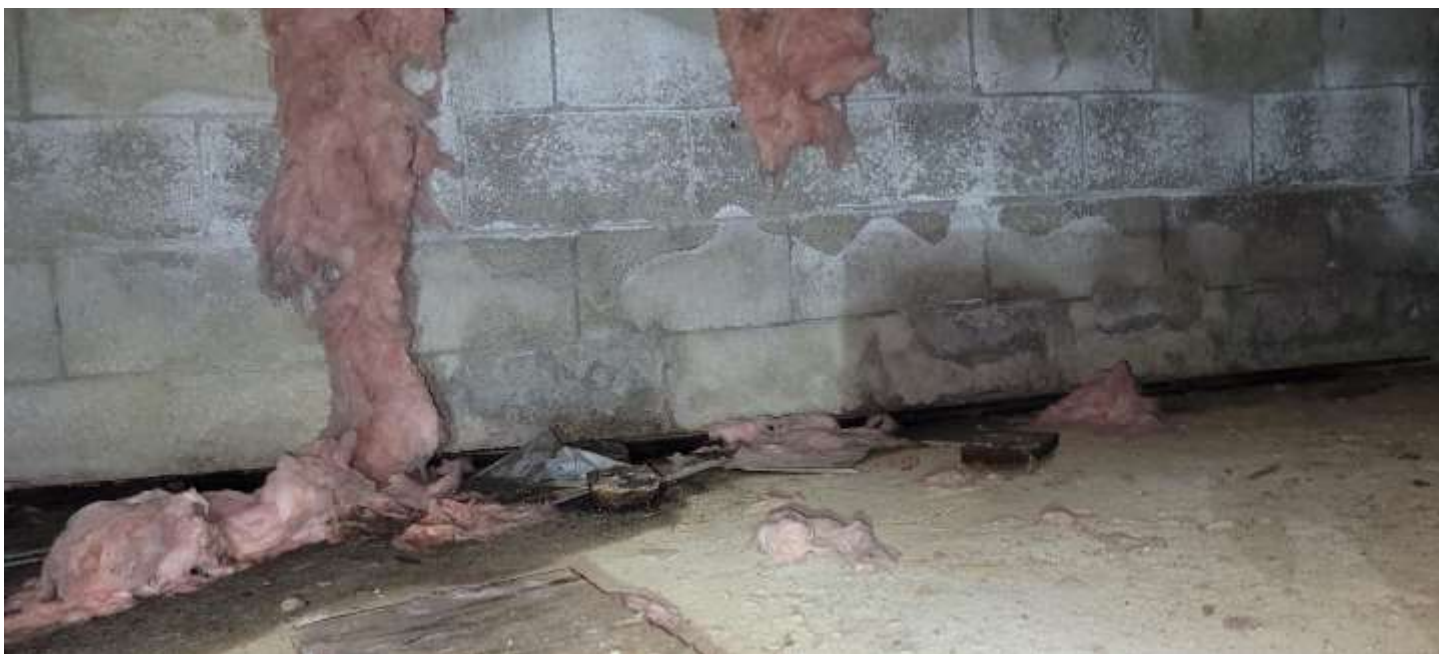
The main foundation of the house looks very good here. I suspect you had animals in this basement that ripped up the fiber glass insulation. There is effluorescence, which indicates the presence of water. This seems to be consistent with some kind of water flow under and around the foundation of this house.

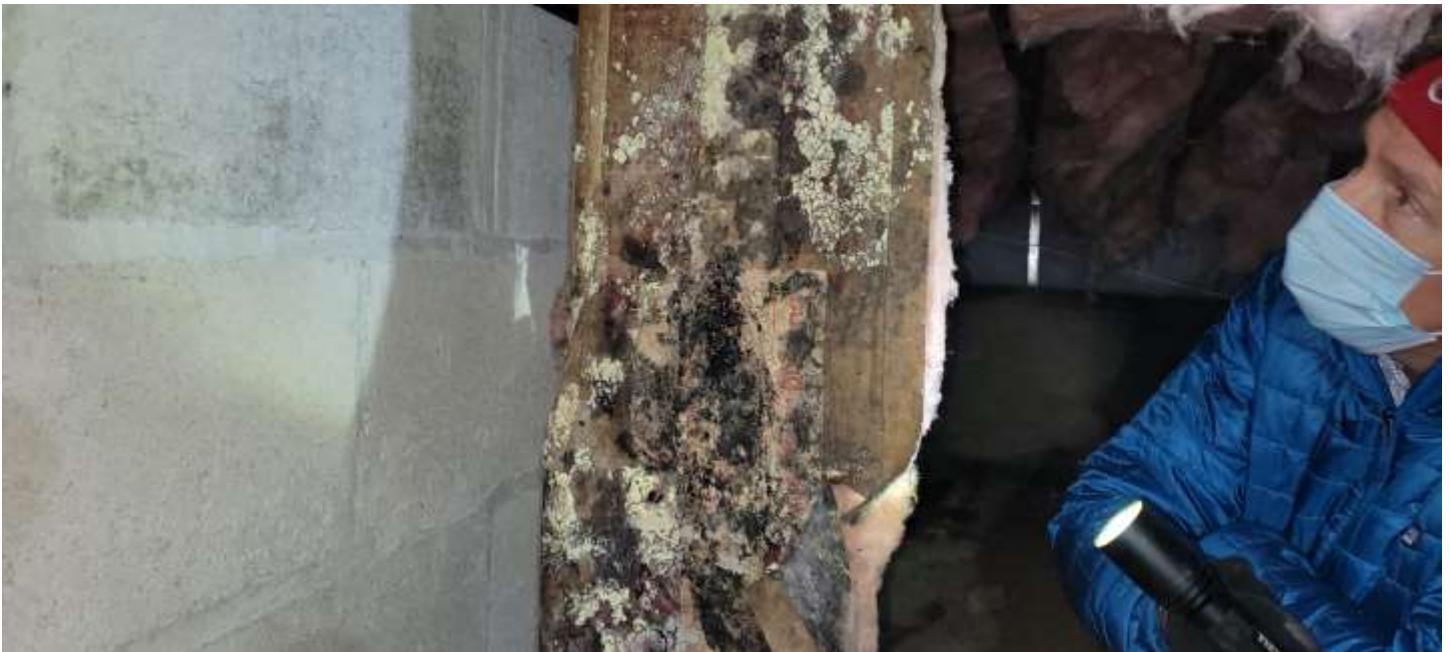
The main foundation of the house looks very good here. I suspect you had animals in this basement that ripped up the fiber glass insulation. There is effluorescence, which indicates the presence of water. This seems to be consistent with some kind of water flow under and around the foundation of this house.

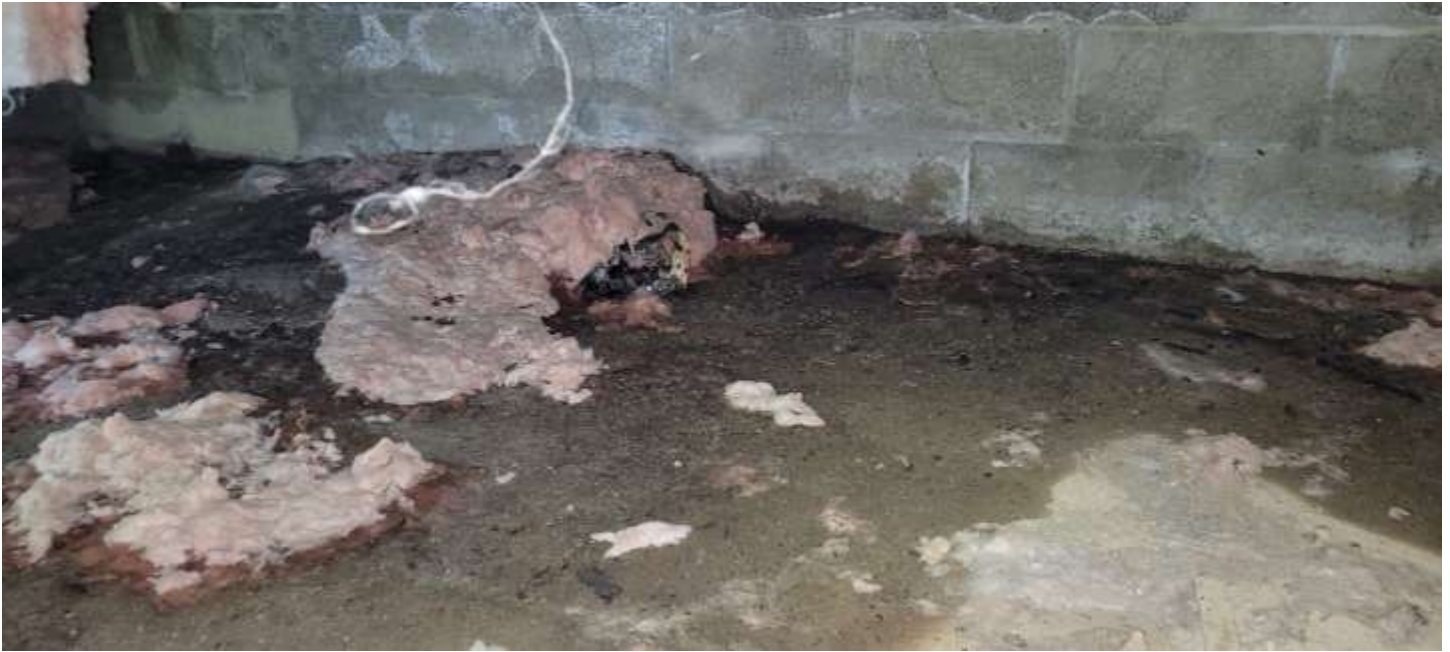
There is some mold in this basement.

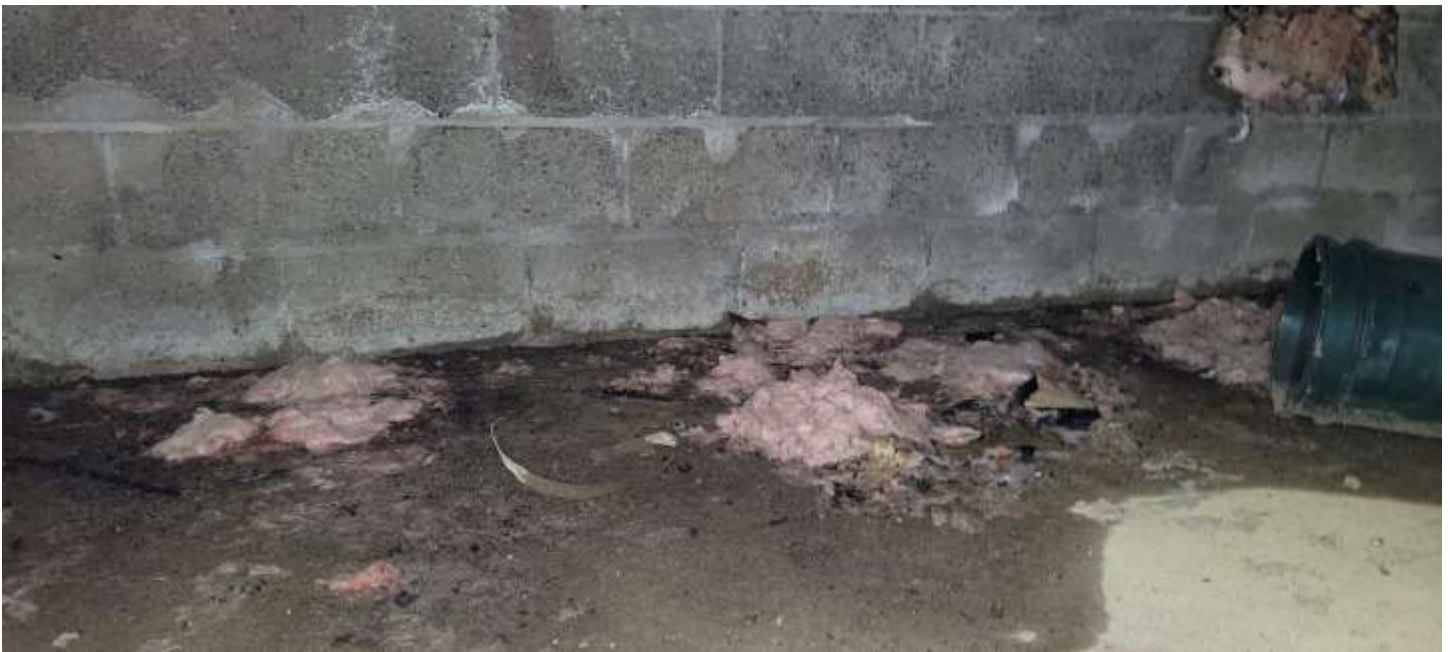
There's also some moisture on the right side of the house. Interesting, and I believe also consistent with water flows surrounding this house, as the center of the house was significantly more dry than the left and right side. Left side being the garage side, and right side being the other side of the house away from the garage.

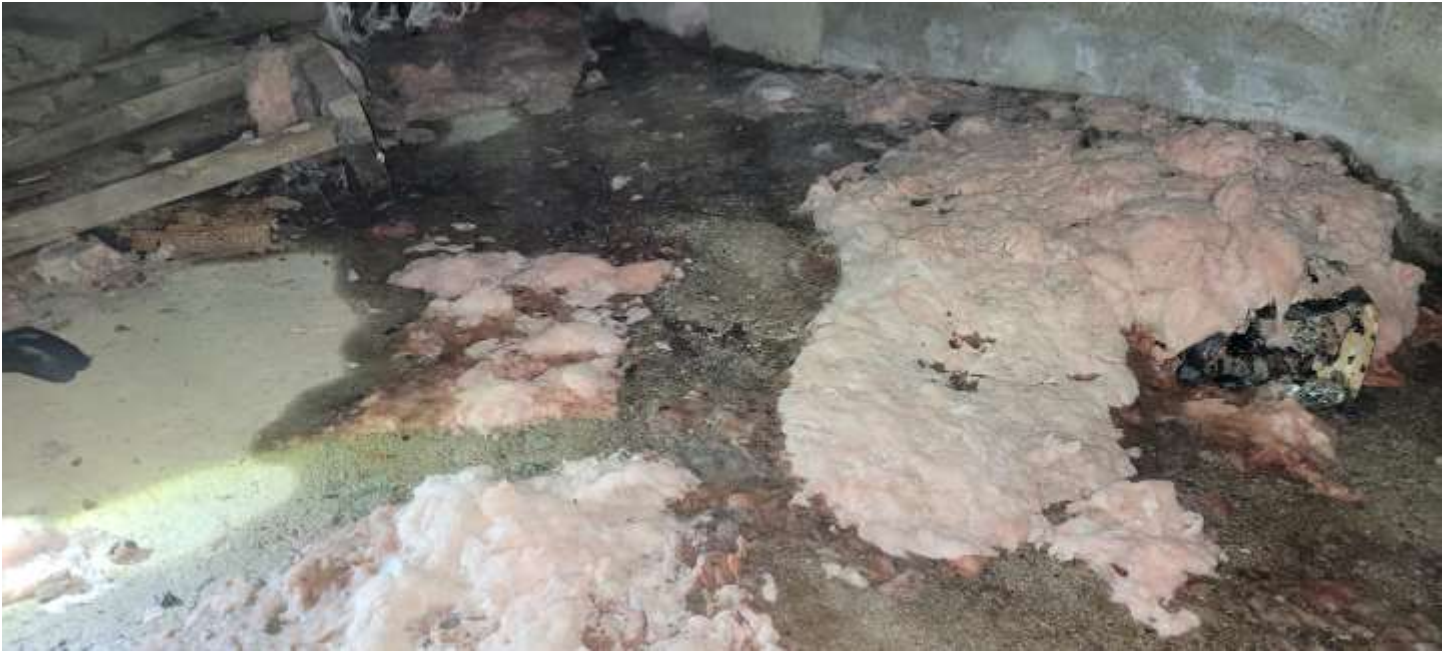
There's also some moisture on the right side of the house. Interesting, and I believe also consistent with water flows surrounding this house, as the center of the house was significantly more dry than the left and right side. Left side being the garage side, and right side being the other side of the house away from the garage.

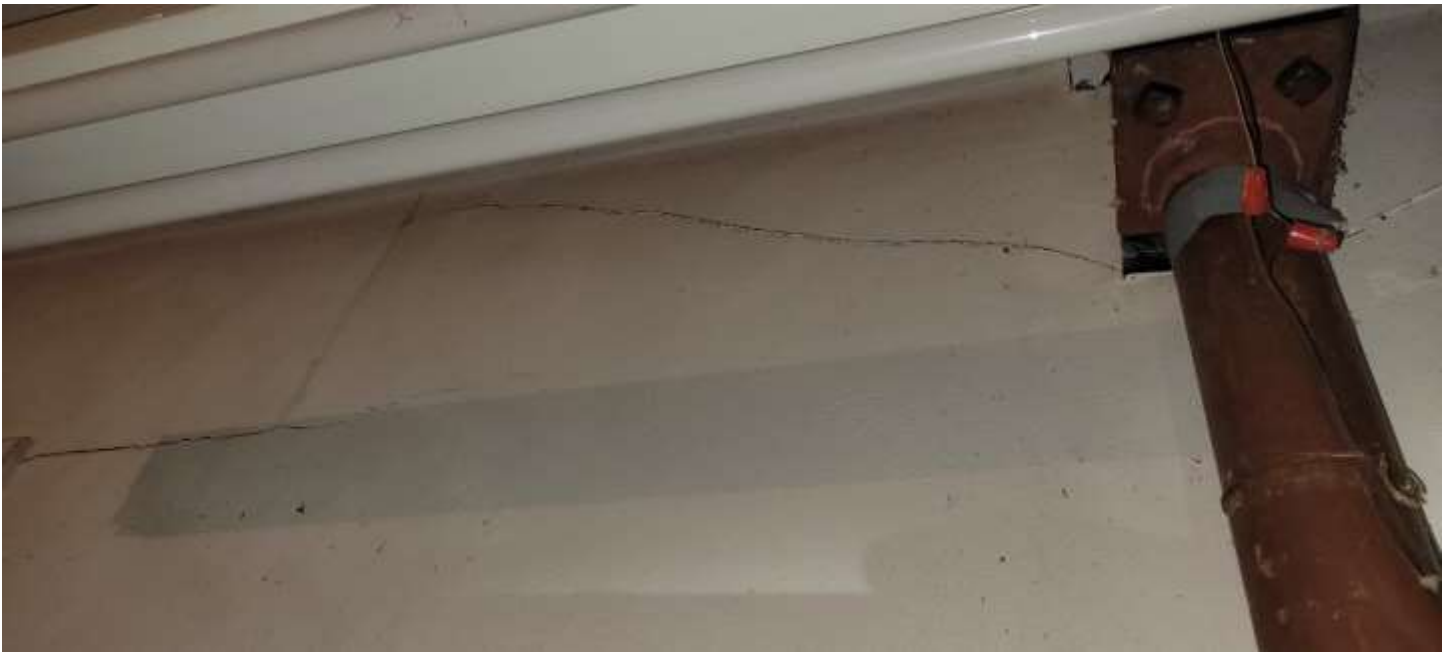
There's also some moisture on the right side of the house. Interesting, and I believe also consistent with water flows surrounding this house, as the center of the house was significantly more dry than the left and right side. Left side being the garage side, and right side being the other side of the house away from the garage.

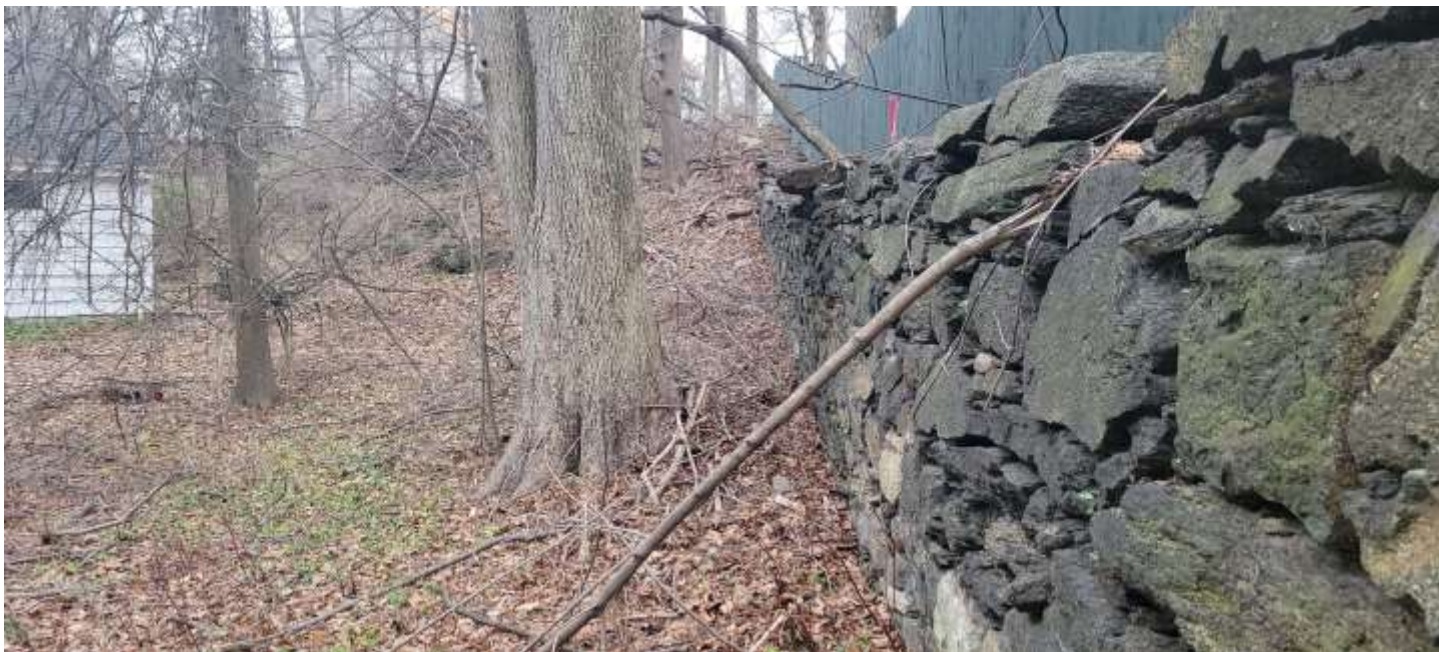
Notice this vertical wall moving inside the garage.

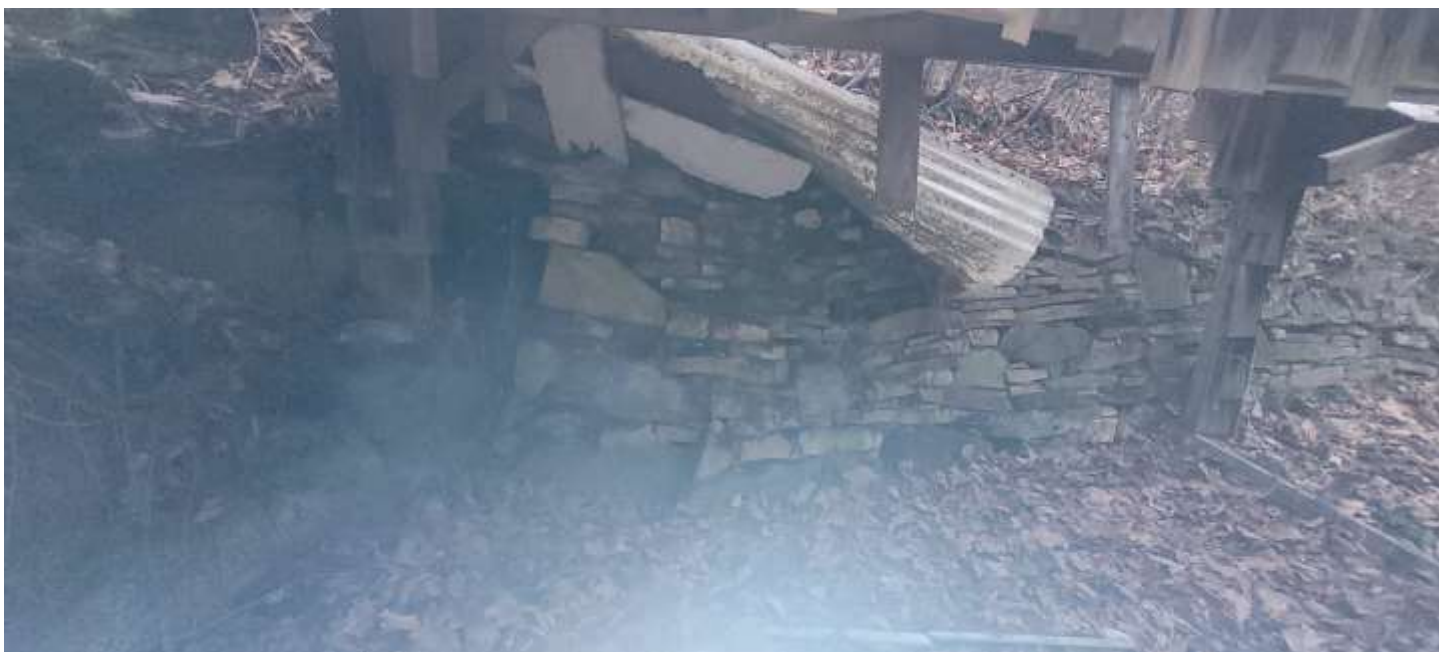
The retaining wall that separates you from the neighbors on the hill above you is starting to show signs of wear.

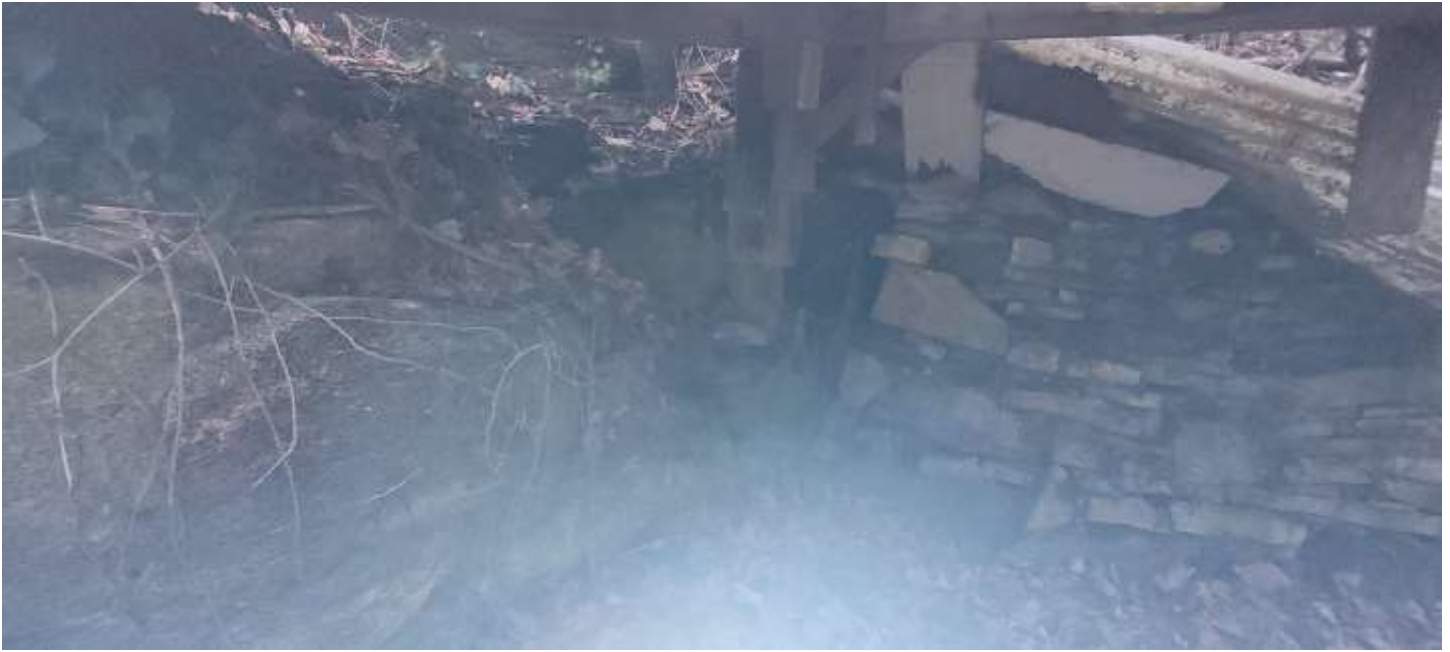
The retaining wall that separates you from the neighbors on the hill above you is starting to show signs of wear.

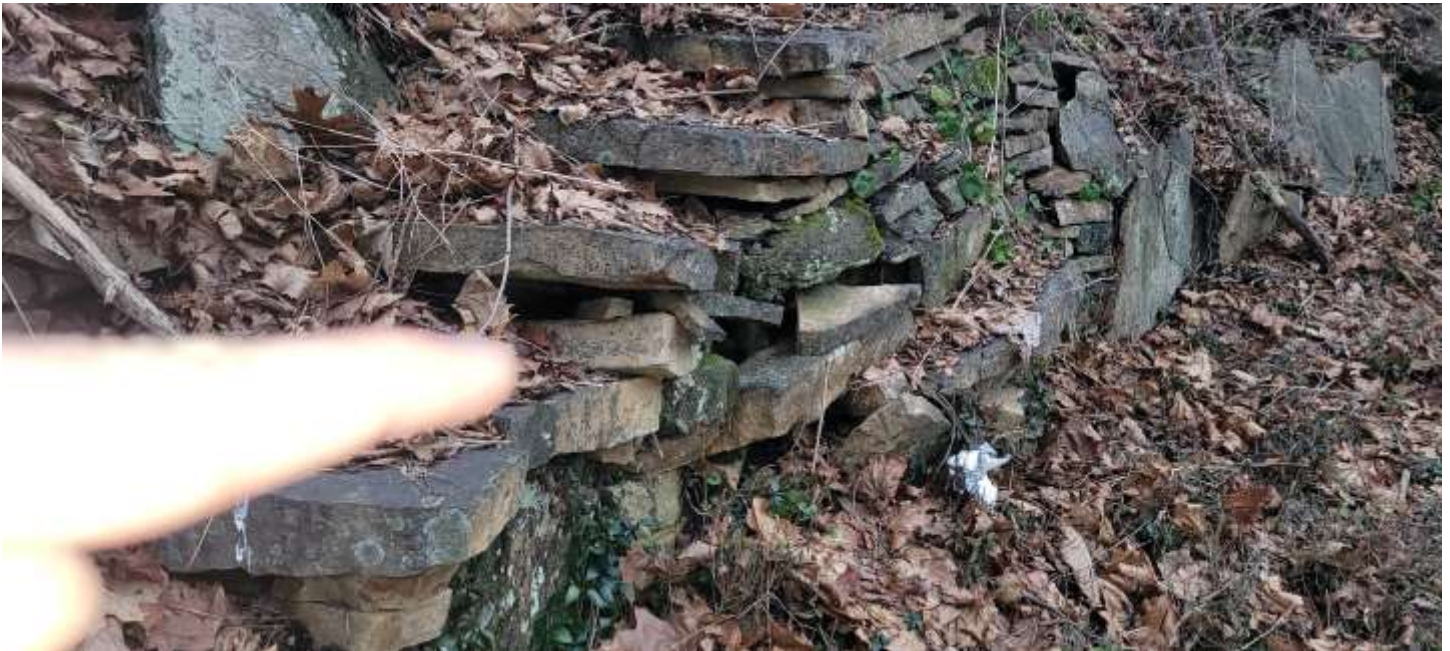
The retaining wall that separates you from the neighbors on the hill above you is starting to show signs of wear.

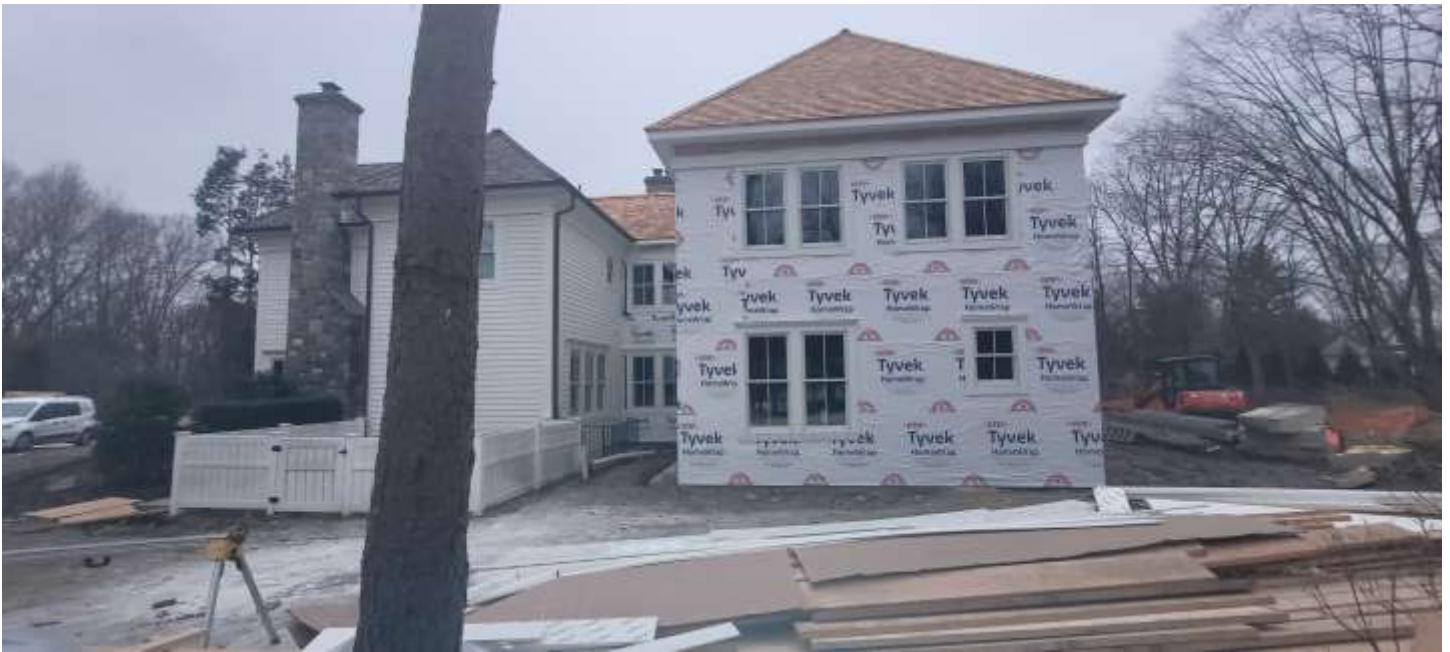
The retaining wall that separates you from the neighbors on the hill above you is starting to show signs of wear.

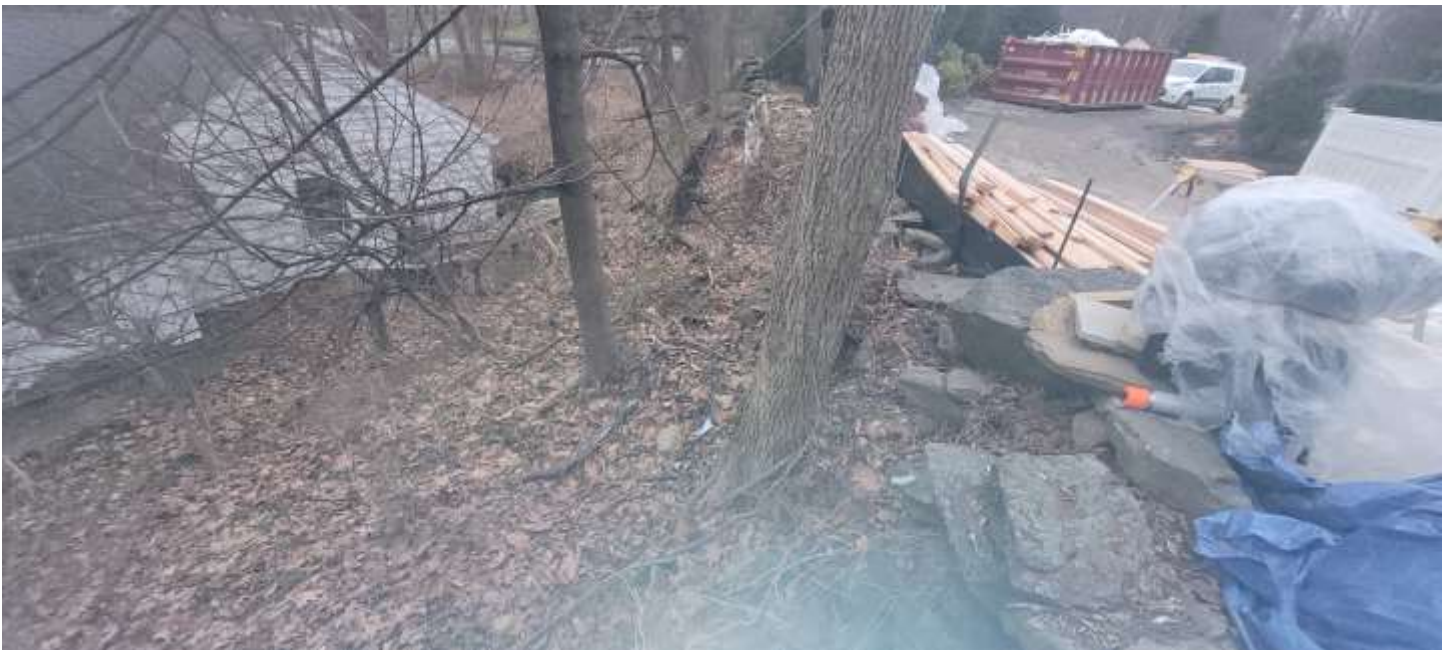
This new construction behind you introduced quite a bit of impervious surfaces. During heavy rain events, this would introduce a very directed flow of rainwater. I believe this is making the situation of your erosion worse.

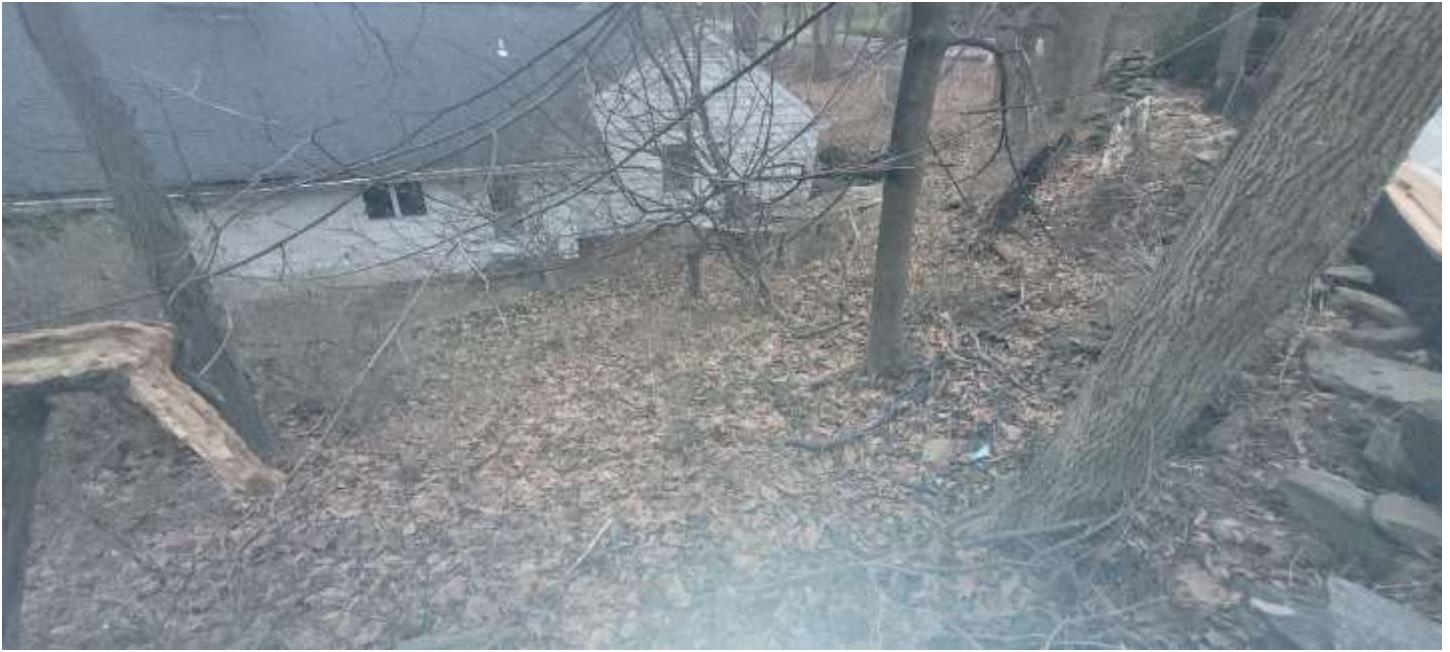
This new construction behind you introduced quite a bit of impervious surfaces. During heavy rain events, this would introduce a very directed flow of rainwater. I believe this is making the situation of your erosion worse.

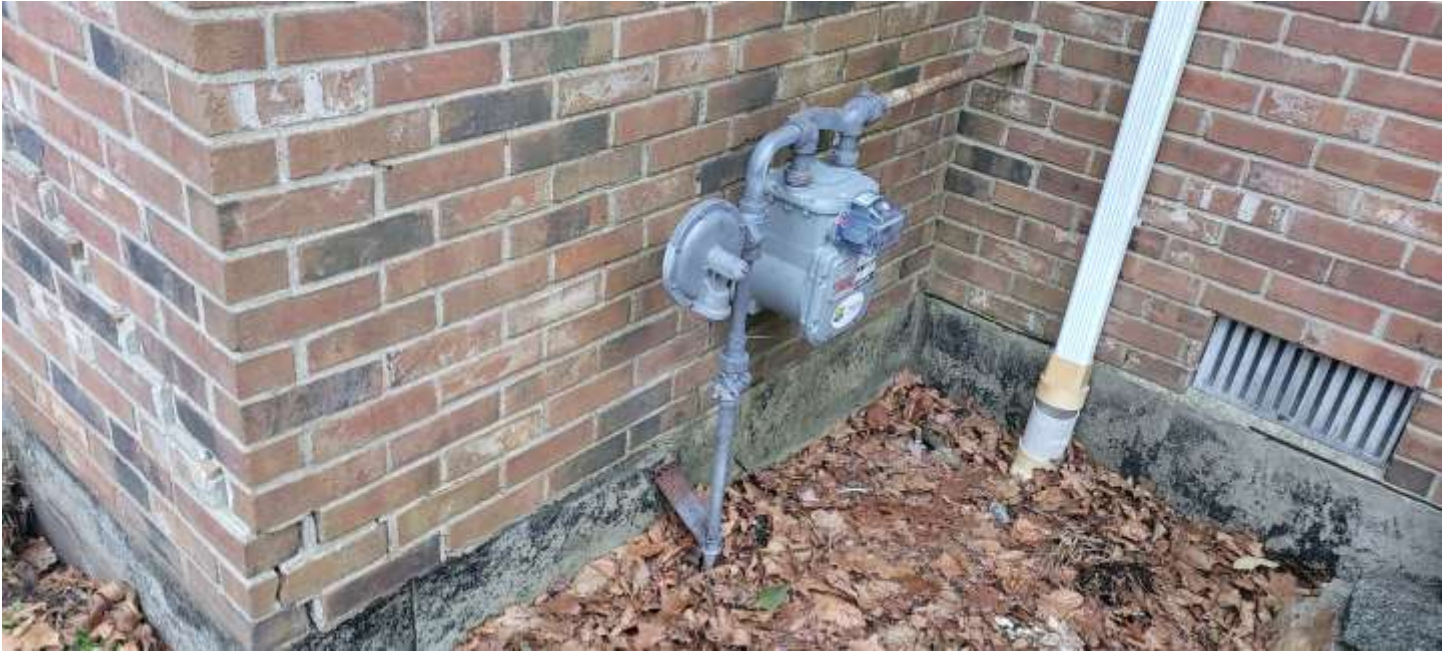
Gas meter and shut off. Notice the cracking of the bricks of the garage.

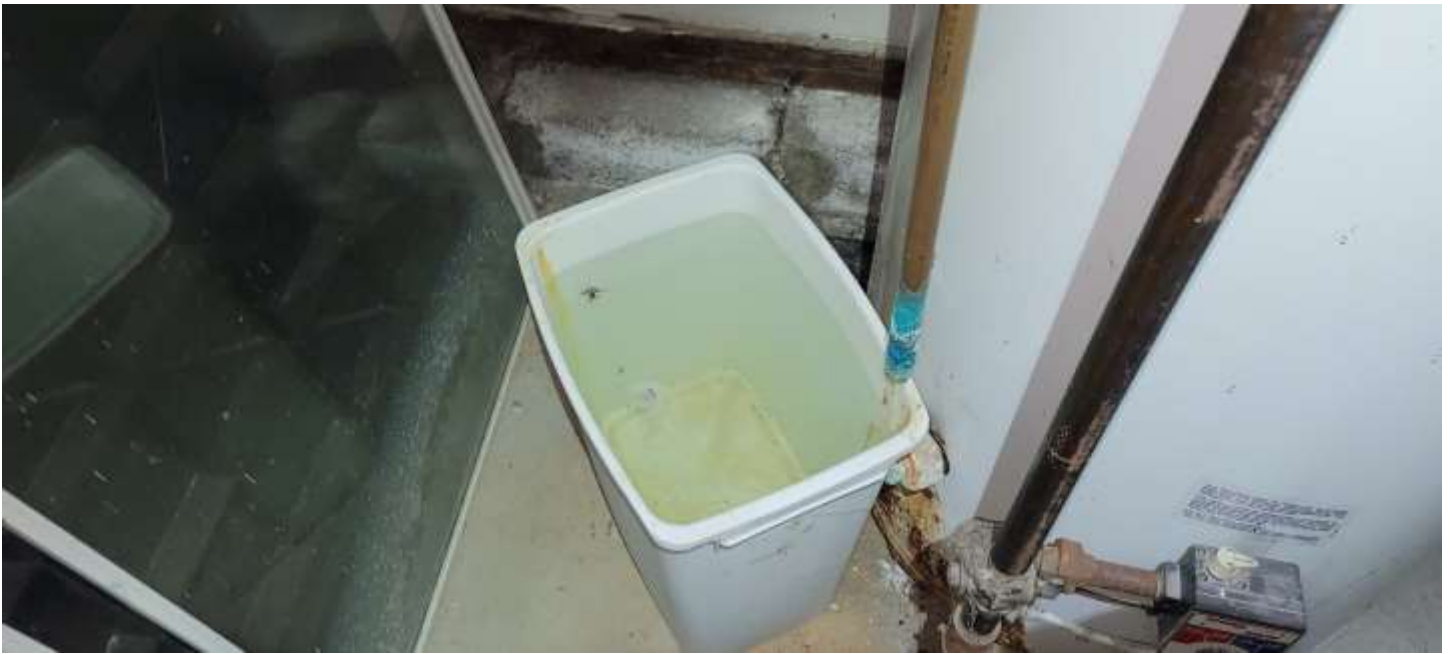
Whole view of hot water tank. Notice the full overflow bucket. That's not a good sign. This tank is very likely going to fail soon.

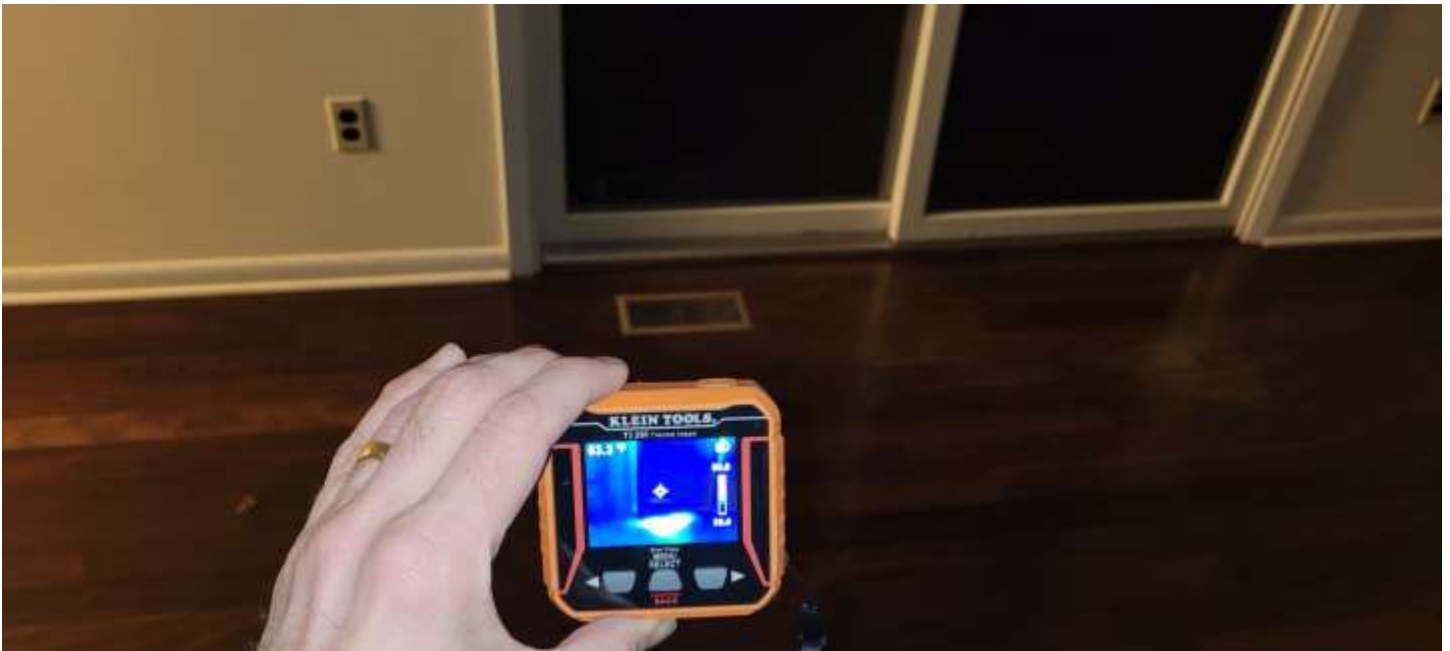
The ducts expressed hot and cold air. Very nice. The cool air got well below 50 degrees Fahrenheit. Very nice. Typical.

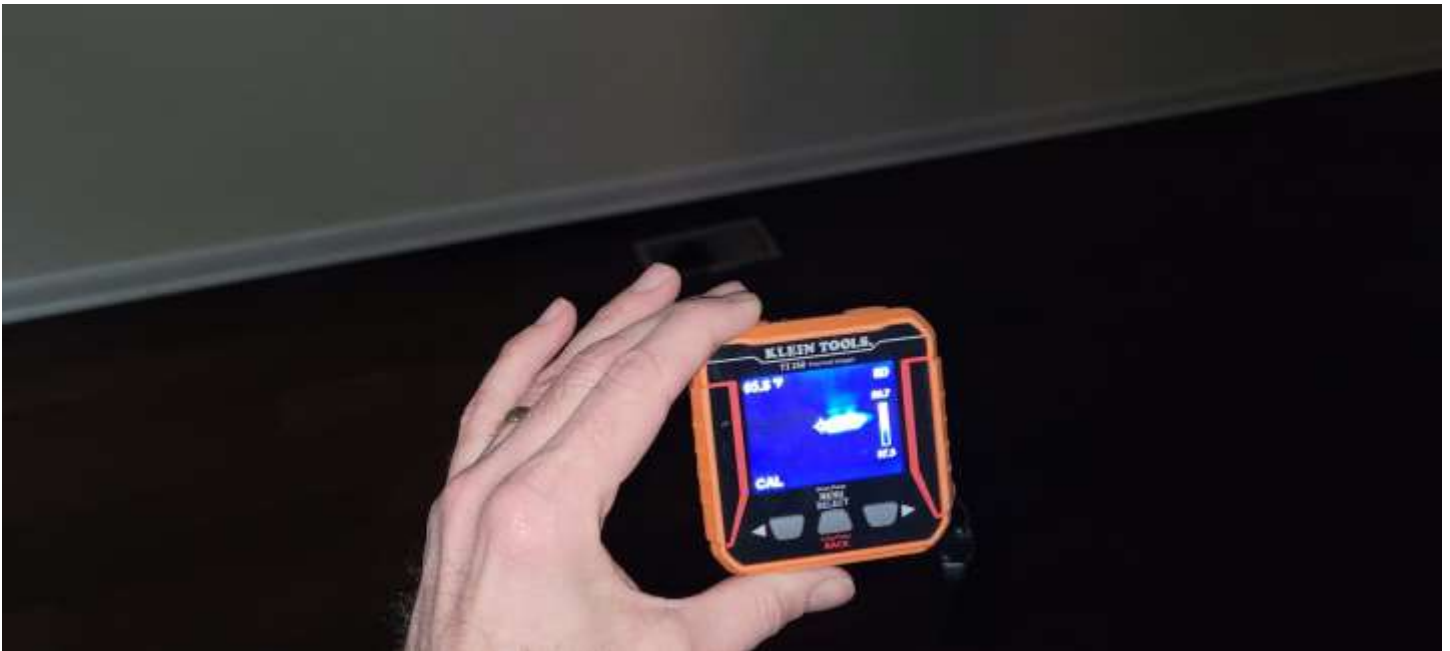
The ducts expressed hot and cold air. Very nice. The cool air got well below 50 degrees Fahrenheit. Very nice. Typical.
