Property: 123 Main Street, Anytown, NY  
Date: 15Jan2021  
Present: Louis Csak, insp.; ####, buyer; ### agent.  
Conditions: 40's, overcast

**Executive summary:** (details in report)

The house was not well maintained, and the garage foundation is beginning to show serious issues, and very likely there is a regular water occurrence that will eventually affect the main foundation badly.

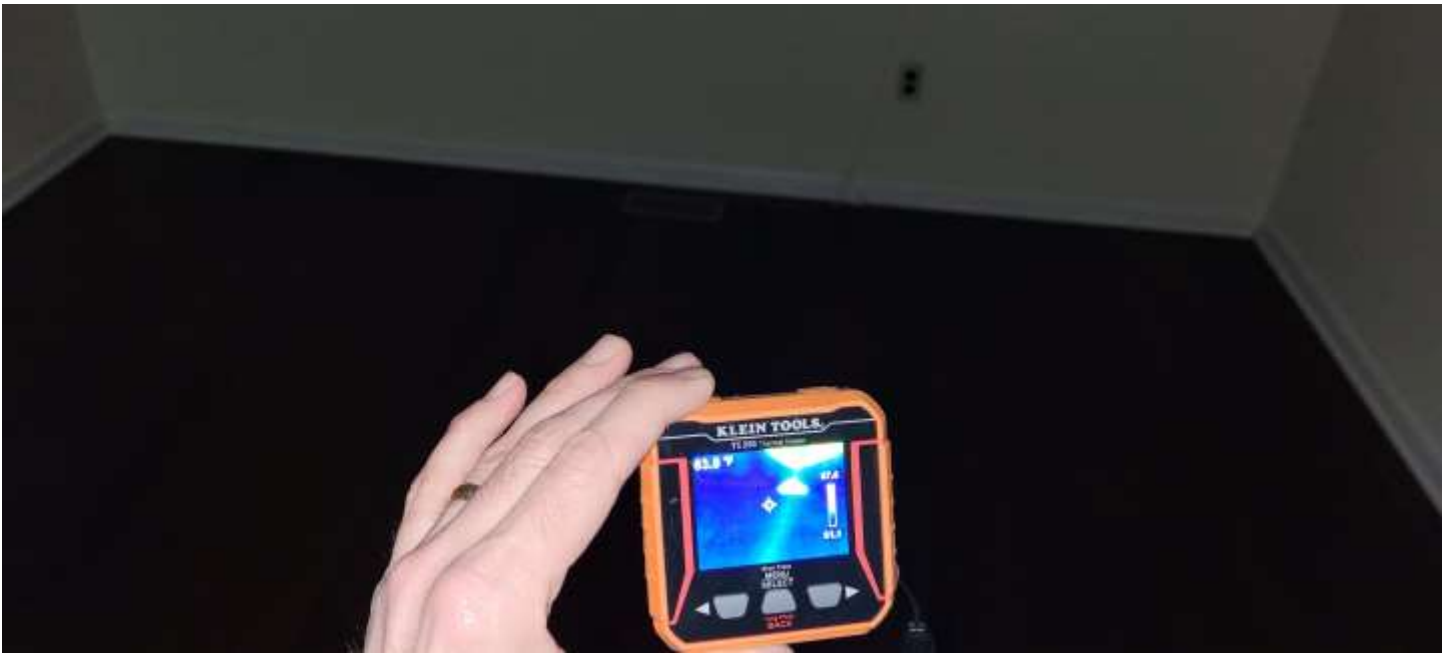
The ducts expressed hot and cold air. Very nice. The cool air got well below 50 degrees Fahrenheit. Very nice. Typical.

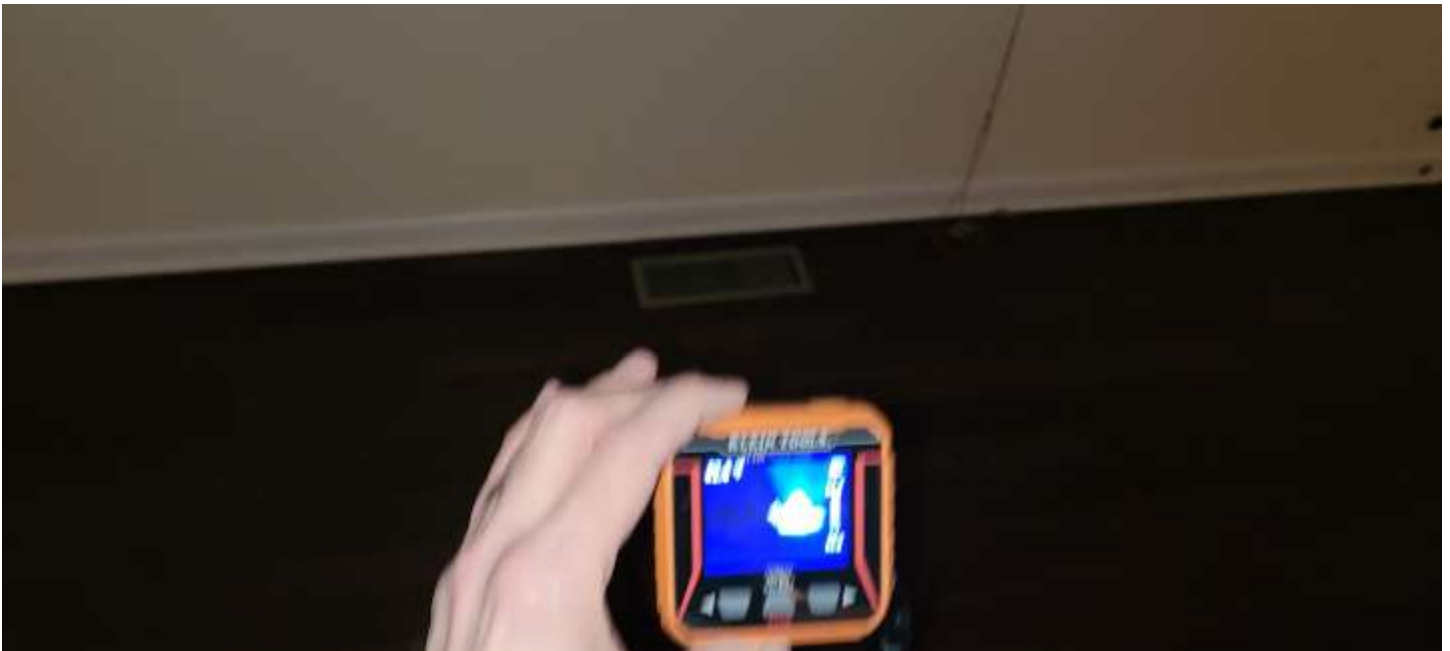
The ducts expressed hot and cold air. Very nice. The cool air got well below 50 degrees Fahrenheit. Very nice. Typical.

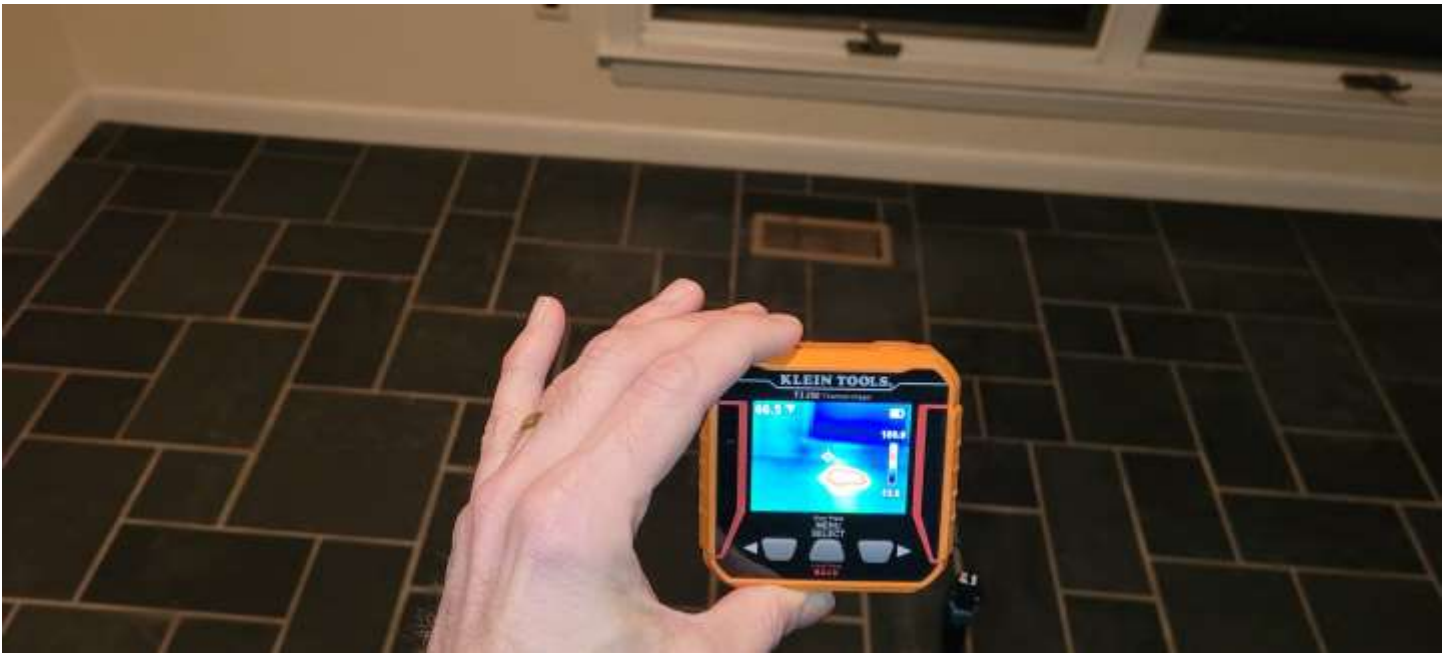
The ducts expressed hot and cold air. Very nice. The cool air got well below 50 degrees Fahrenheit. Very nice. Typical.

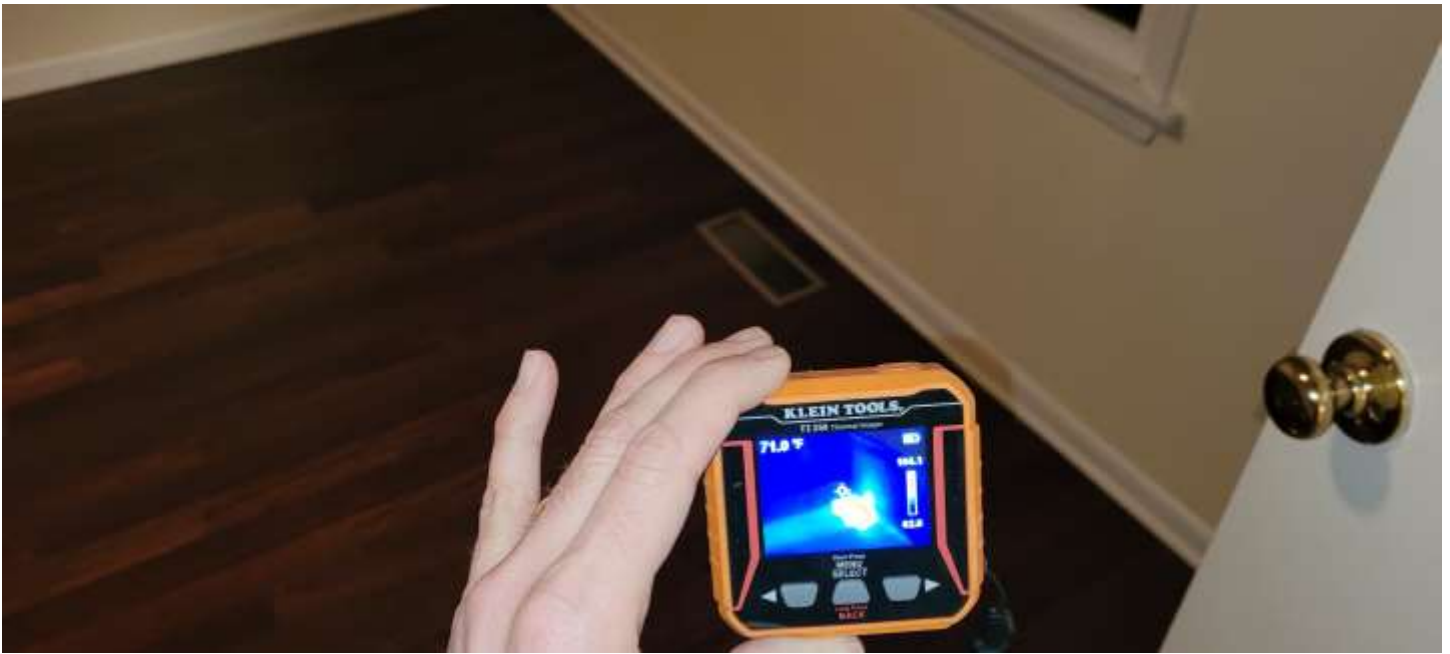
The ducts expressed hot and cold air. Very nice. The cool air got well below 50 degrees Fahrenheit. Very nice. Typical.

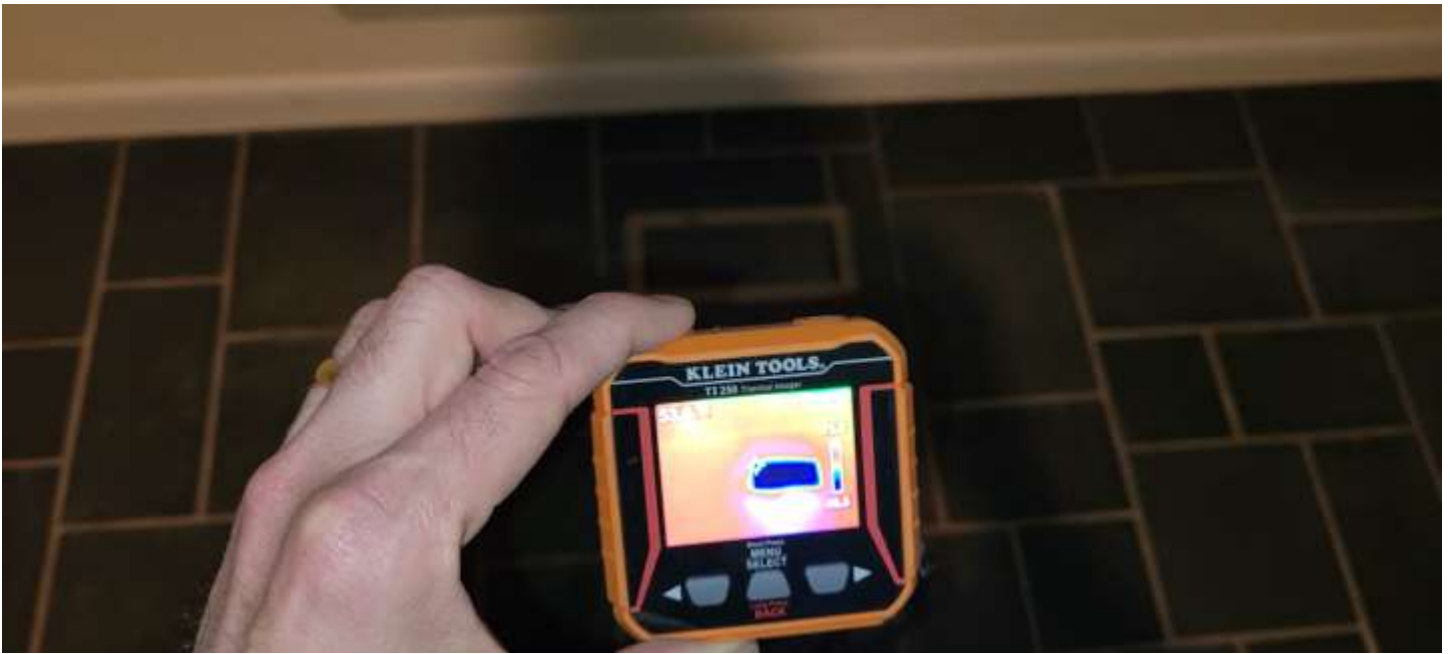
The ducts expressed hot and cold air. Very nice. The cool air got well below 50 degrees Fahrenheit. Very nice. Typical.

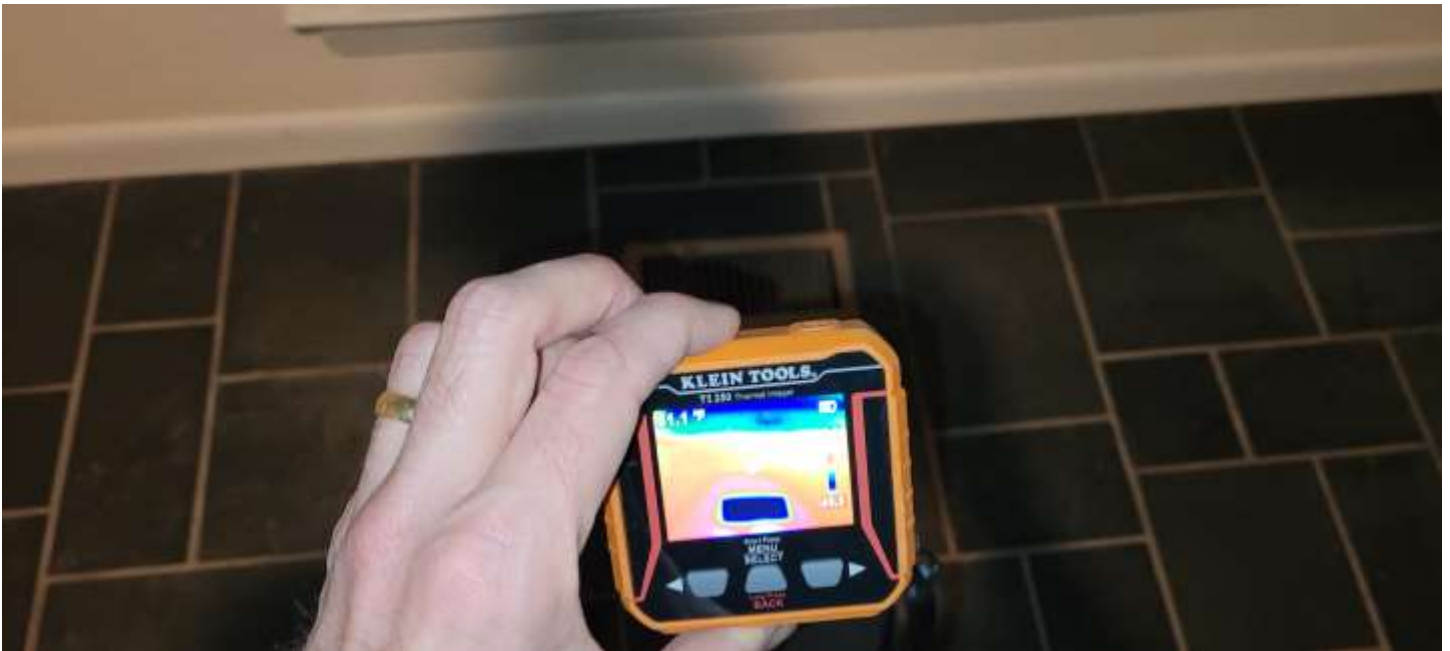
The ducts expressed hot and cold air. Very nice. The cool air got well below 50 degrees Fahrenheit. Very nice. Typical.

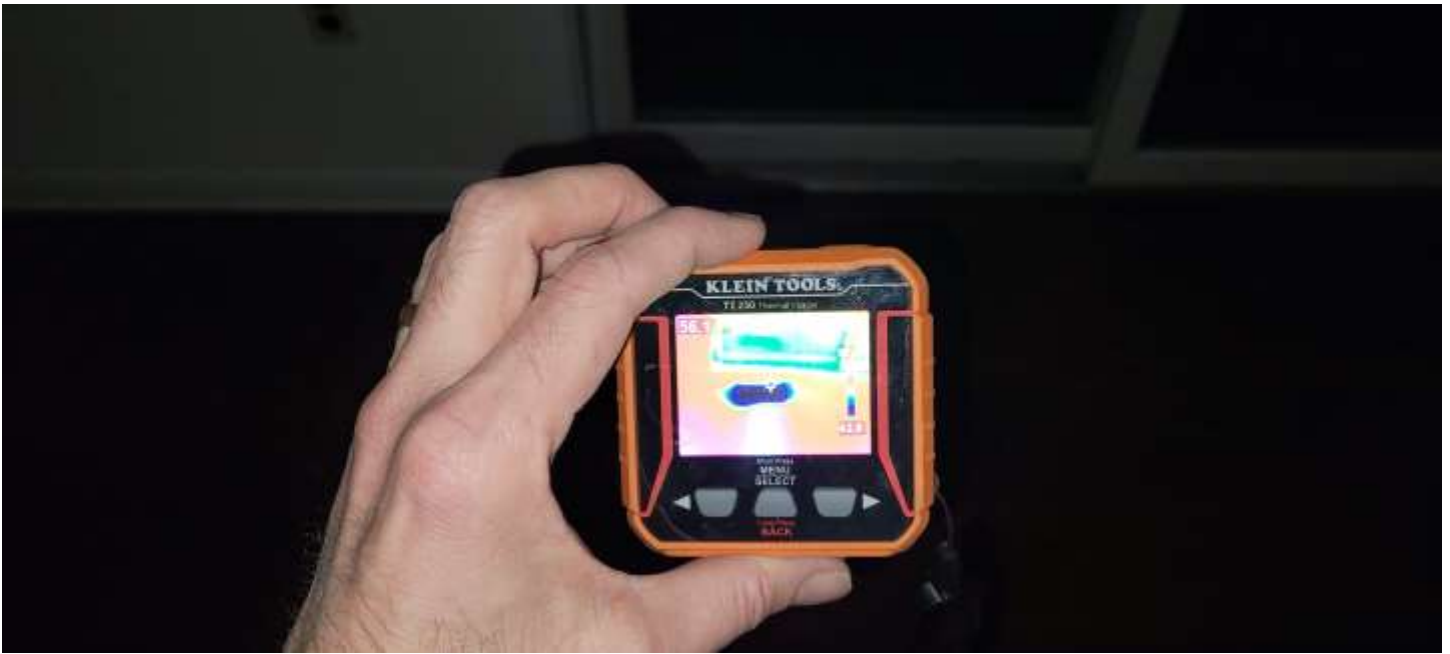
The ducts expressed hot and cold air. Very nice. The cool air got well below 50 degrees Fahrenheit. Very nice. Typical.

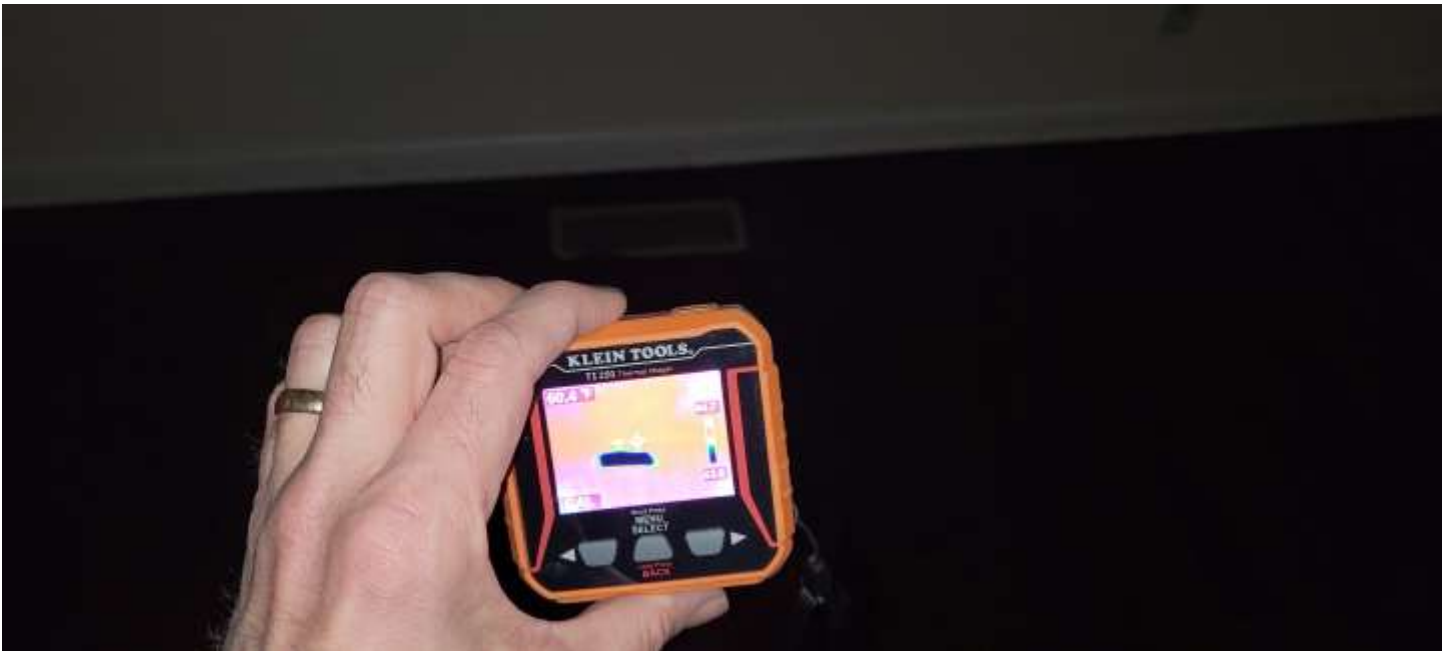
The ducts expressed hot and cold air. Very nice. The cool air got well below 50 degrees Fahrenheit. Very nice. Typical.

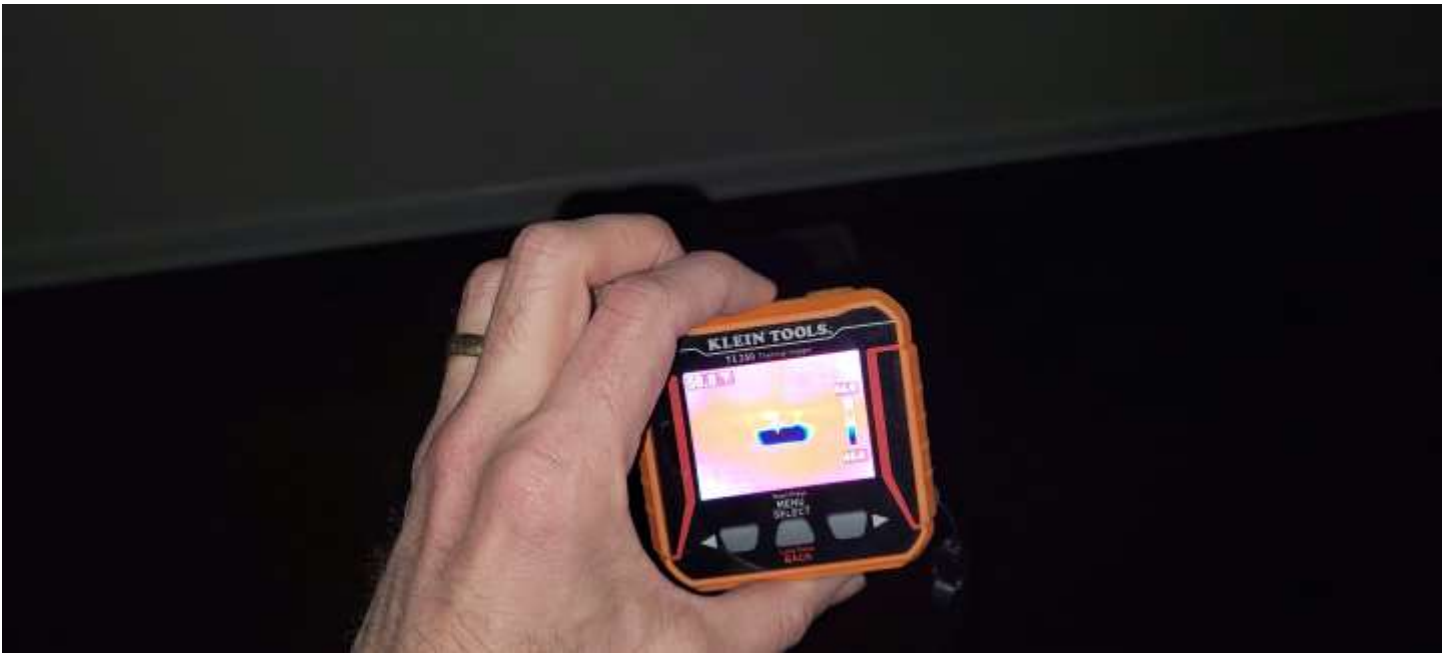
The ducts expressed hot and cold air. Very nice. The cool air got well below 50 degrees Fahrenheit. Very nice. Typical.

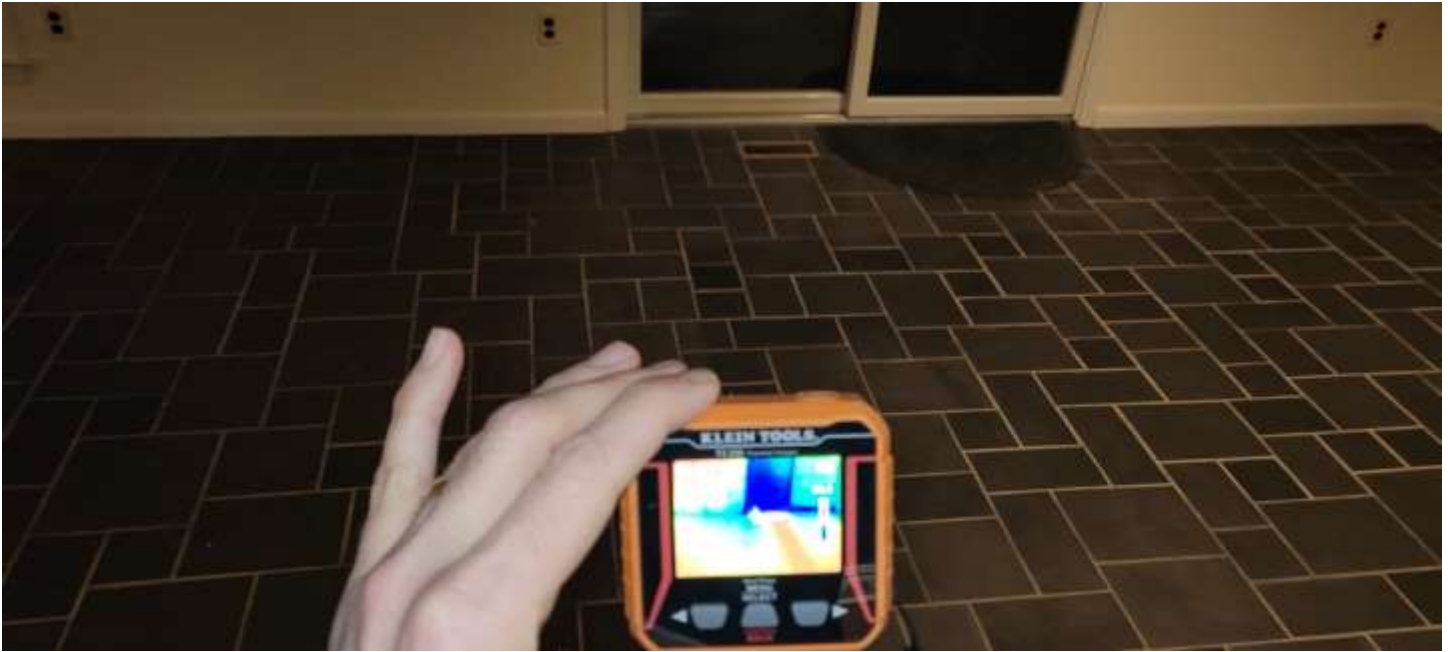
The ducts expressed hot and cold air. Very nice. The cool air got well below 50 degrees Fahrenheit. Very nice. Typical.

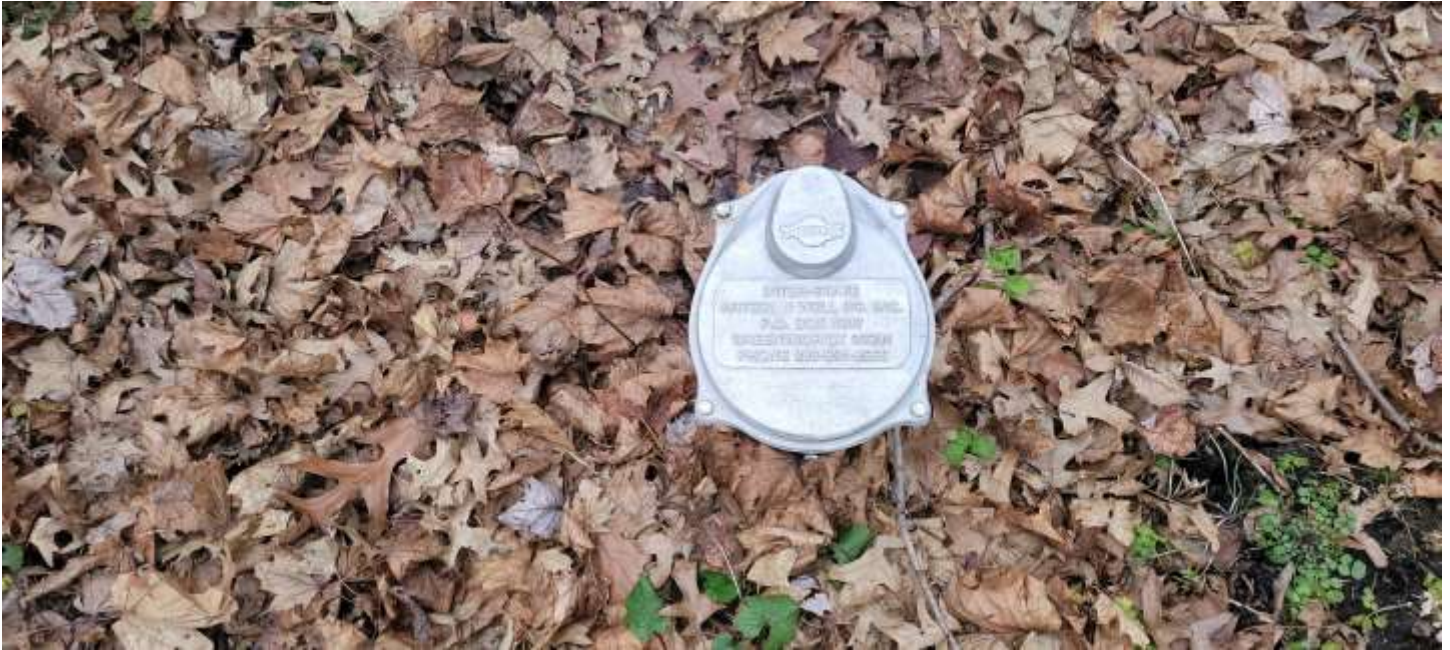
Well pump.

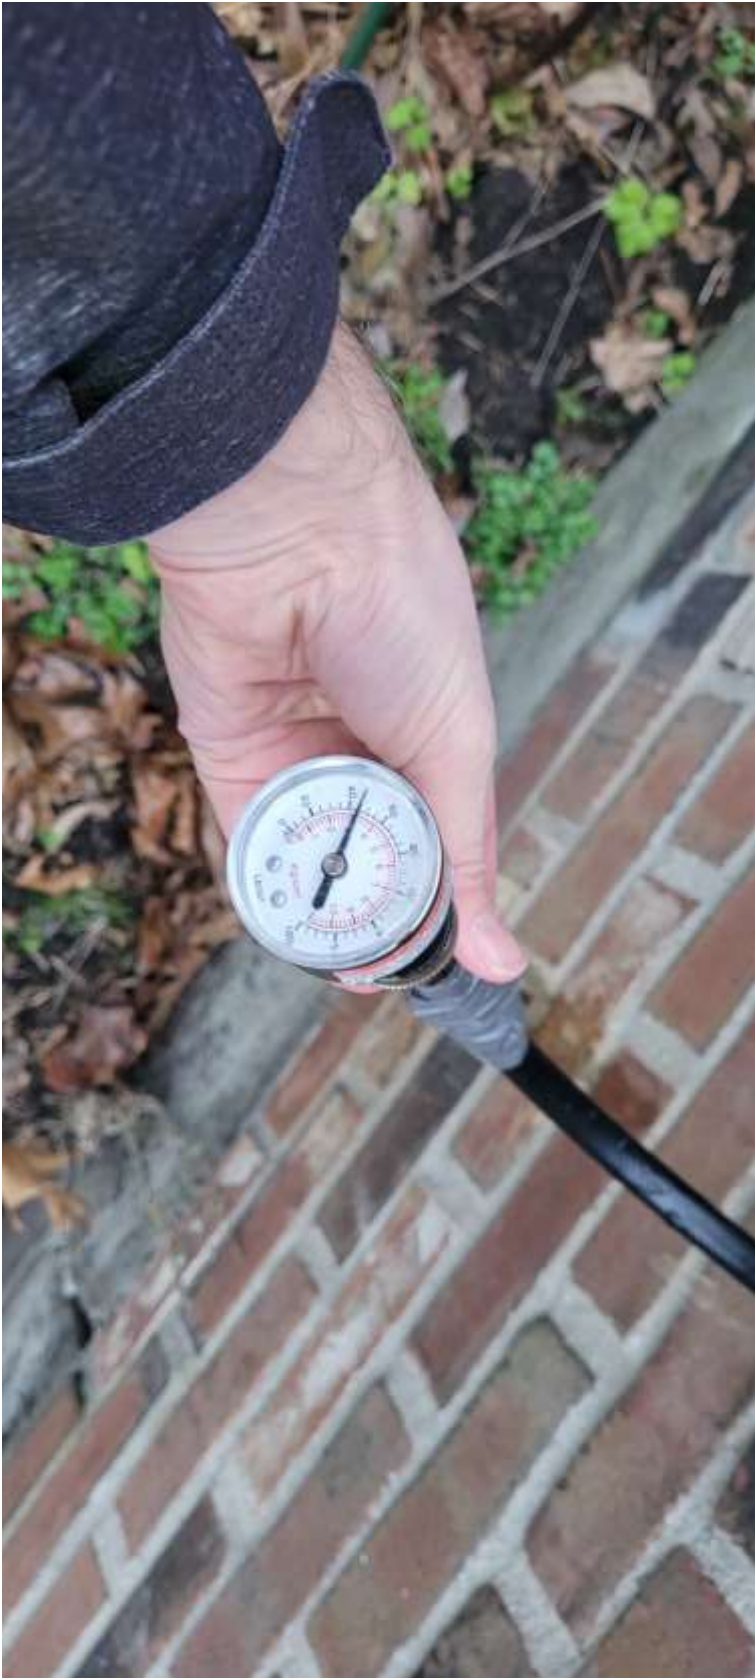
Static water pressure is about 45psi. That's good. You may want to increase that just a little bit, so you have more powerful showers. But have a plumber do this.

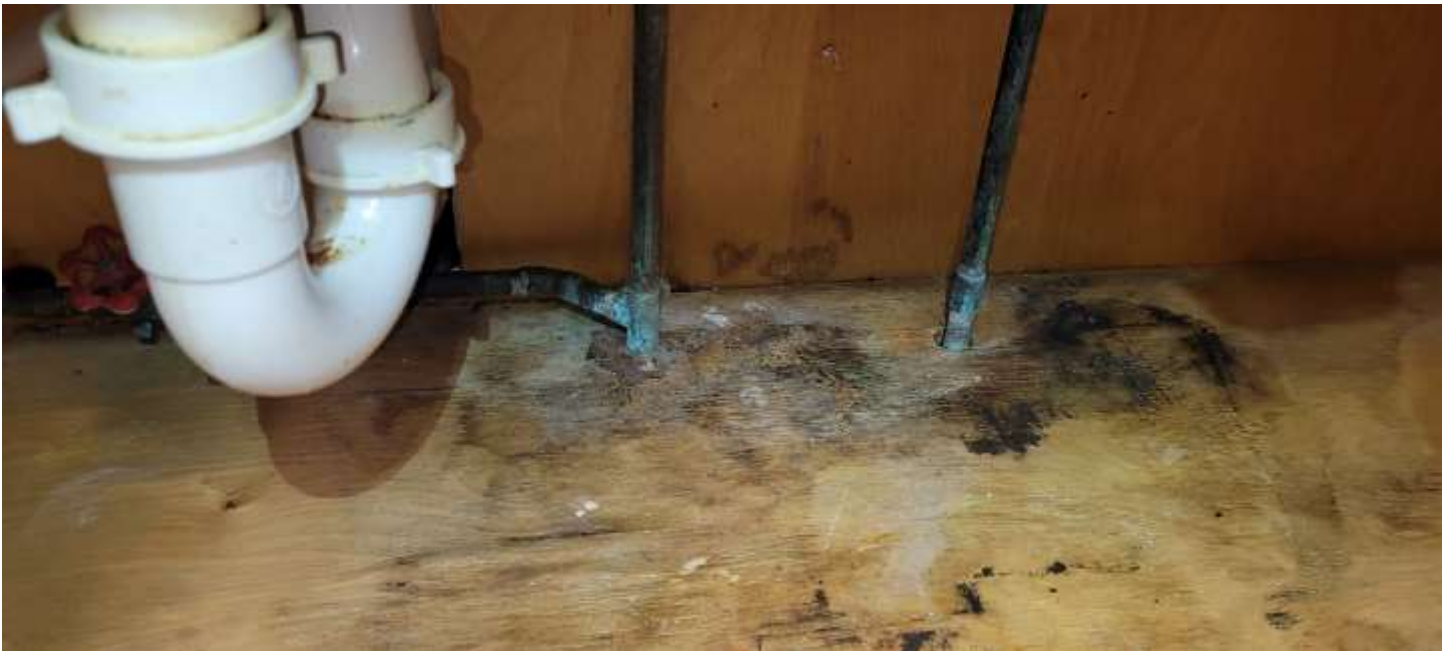
But the wood seems to have degraded and even rotted here. I don't have an explanation as to why.

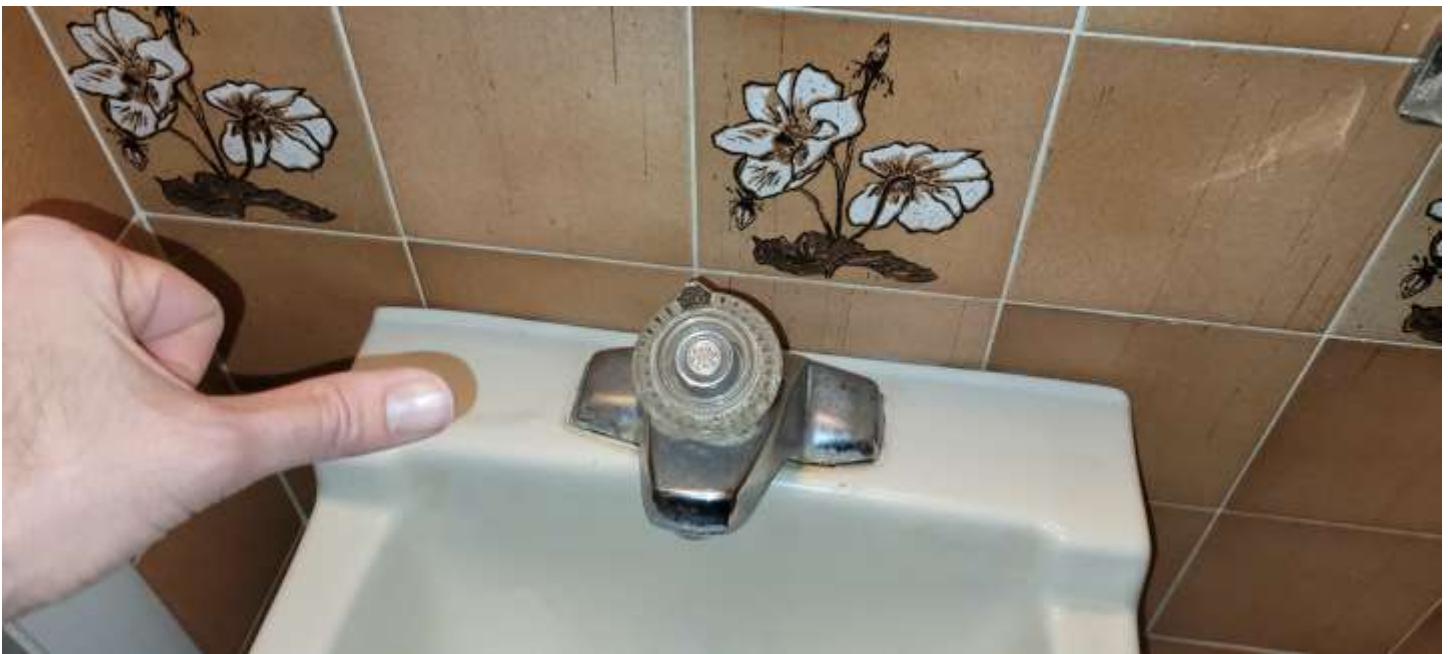
This faucet actuator is sticky.

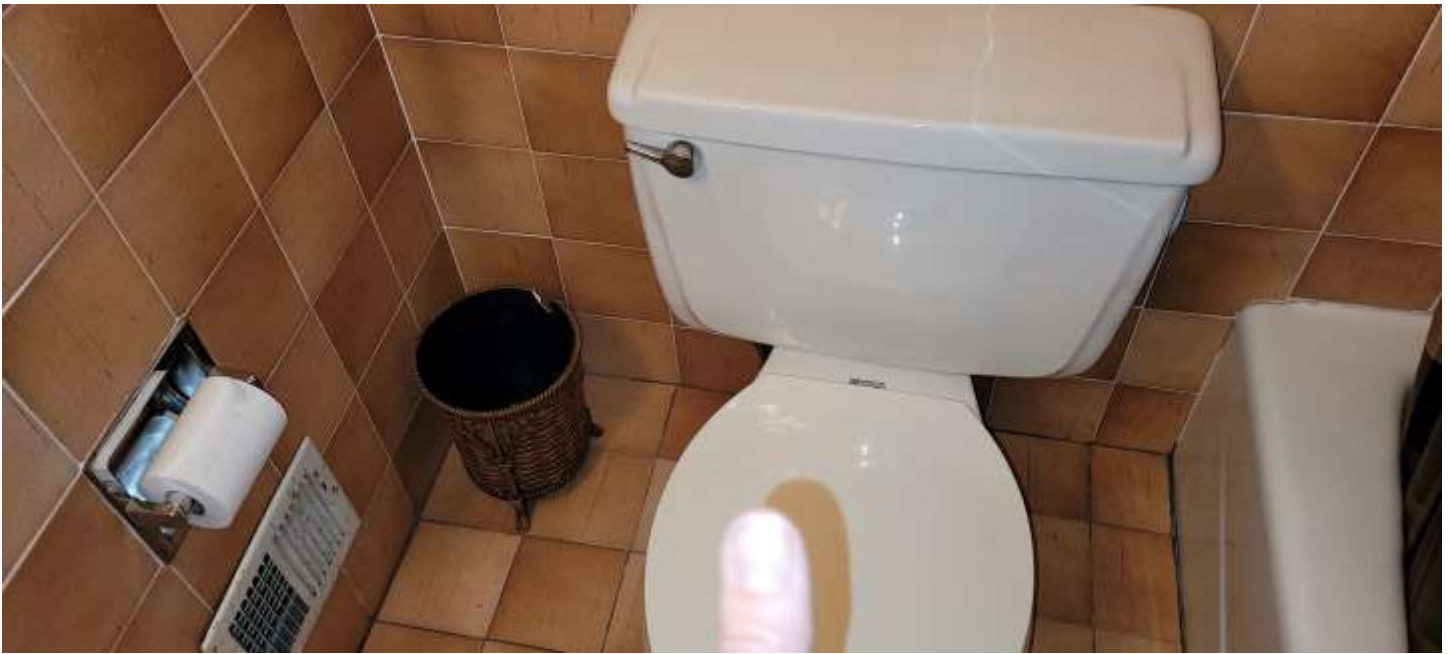
This toilet flushes properly.

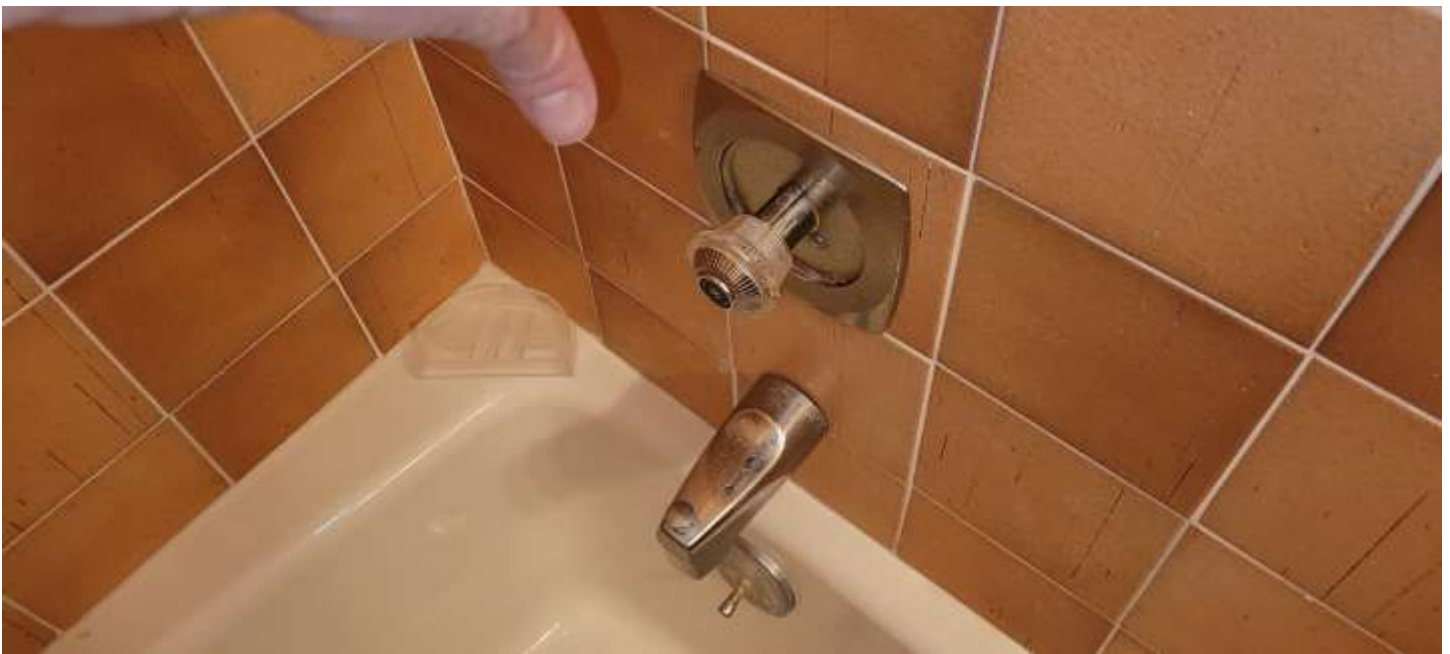
This faucet actuator is sticky, and I could not get it to operate.

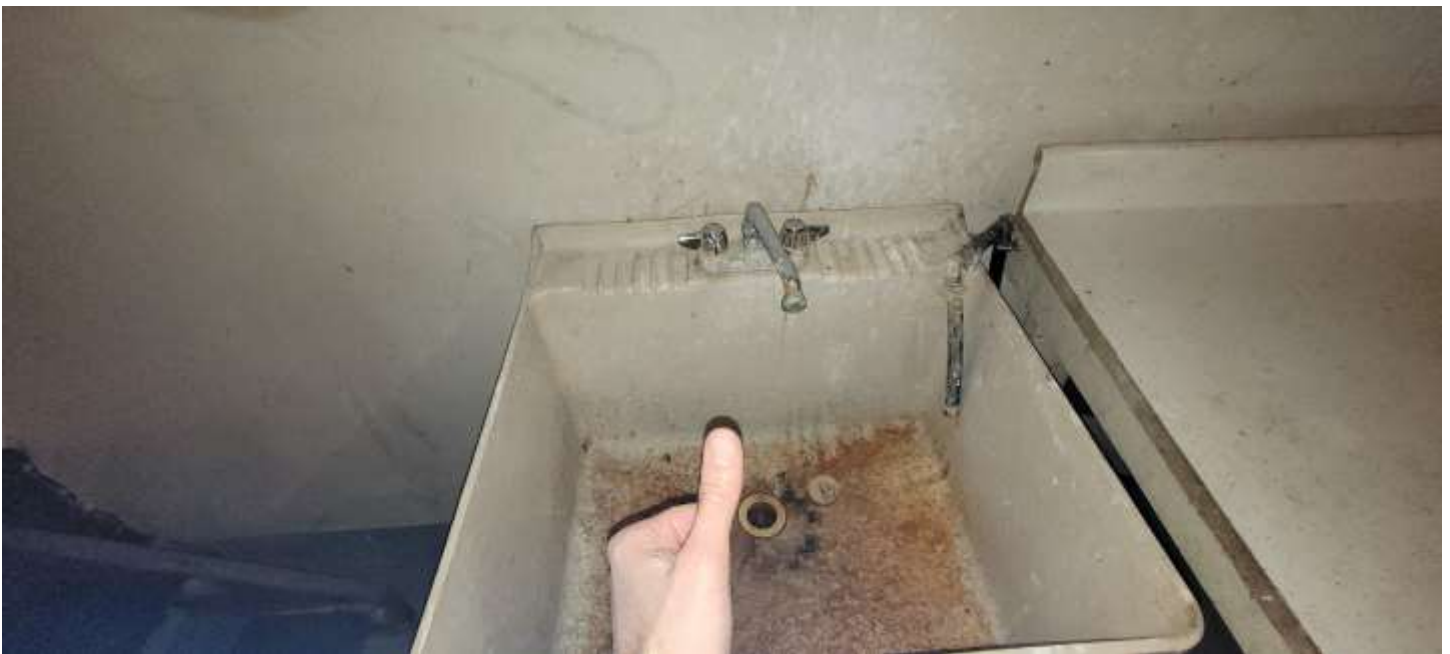
This faucet and sink functioned properly.

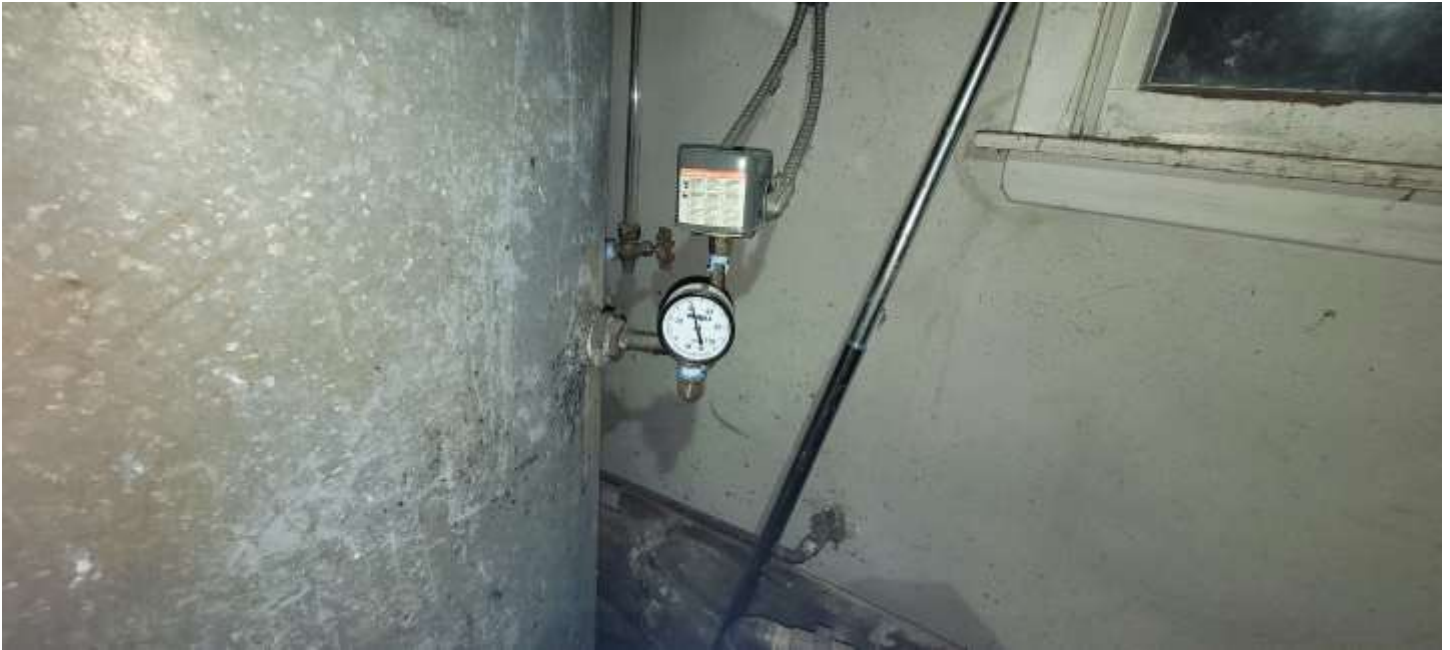
Static water pressure from the systems pressure gauge.

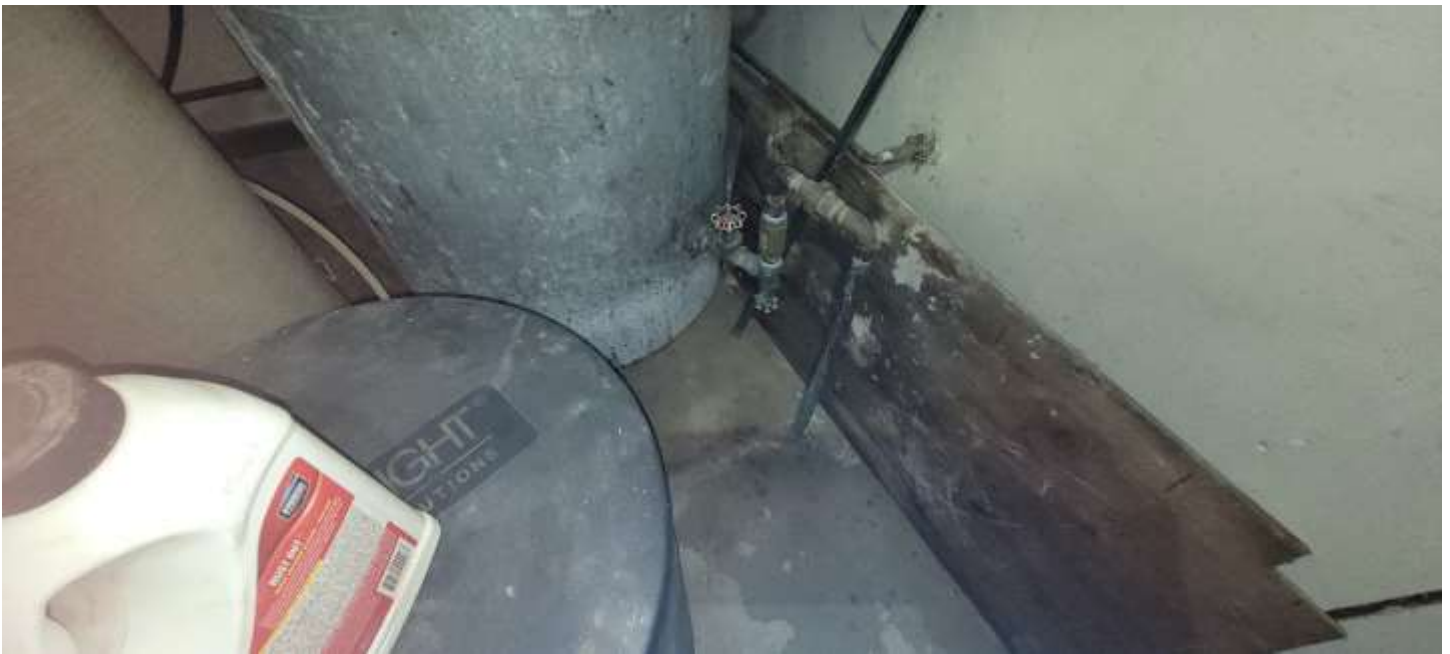
Water main shut off.

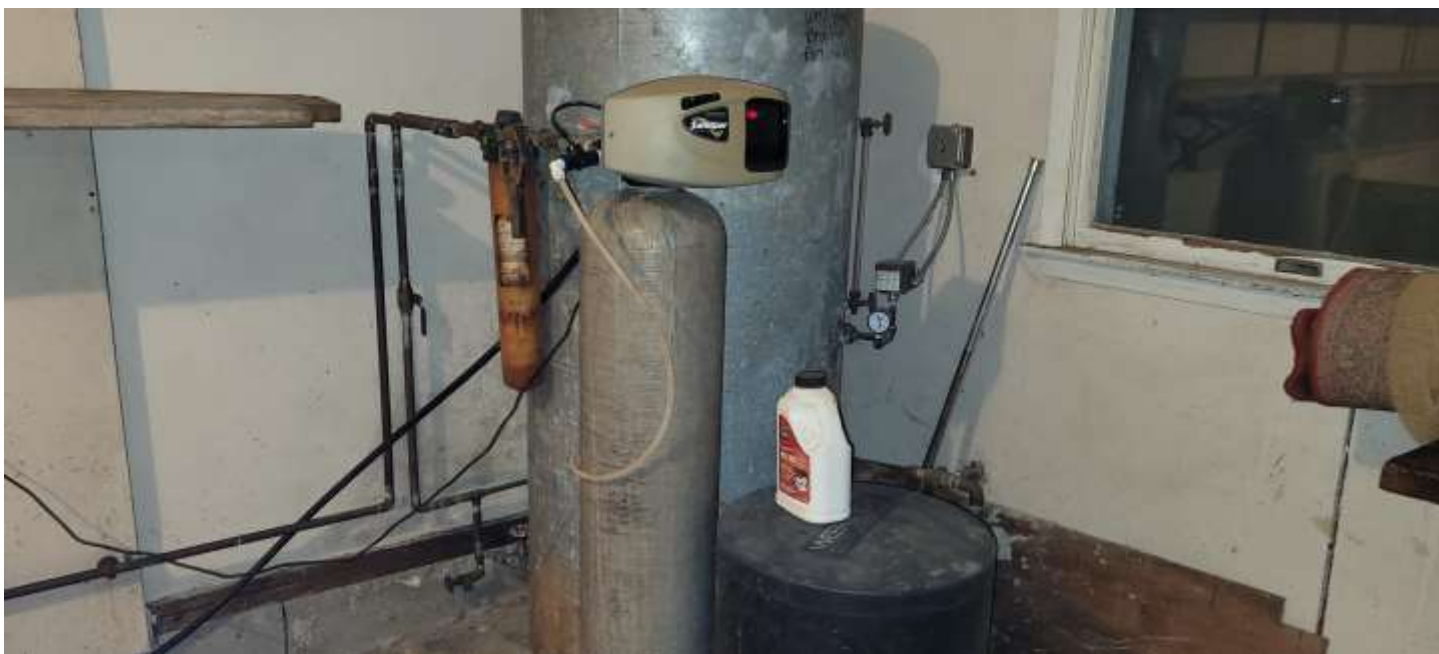
Water treatment system whole view.

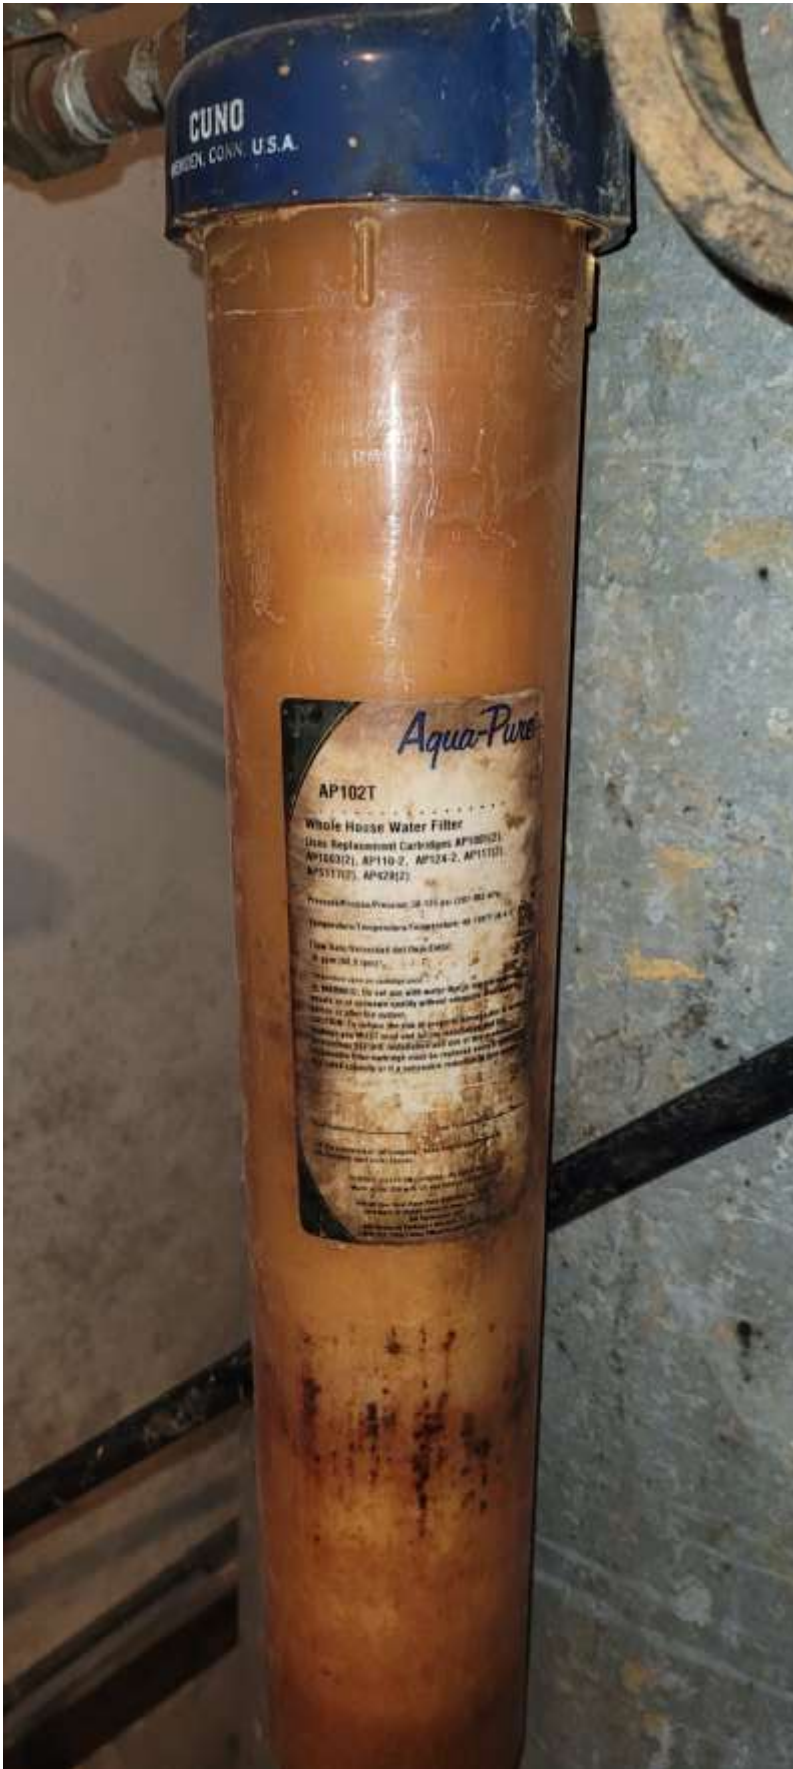
Close up of filter.

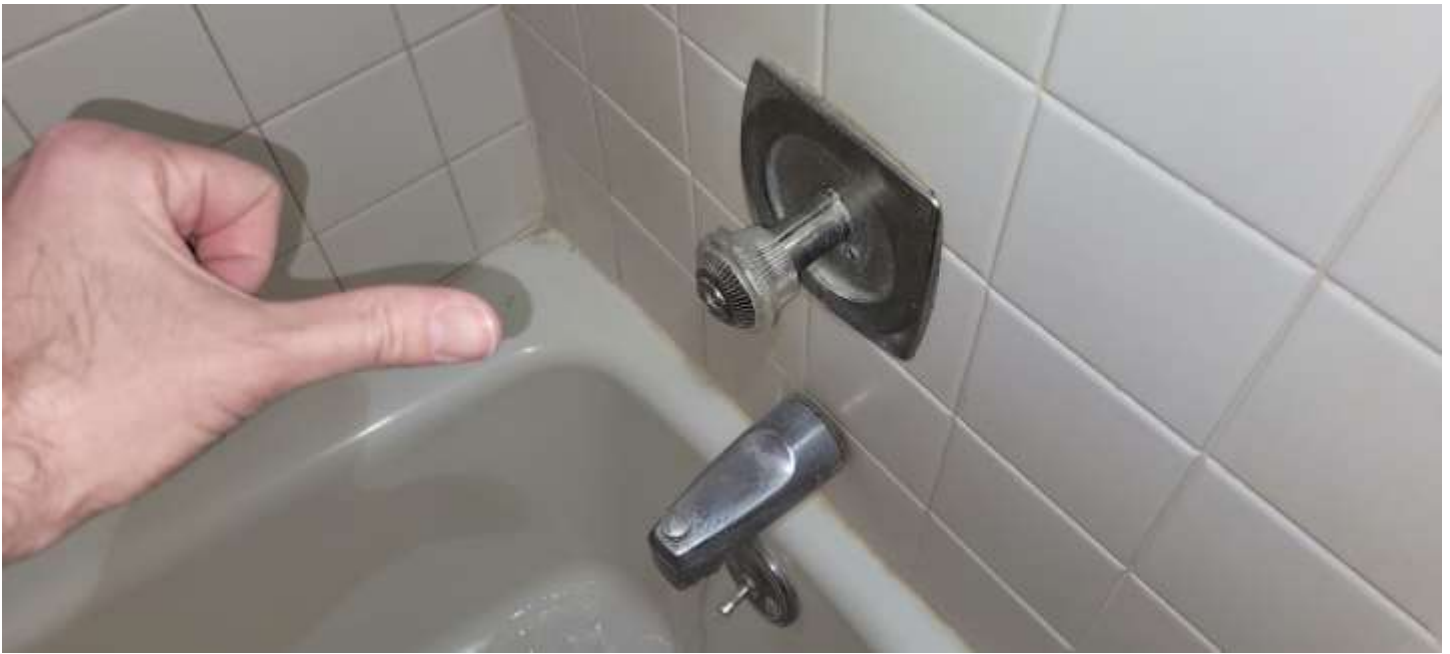
This faucet actuator is sticky.

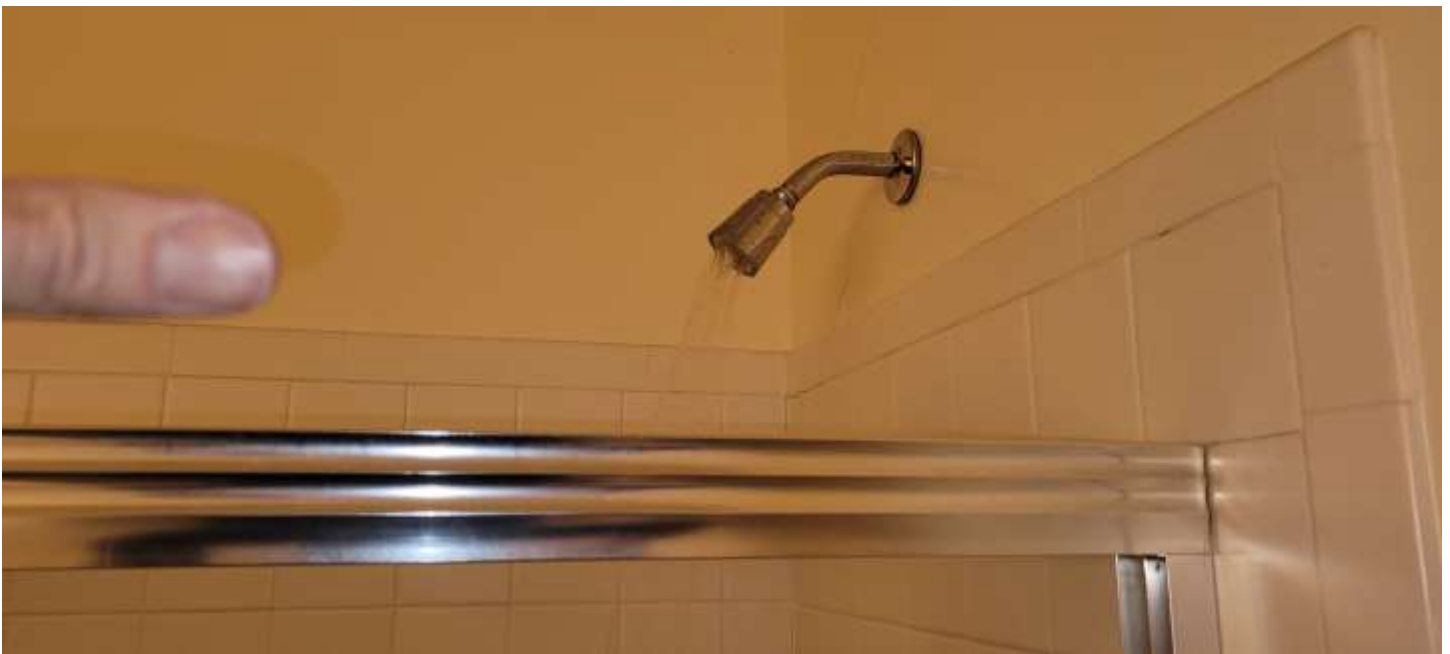
The water came out a little bit slowly from the shower.
