Property: 123 Main Street, Anytown, NY  
Date: 15Jan2021  
Present: Louis Csak, insp.; ####, buyer; ### agent.  
Conditions: 40's, overcast

**Executive summary:** (details in report)

The house was not well maintained, and the garage foundation is beginning to show serious issues, and very likely there is a regular water occurrence that will eventually affect the main foundation badly.

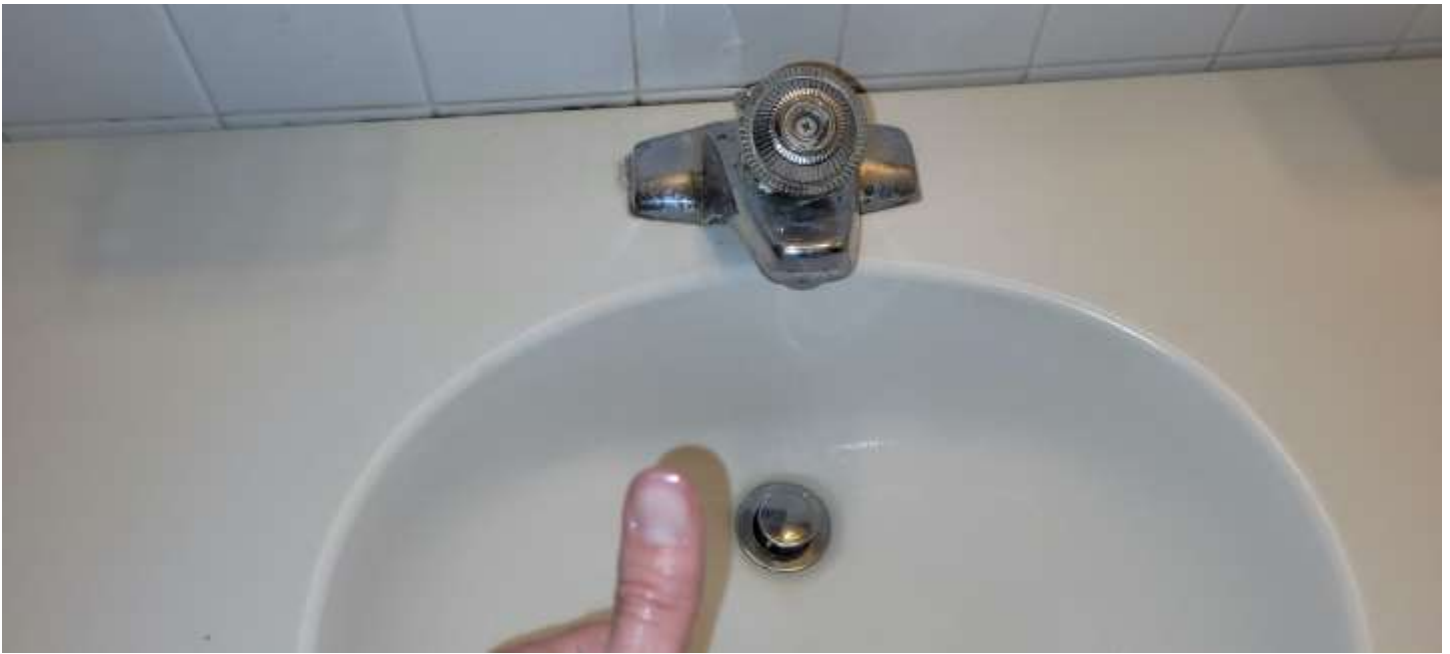
This faucet and sink function properly.

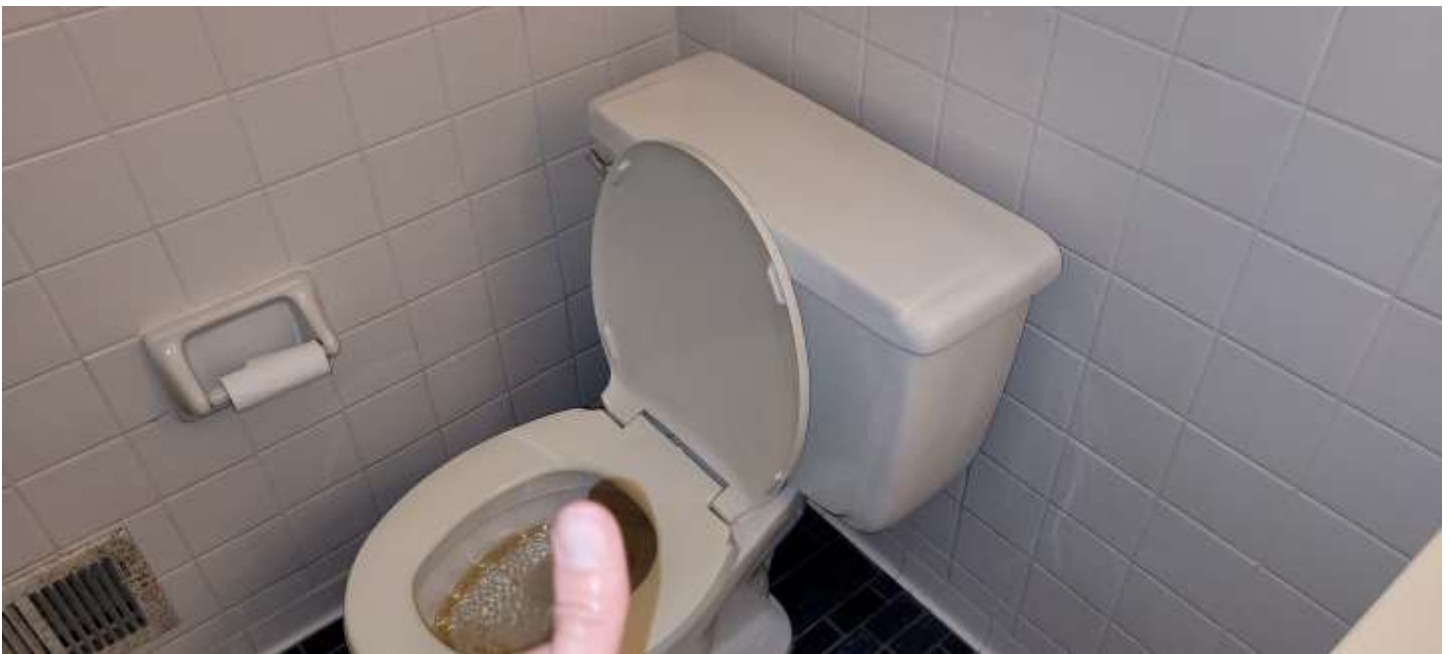
This toilet functions properly.

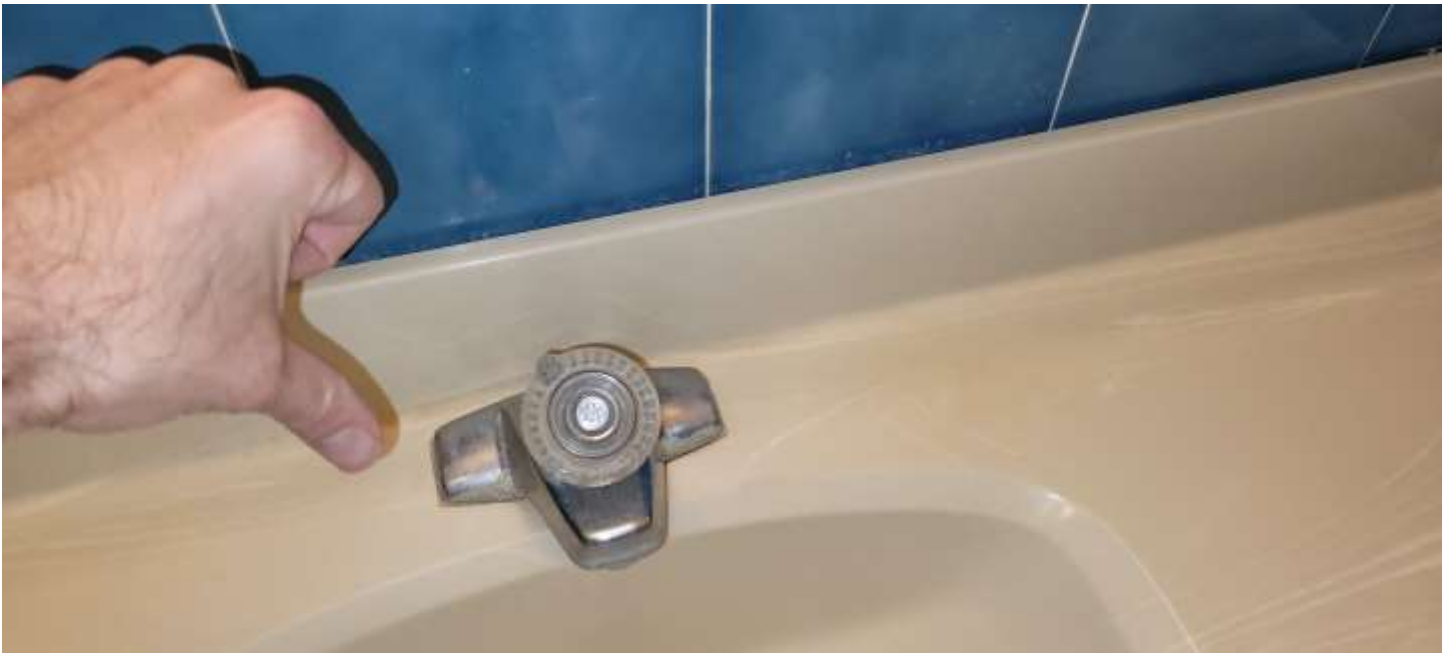
This faucet and sink do not function properly.

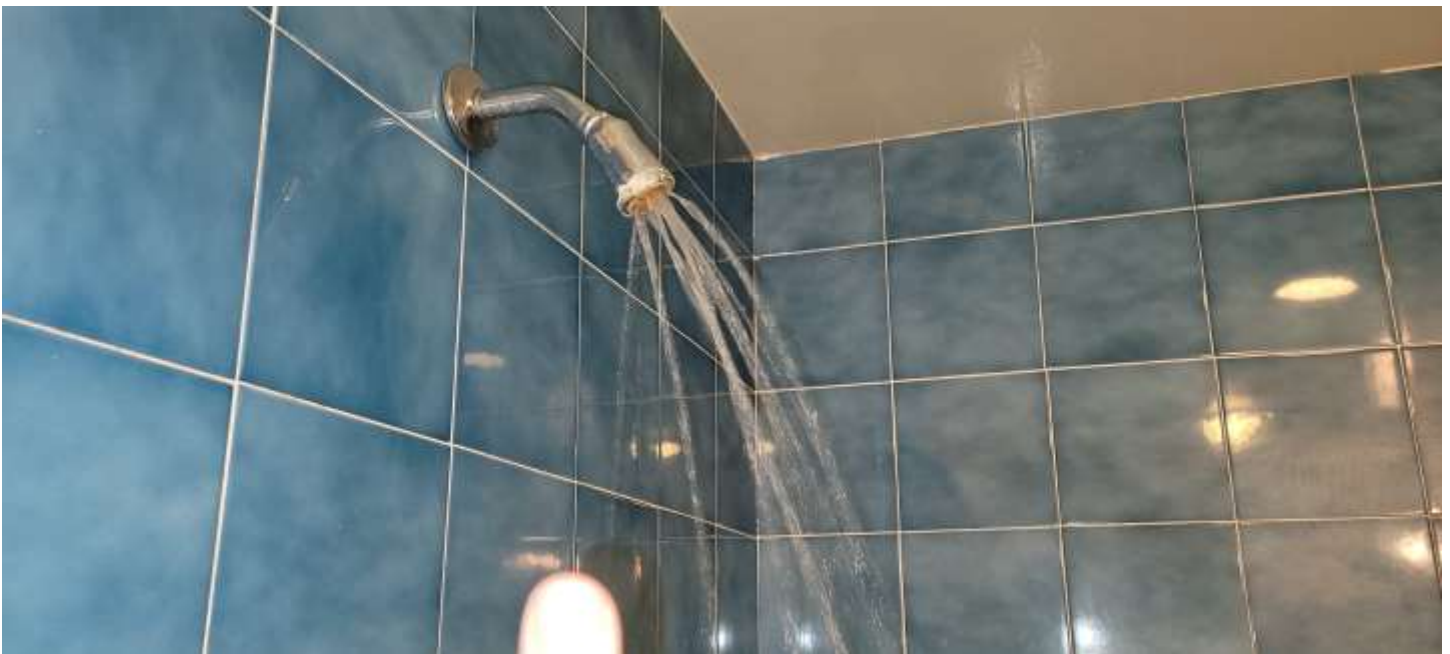
The water comes out of this showerhead a little bit better. Given that there is a lot of scale around most of the showers , I suspect this water is very hard.

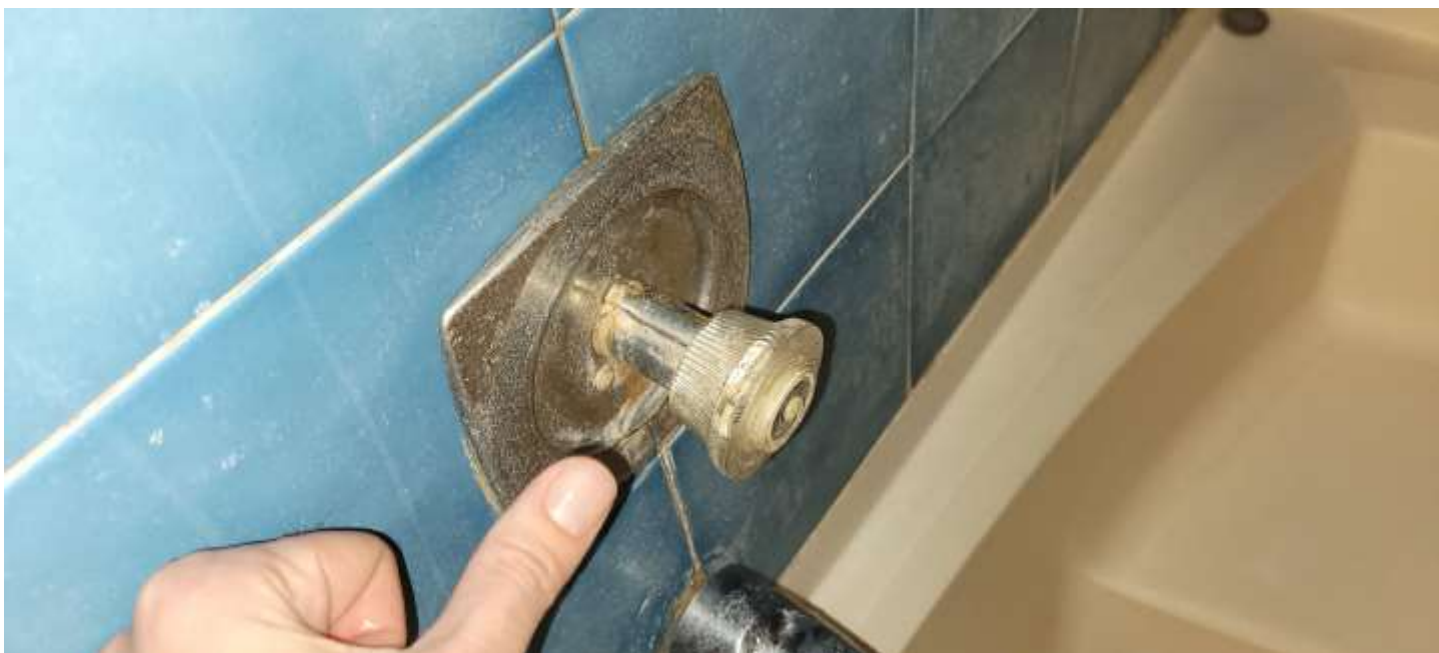
However the actuator was a little bit sticky.

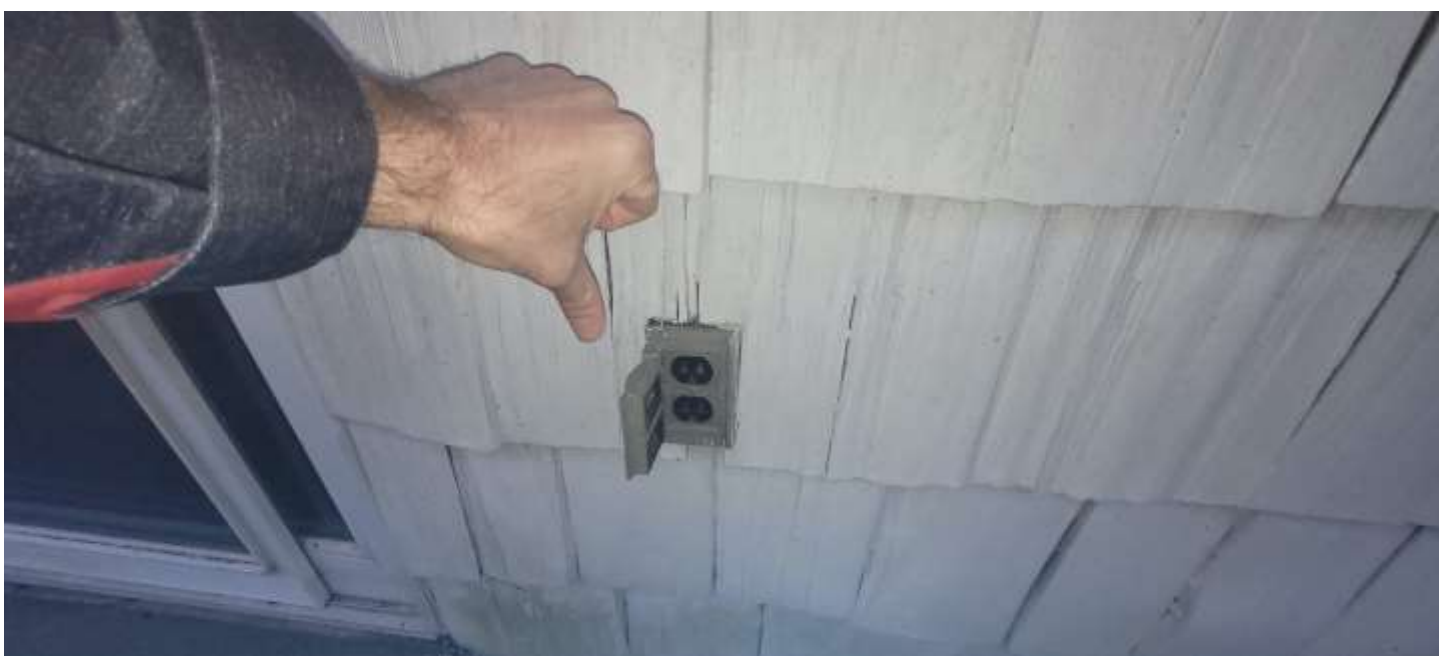
This outlet should be GFCI protected.

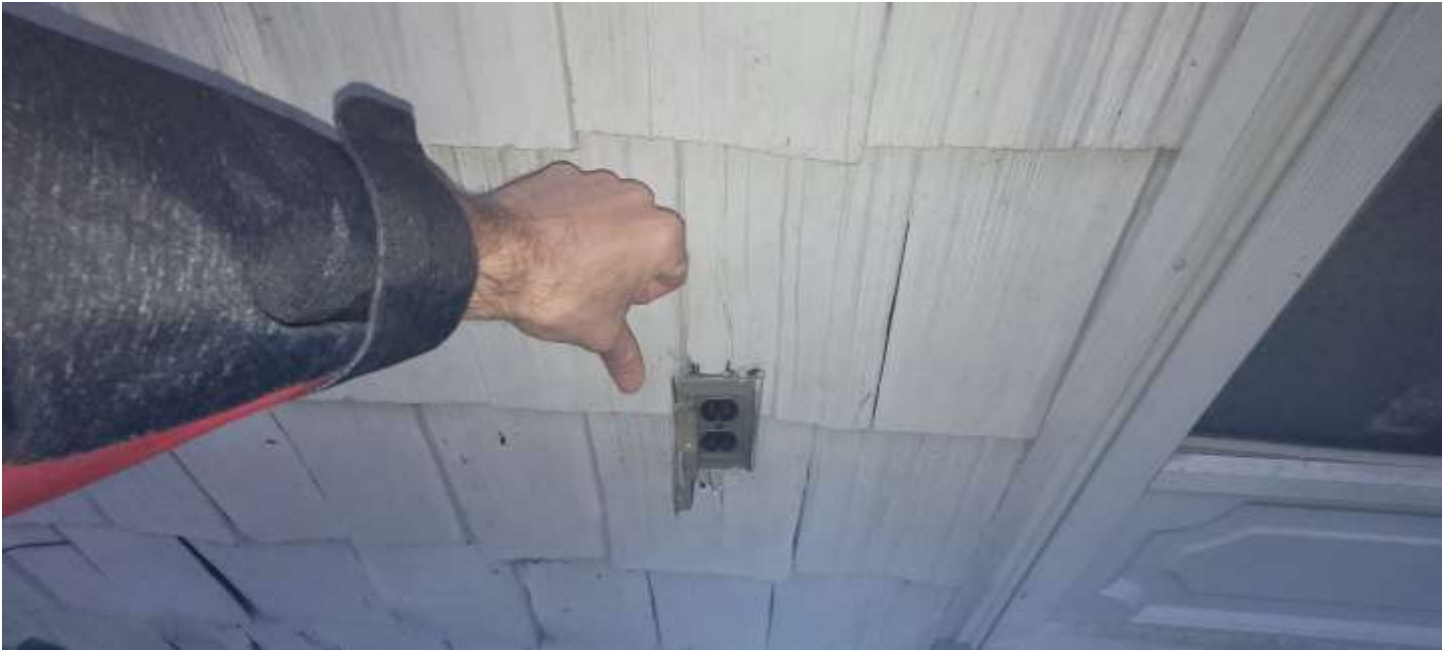
This outlet should be GFCI protected.

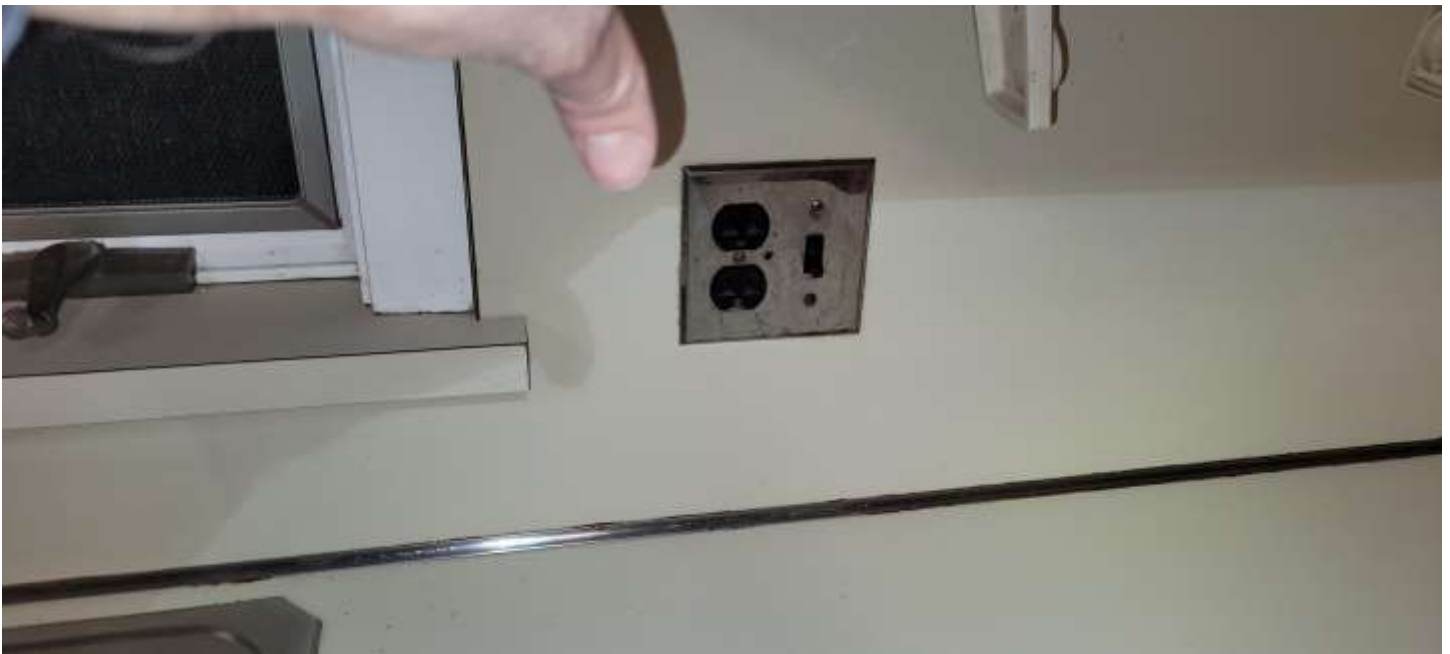
This outlet should be GFCI protected.

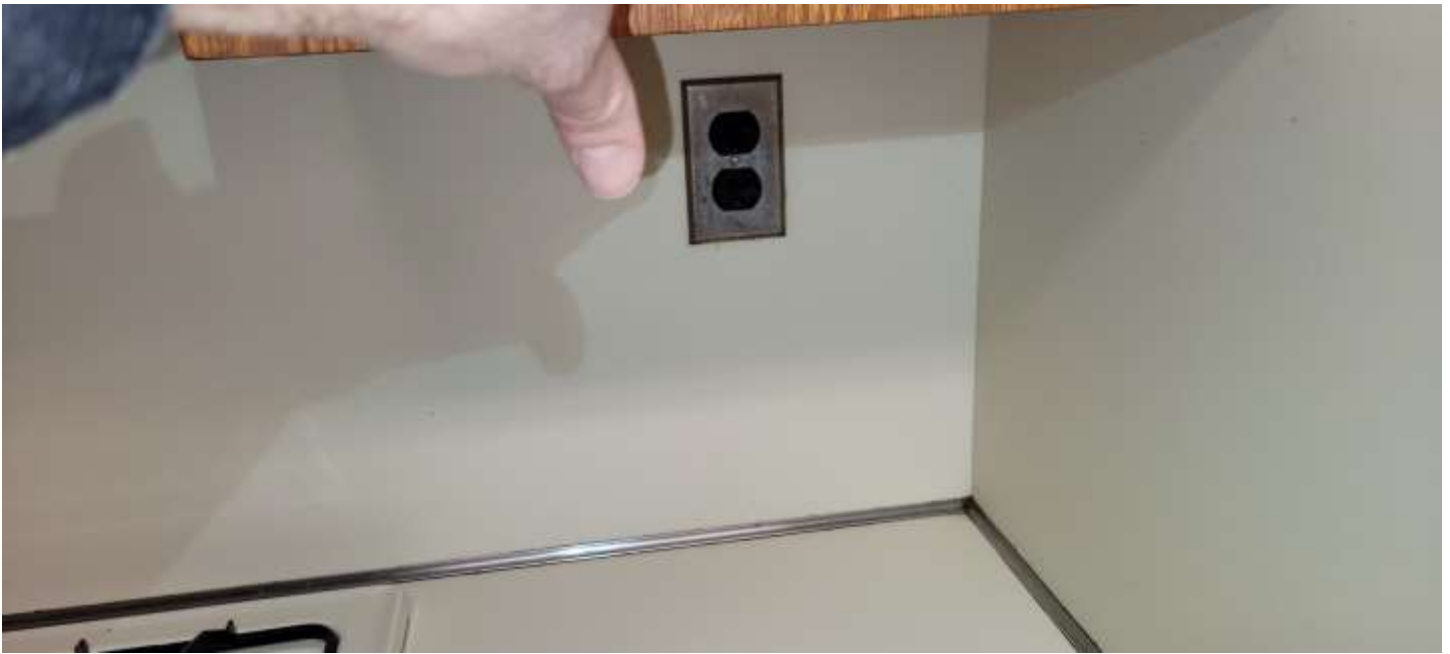
This outlet should be GFCI protected.

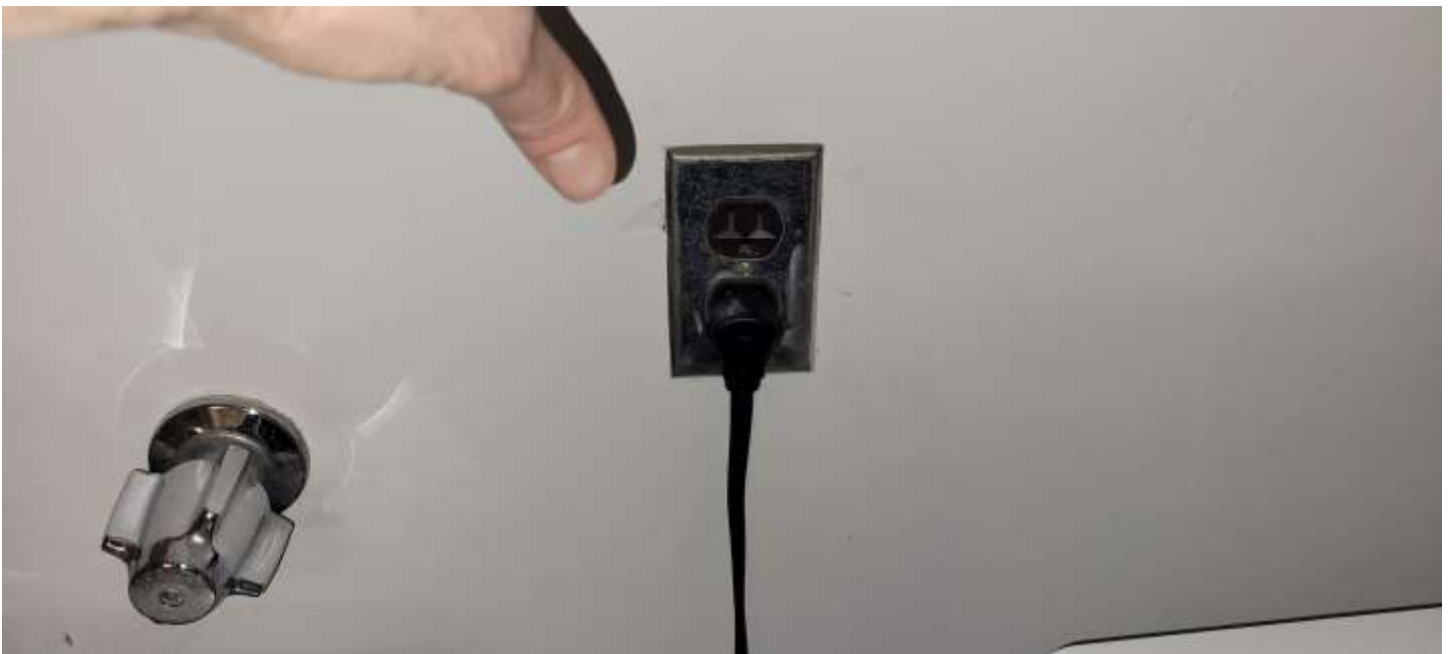
This outlet should be GFCI protected.

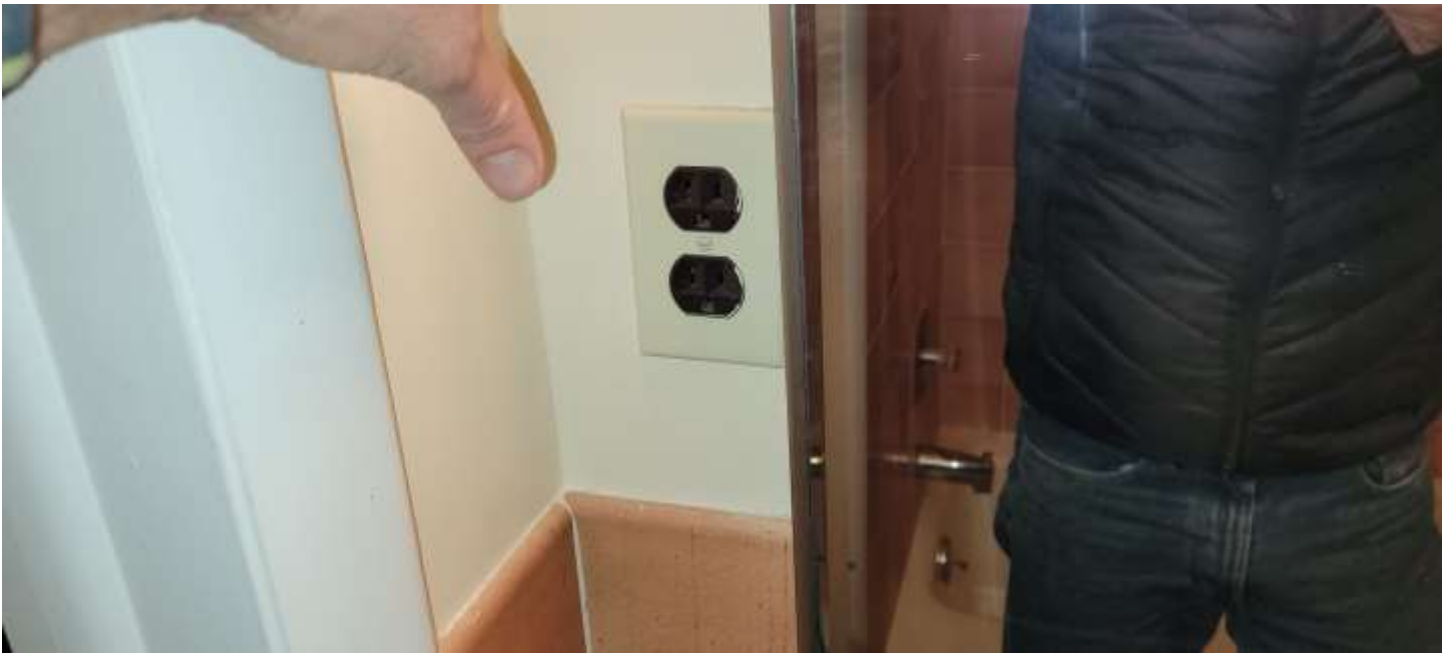
This outlet should be GFCI protected.

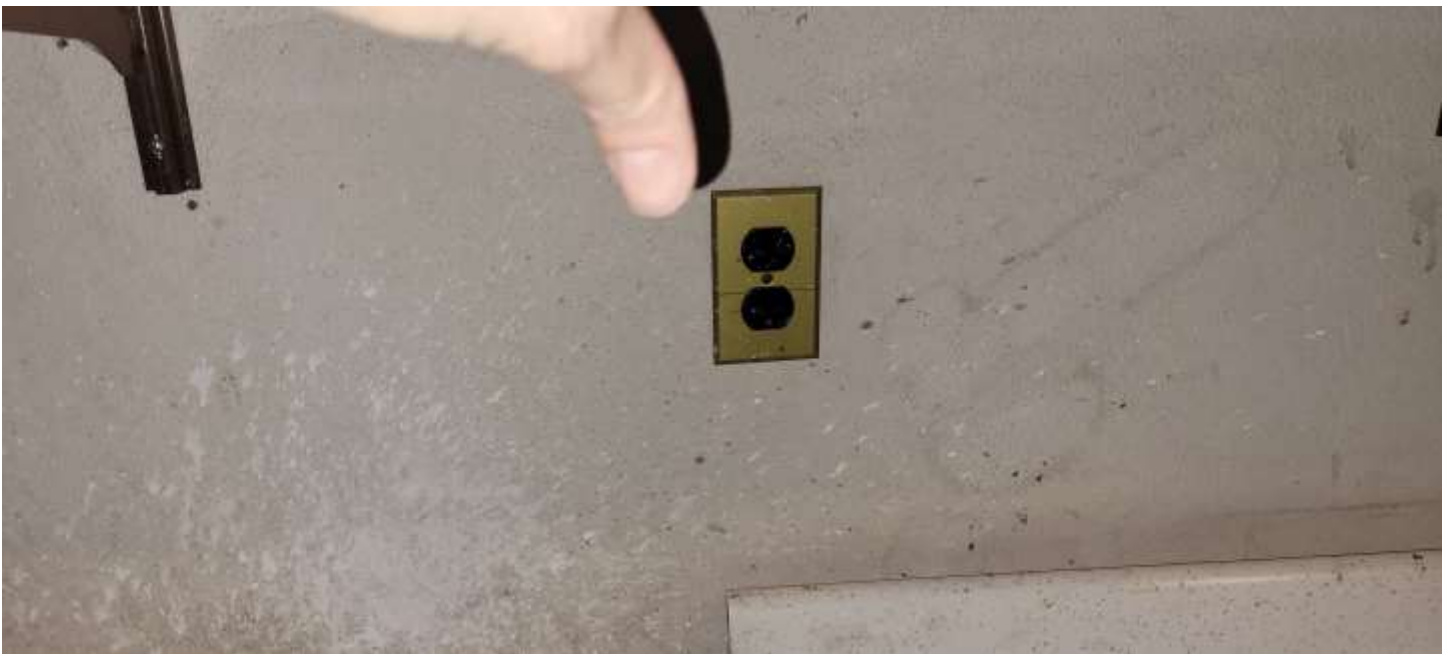
This outlet should be GFCI protected.

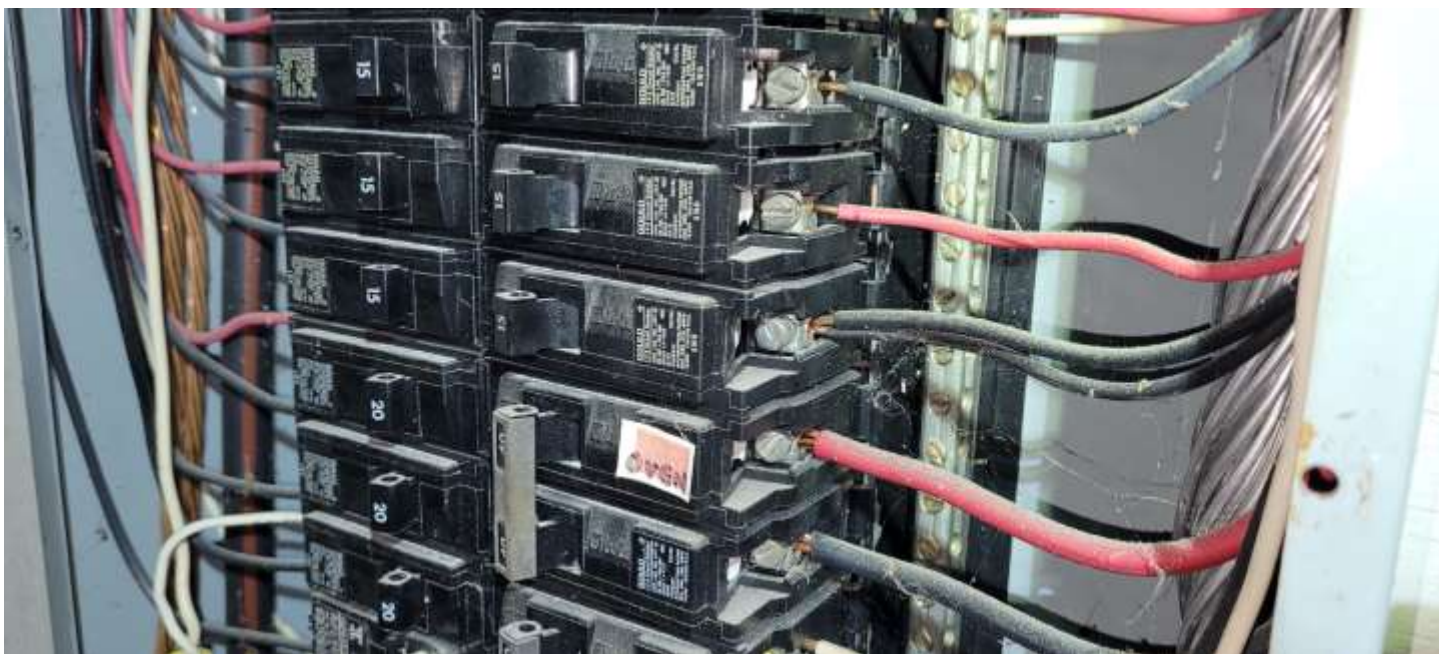
Notice the instance of double wiring here.

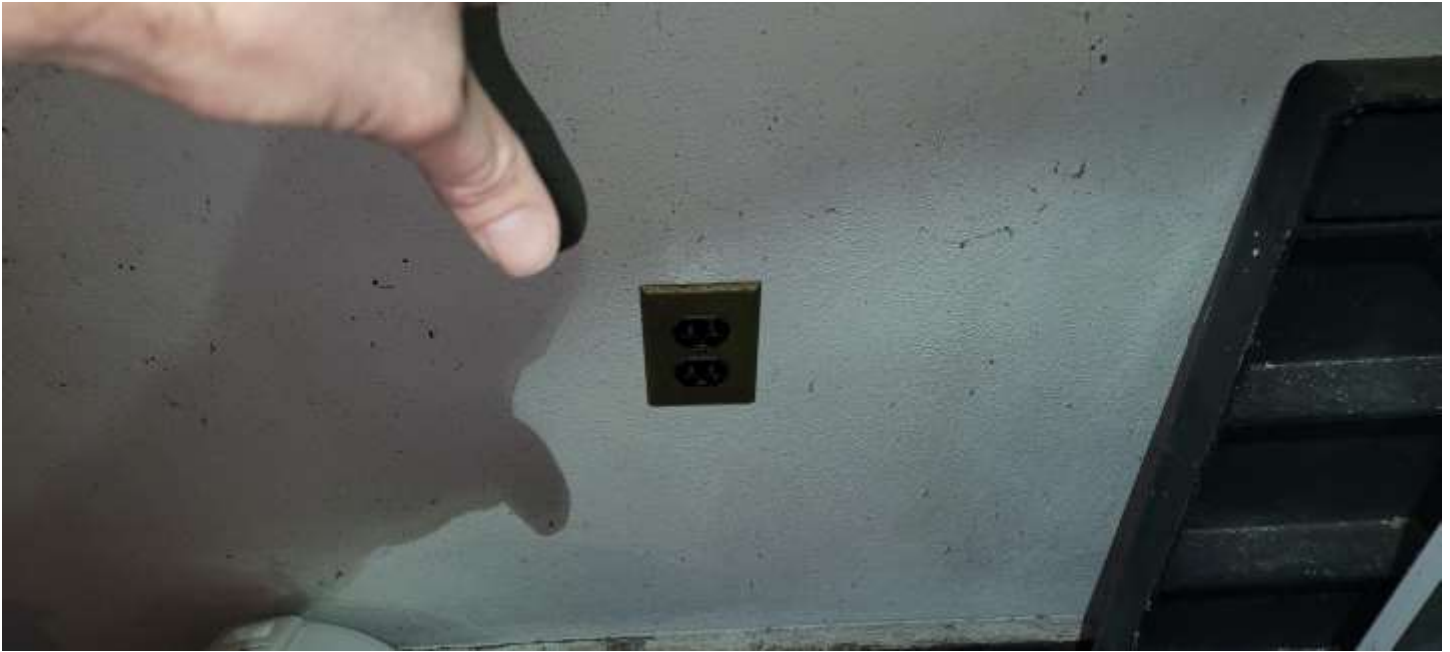
This outlet should be GFCI protected.

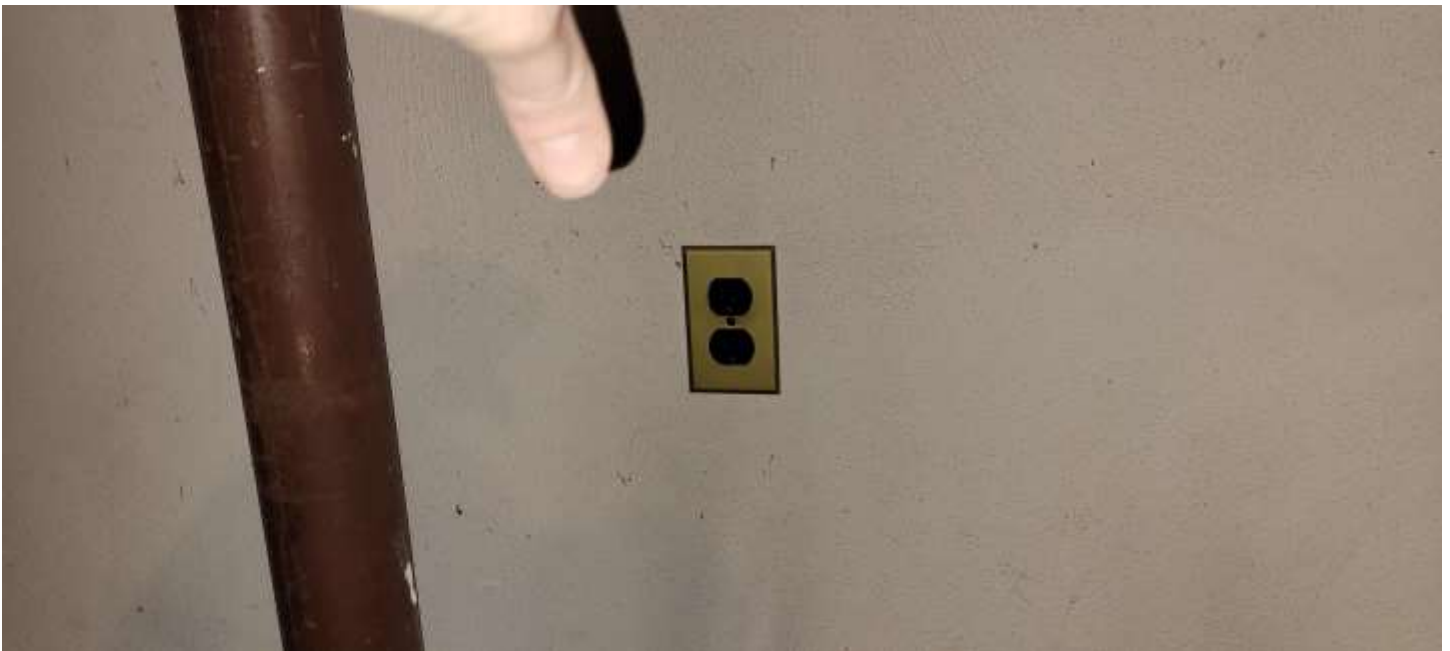
This outlet should be GFCI protected.

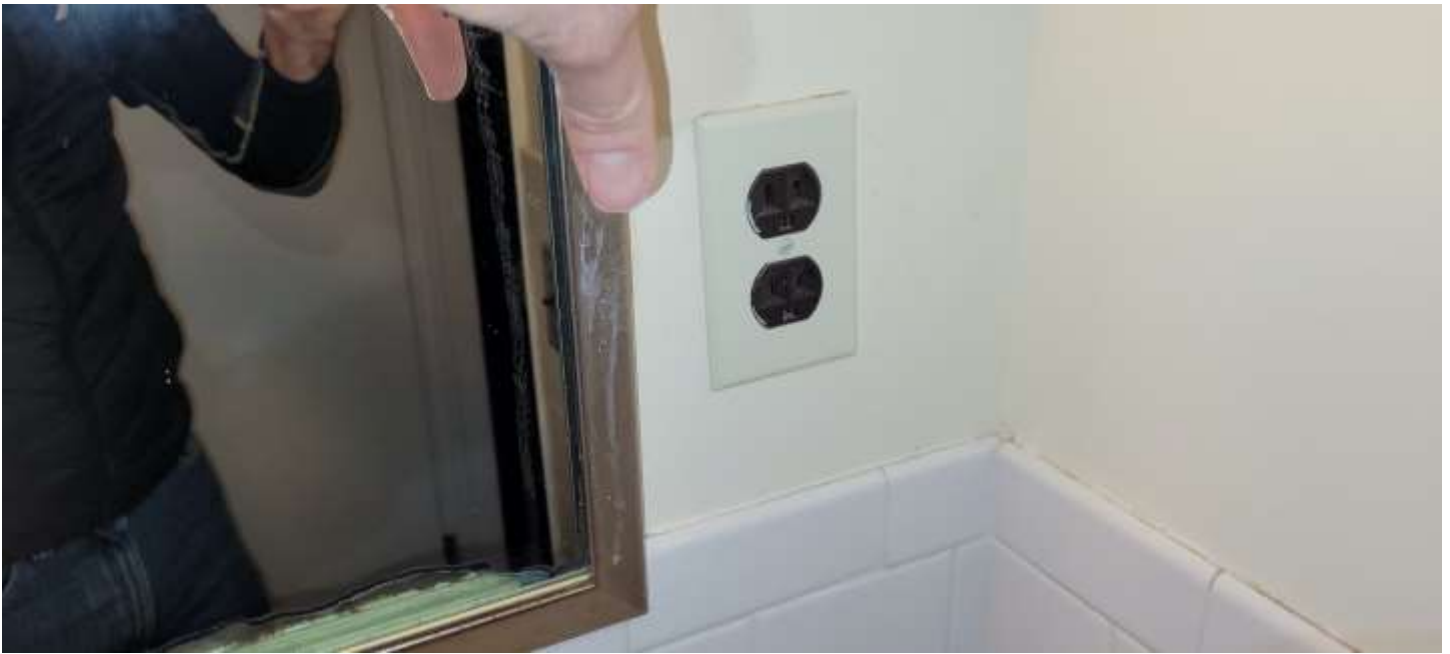
This outlet should be GFCI protected.

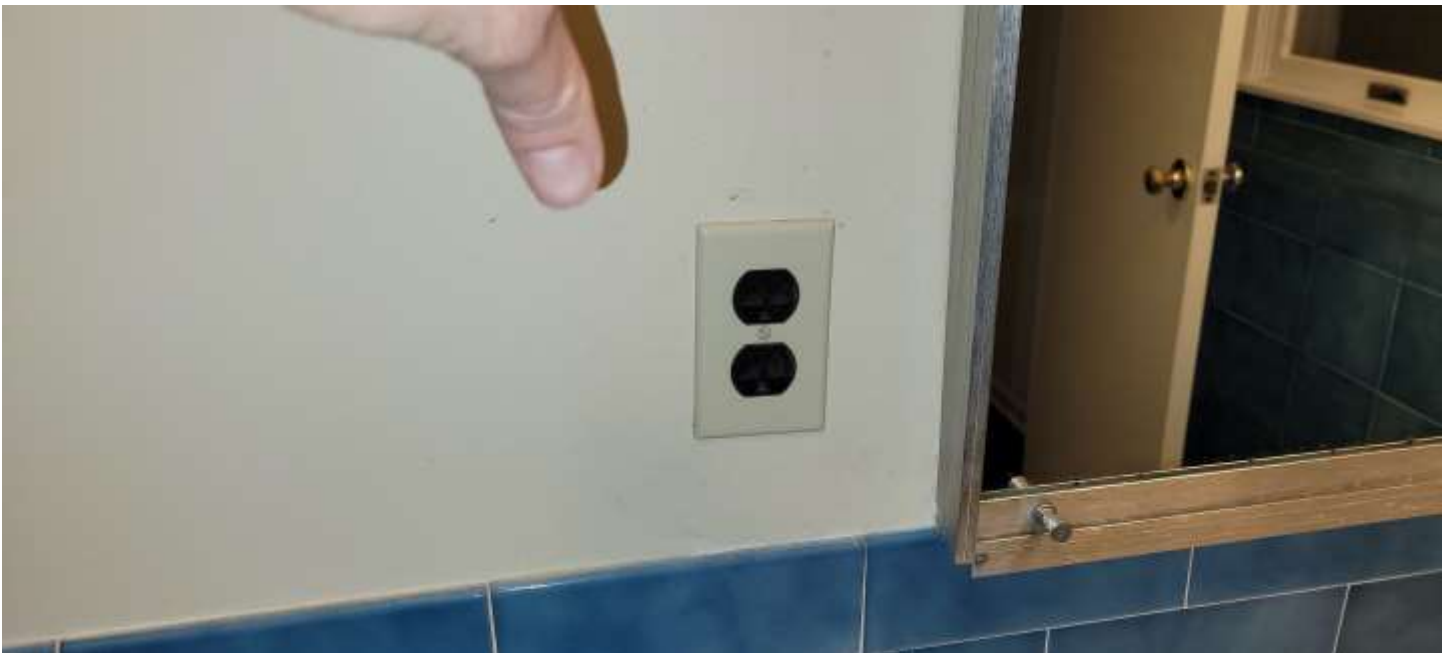
This outlet should be GFCI protected.

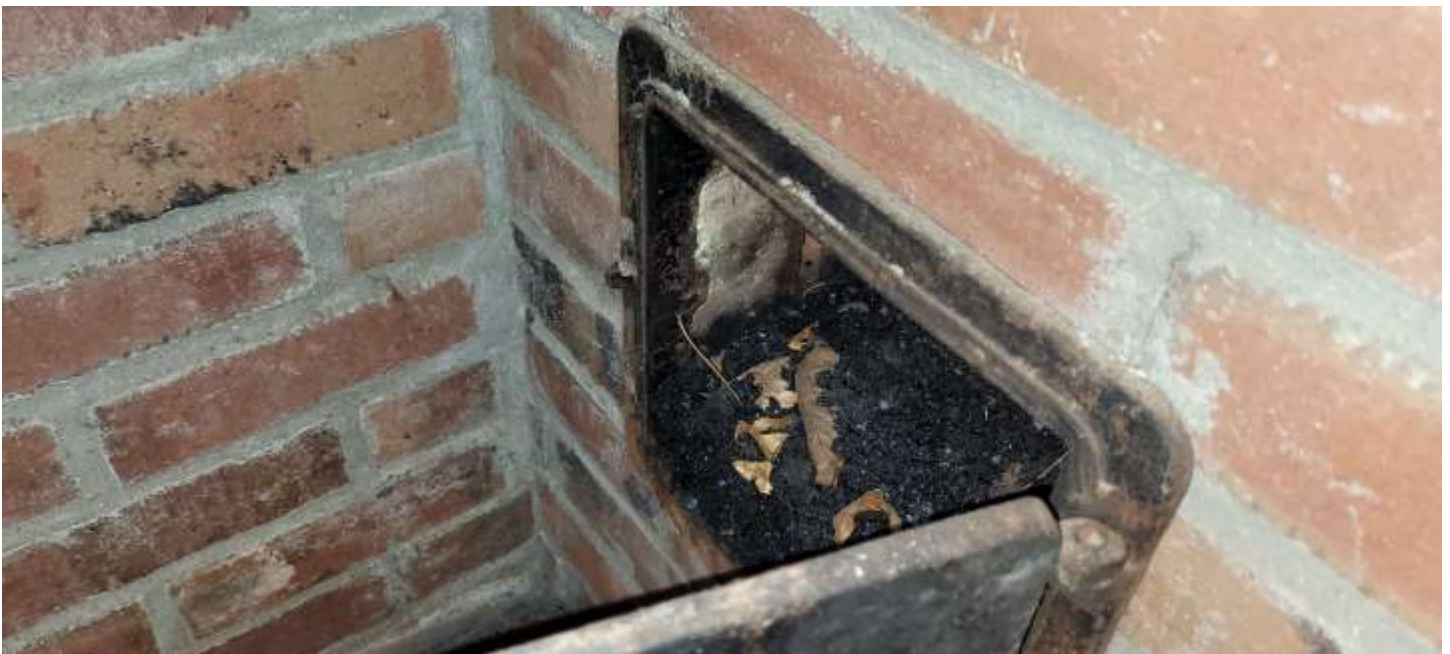
Fireplace clean out needs to be cleaned out.

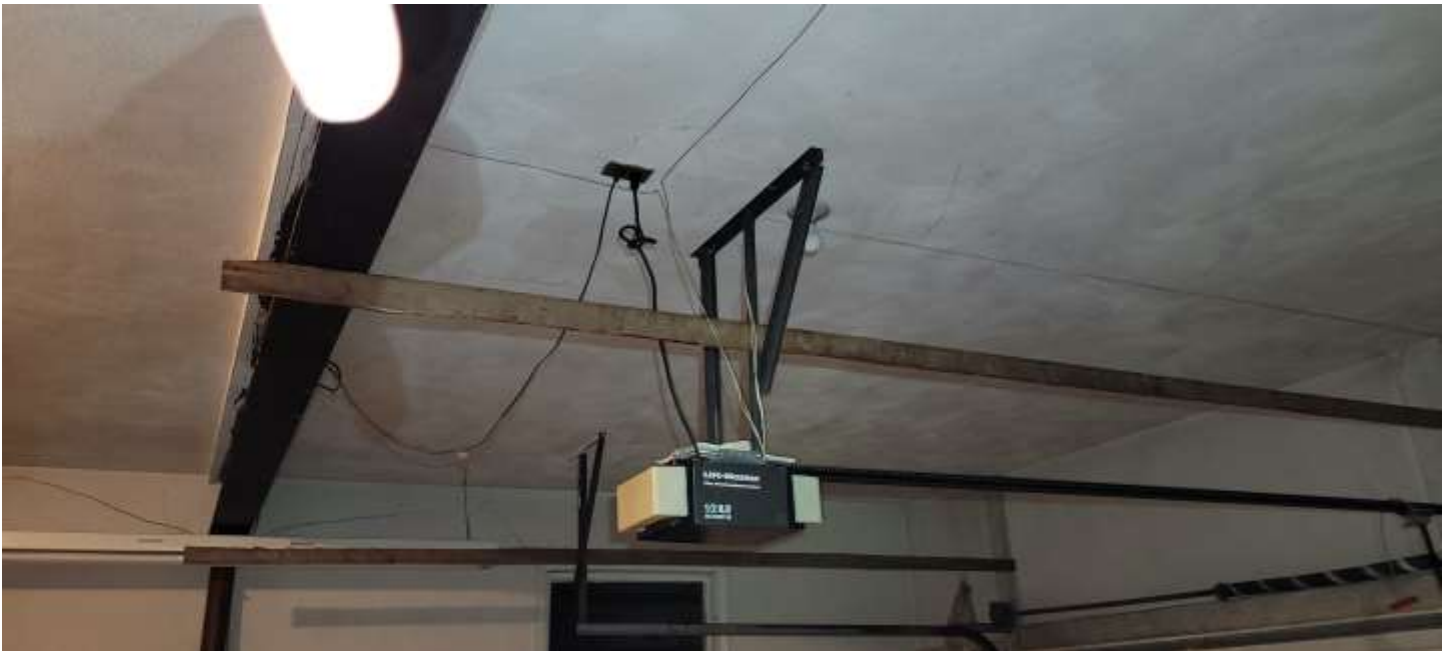
No smoke and carbon monoxide detector in the garage, which is also the mechanical room.

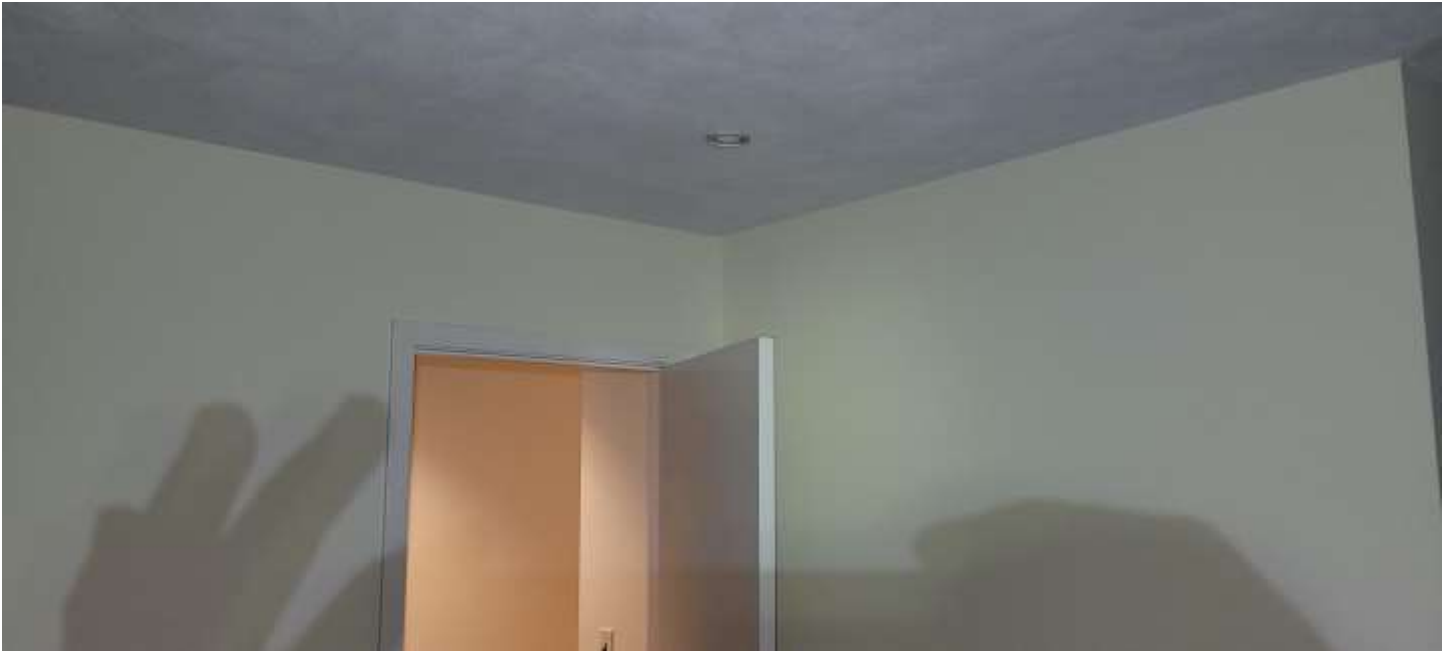
Missing detector.

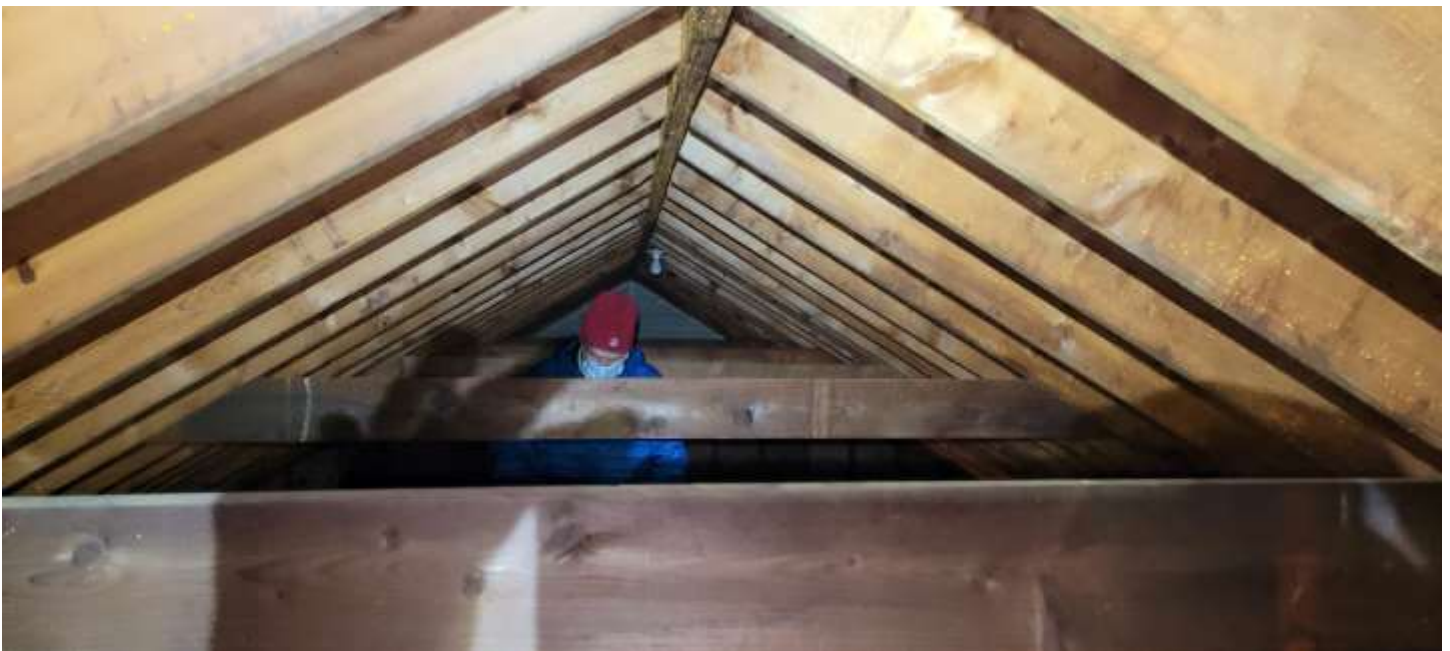
I think if you add more collar ties, you will extend the life of these shingles.

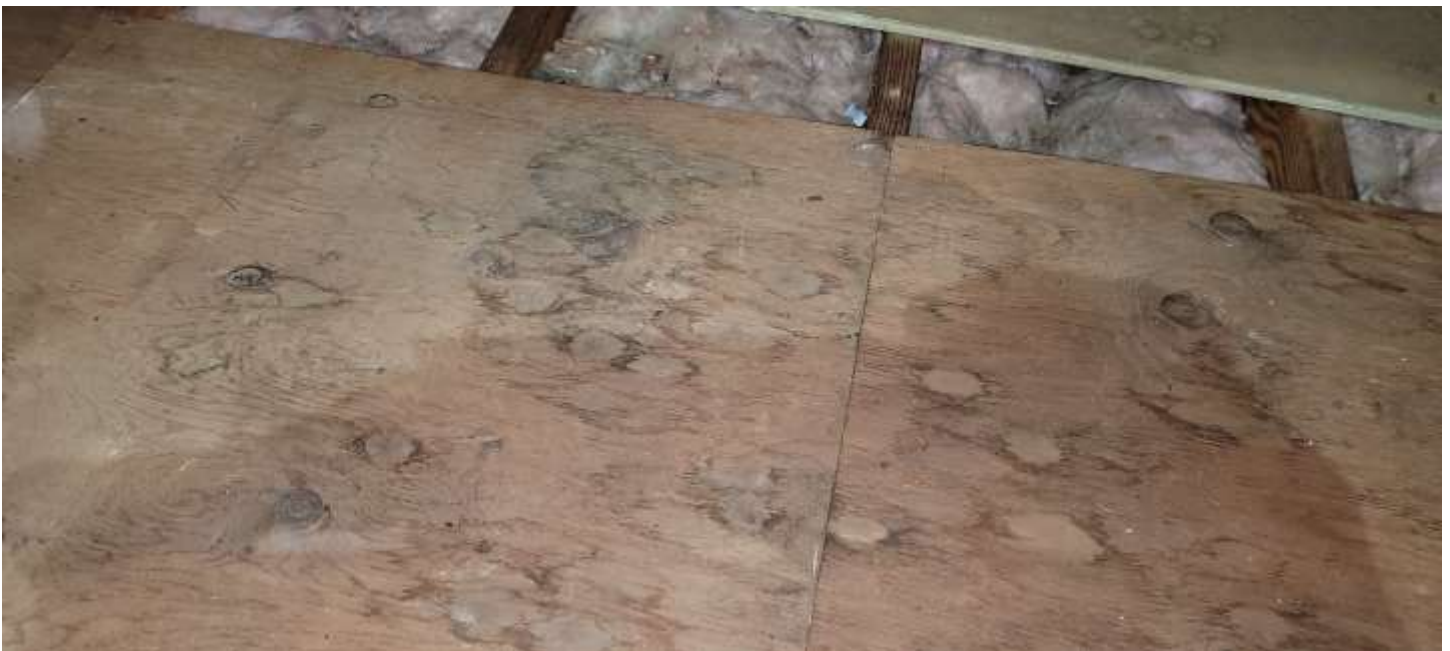
I couldn't tell if this was an old, or current leak. Given the roof is supposed to be only from 2011, hopefully this is old water.

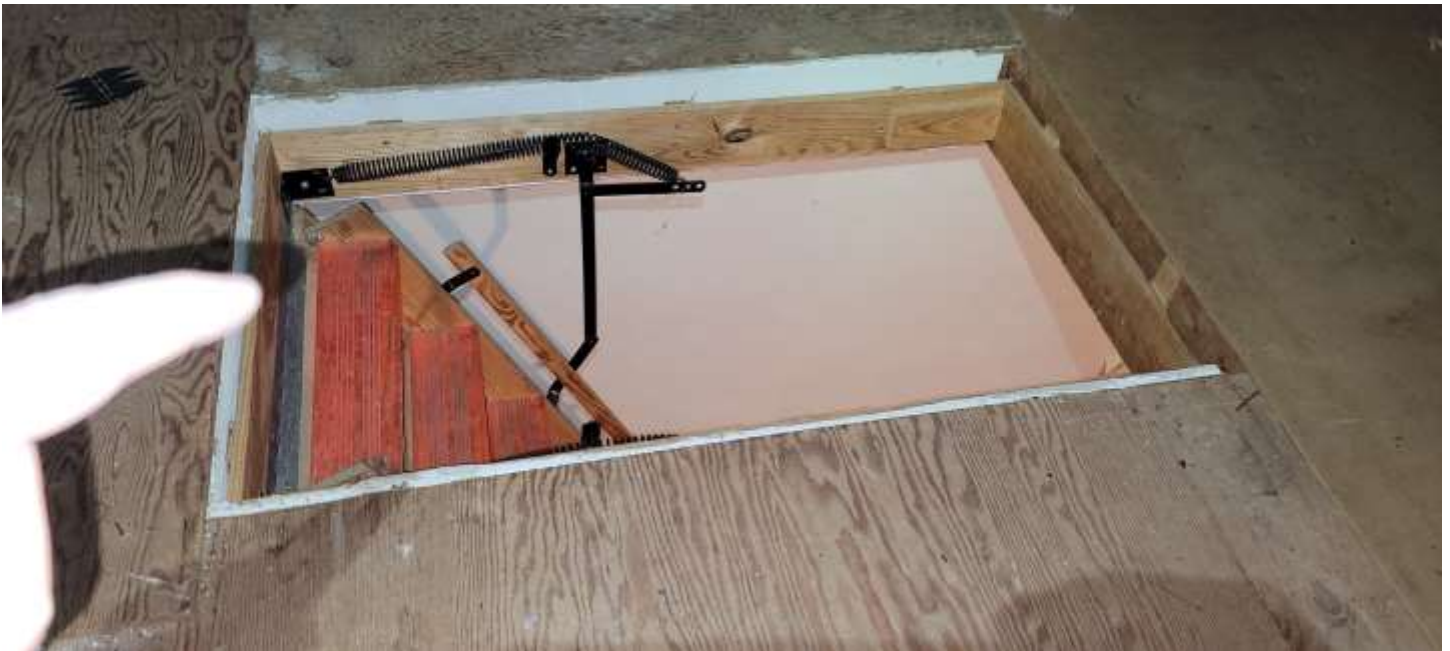
You might want to consider a fall protection around this attic entrance.

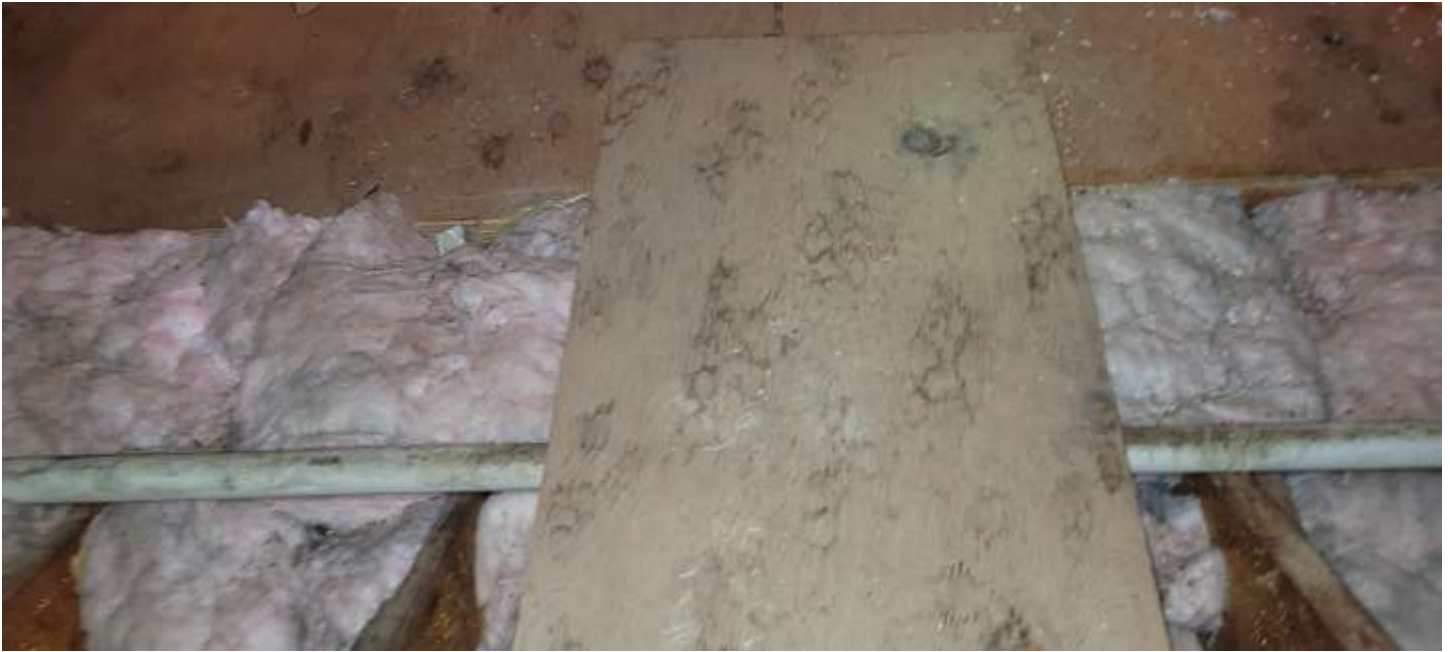
I couldn't tell if this was an old, or current leak. Given the roof is supposed to be only from 2011, hopefully this is old water.
