Property: 123 Main Street, Anytown, NY  
Date: 15Jan2021  
Present: Louis Csak, insp.; ####, buyer; ### agent.  
Conditions: 40's, overcast

**Executive summary:** (details in report)

The house was not well maintained, and the garage foundation is beginning to show serious issues, and very likely there is a regular water occurrence that will eventually affect the main foundation badly.

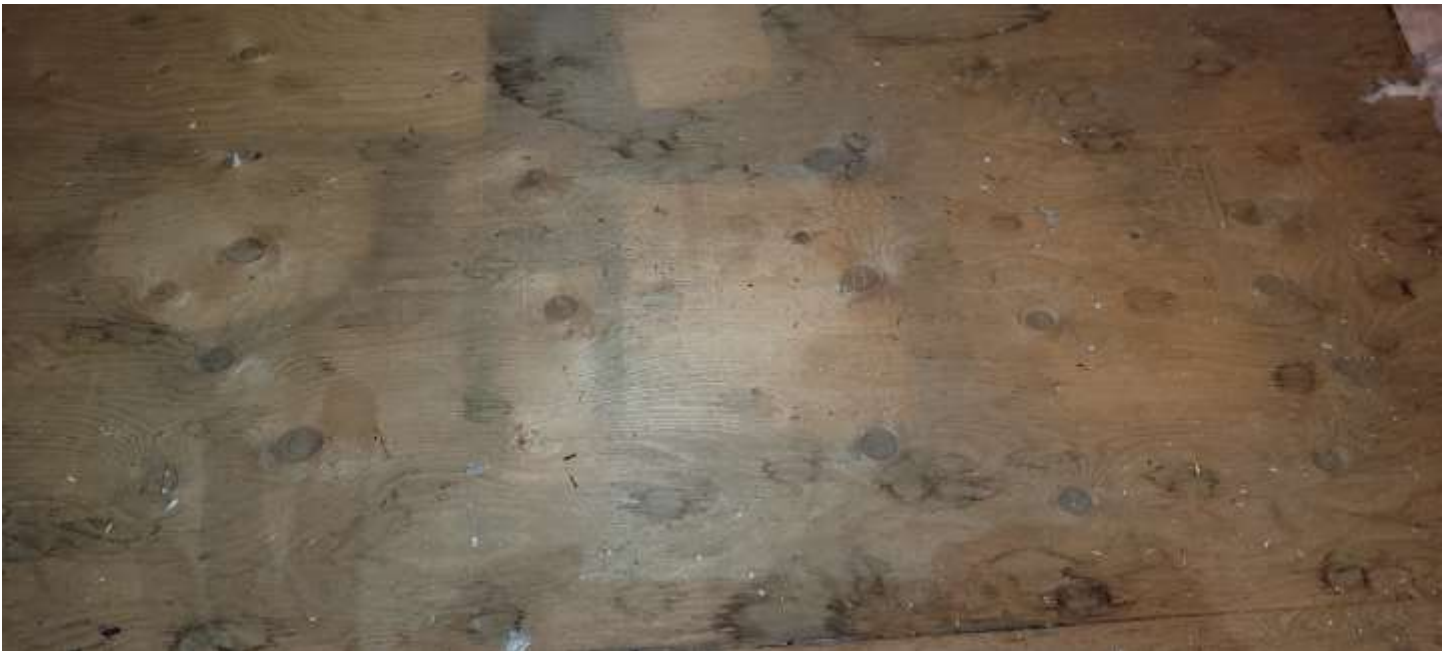
I couldn't tell if this was an old, or current leak. Given the roof is supposed to be only from 2011, hopefully this is old water.

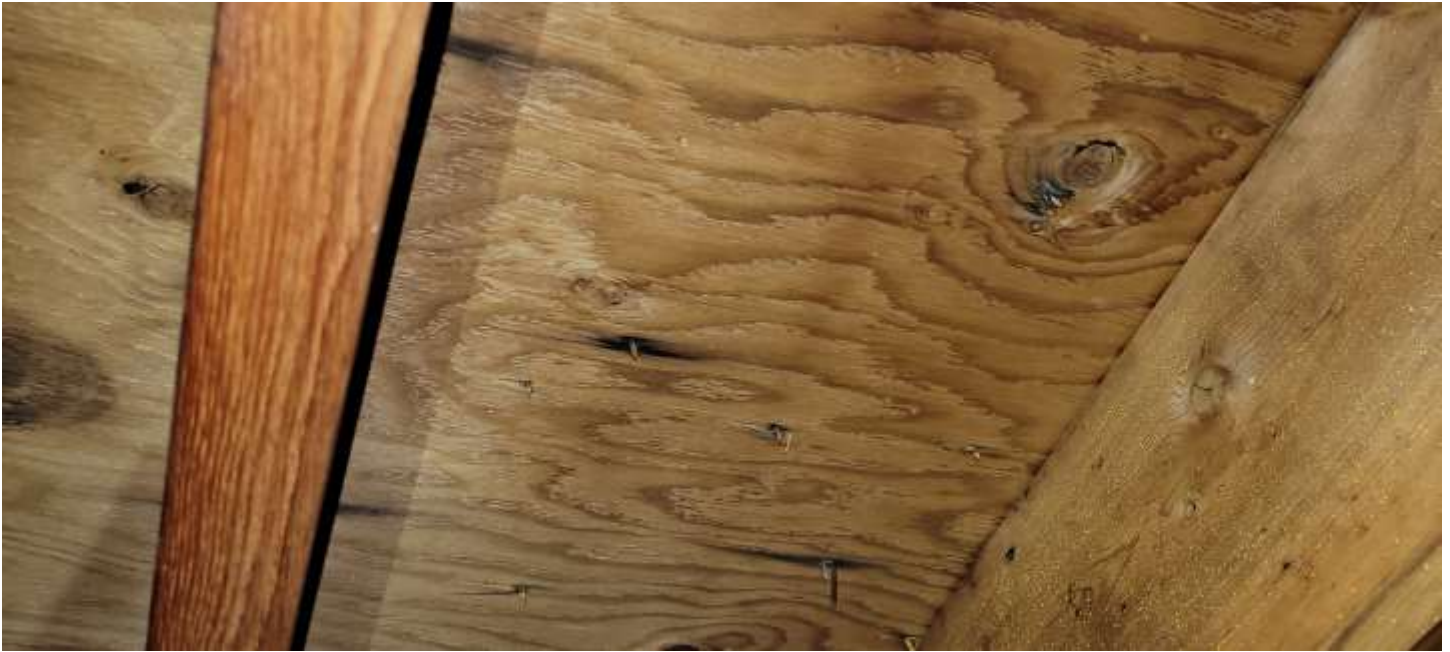
Notice the rust on those nails. I couldn't tell if this was an old, or current leak. Given the roof is supposed to be only from 2011, hopefully this is old water.

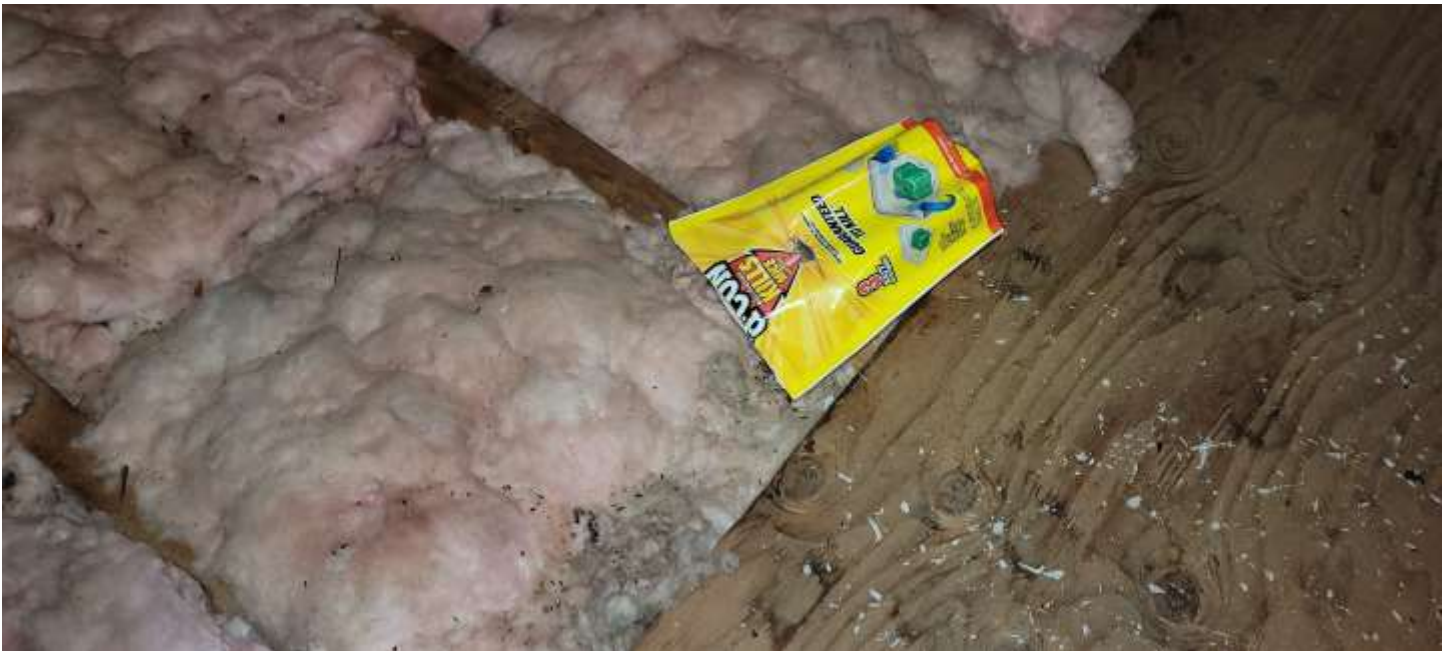
There were some signs of mice burrowing in the insulation. But I did not find significant quantities of mouse feces.

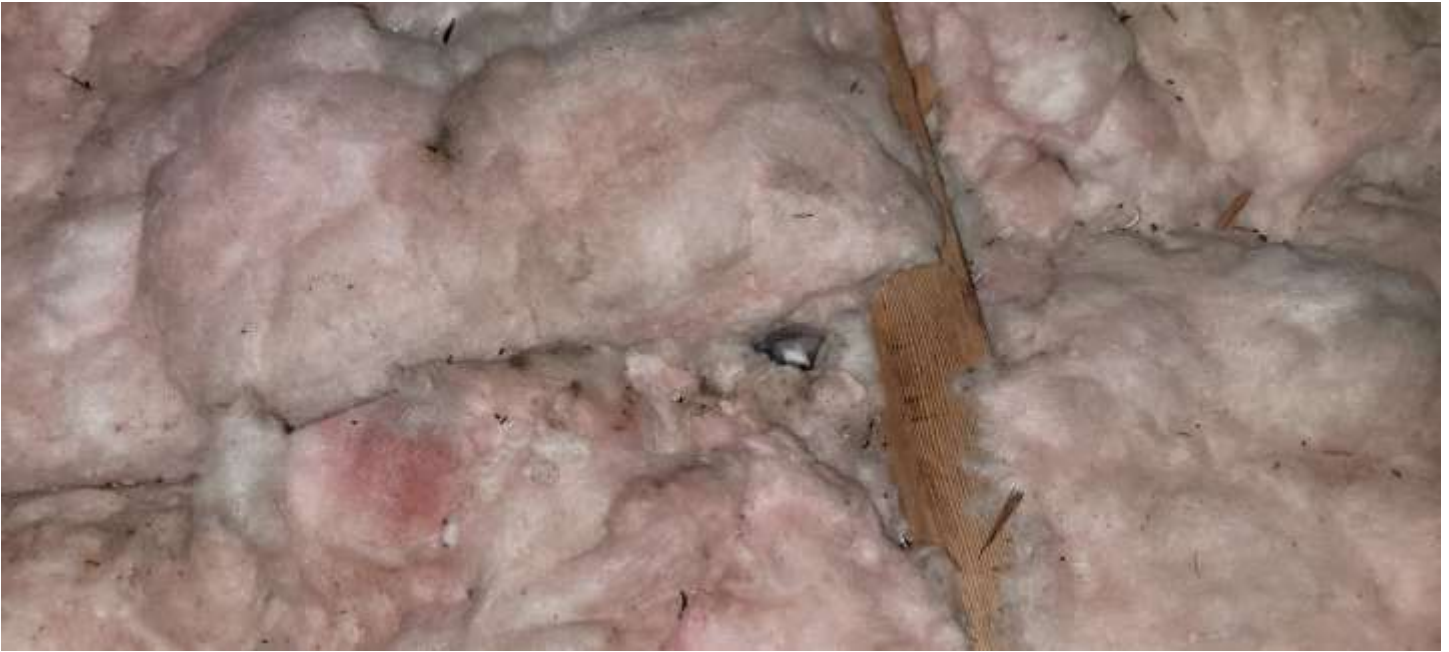
There were some signs of mice burrowing in the insulation. But I did not find significant quantities of mouse feces.

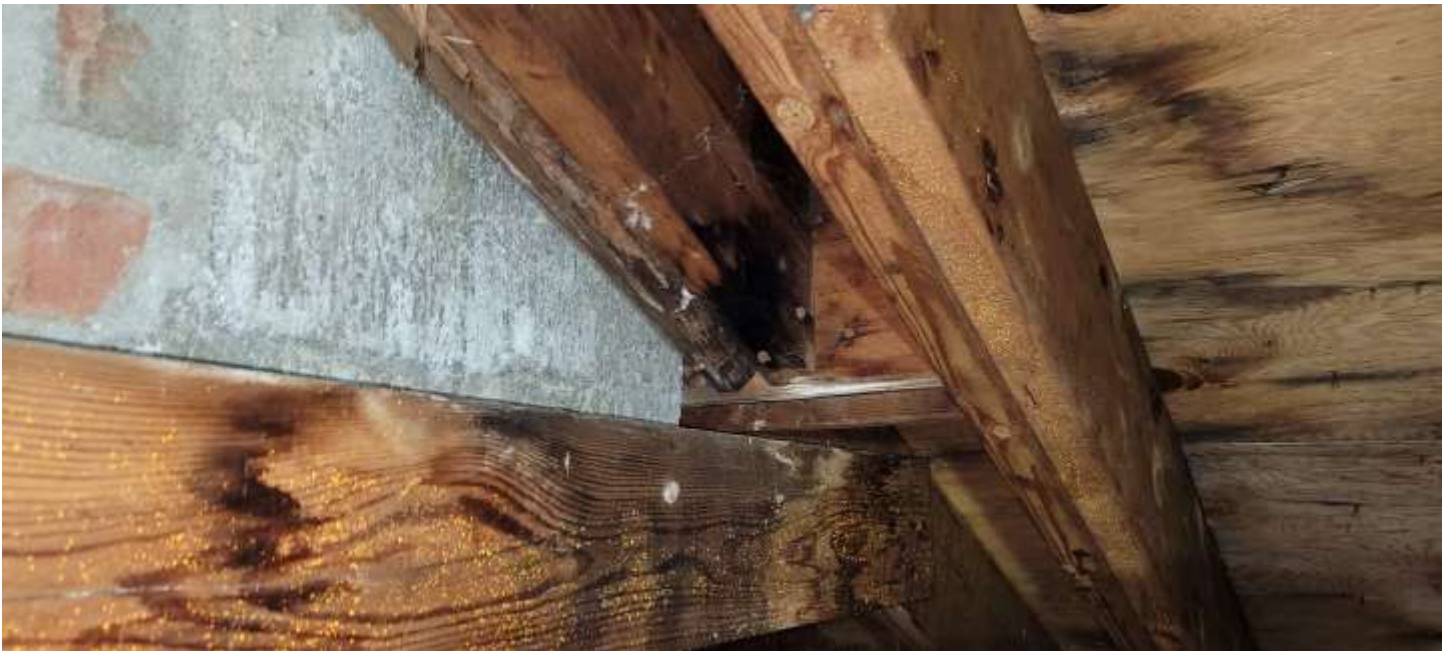
Chimney in good visual condition. Typical. There seems to be one area in the flashing where water got in. Consider re sealing that, if this is a “current” leak.

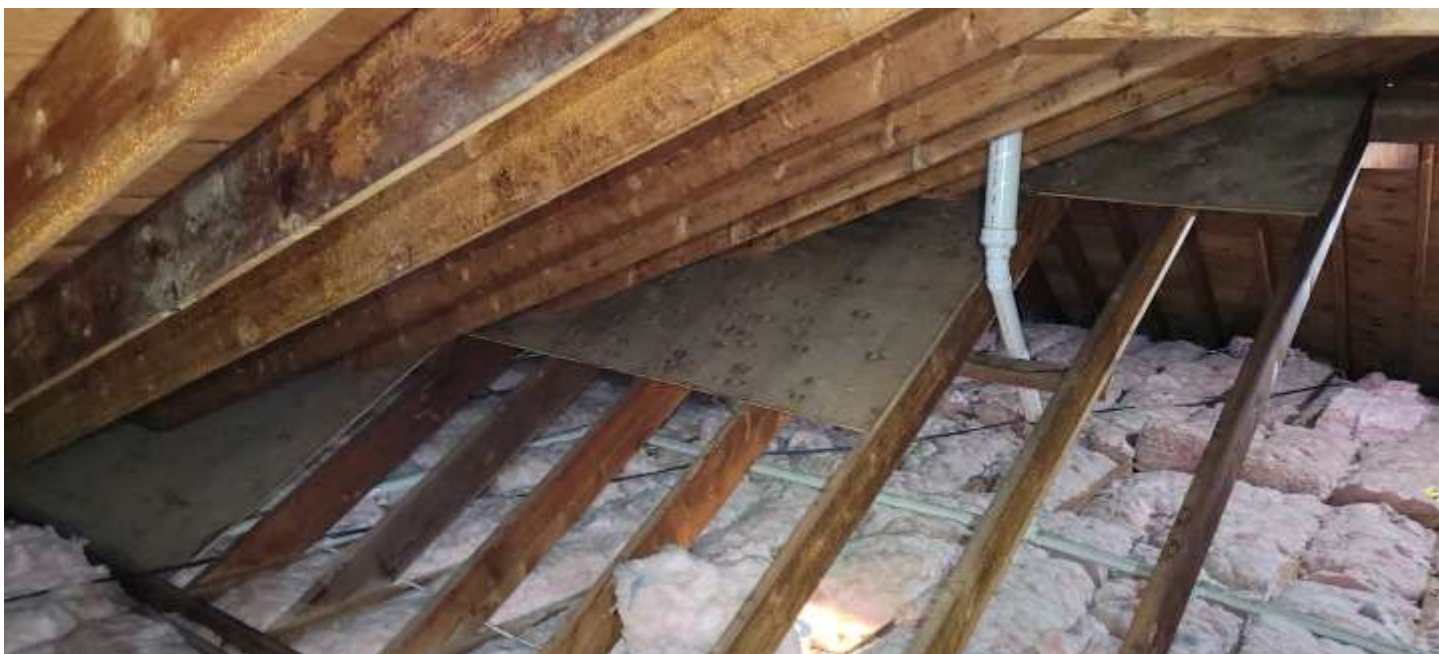
I couldn't tell if this was an old, or current leak. Given the roof is supposed to be only from 2011, hopefully this is old water.

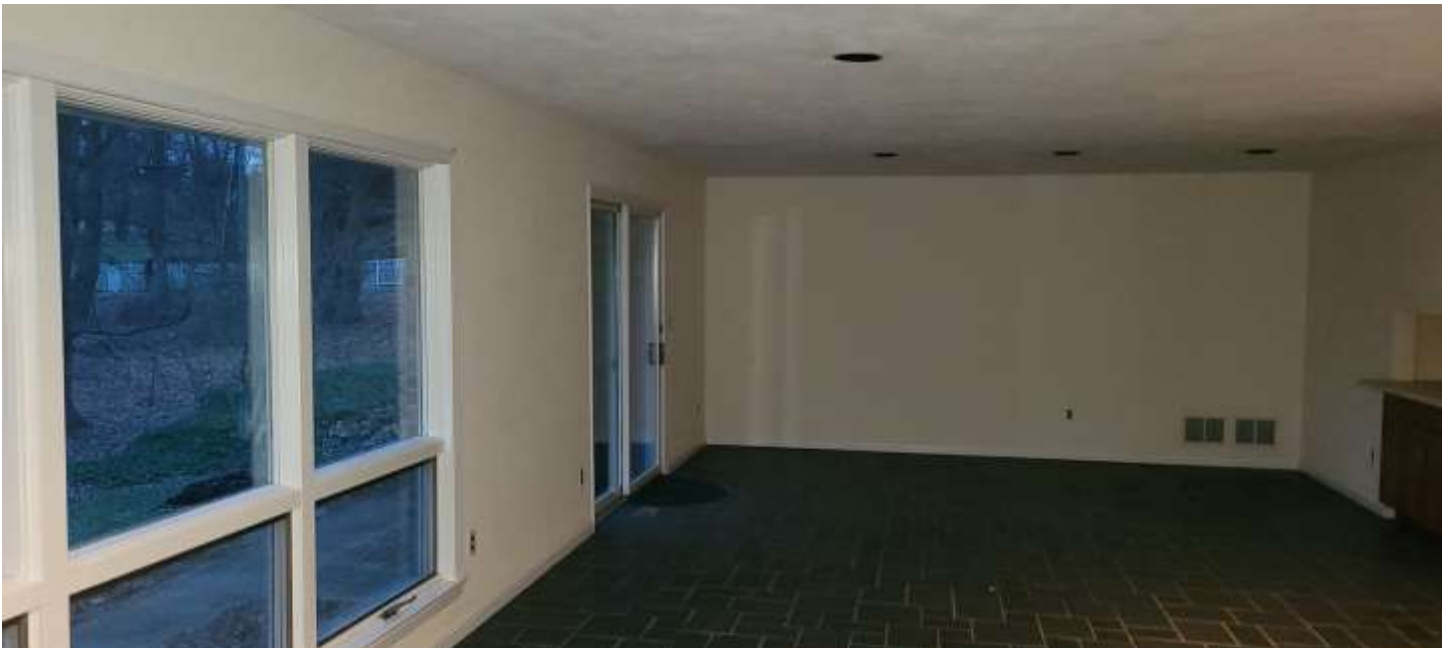
Living room.

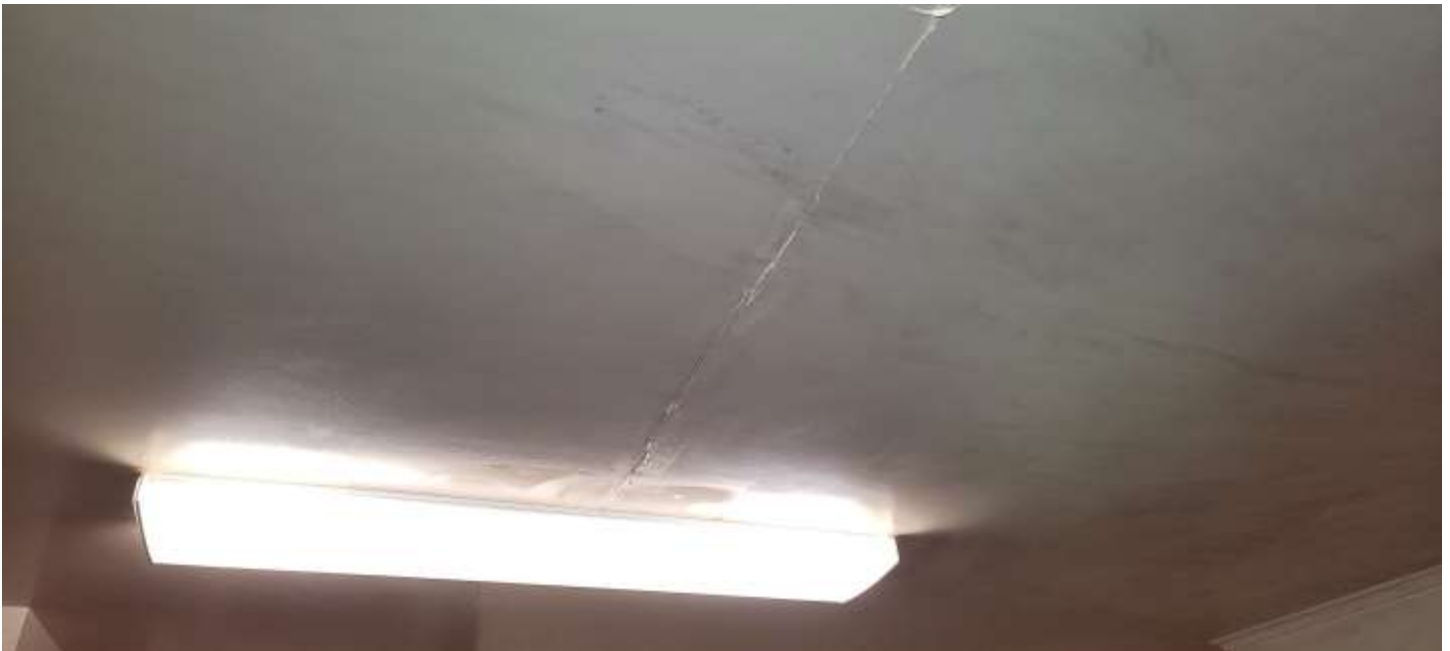
Kitchen ceiling. I don't think that crack is structural.

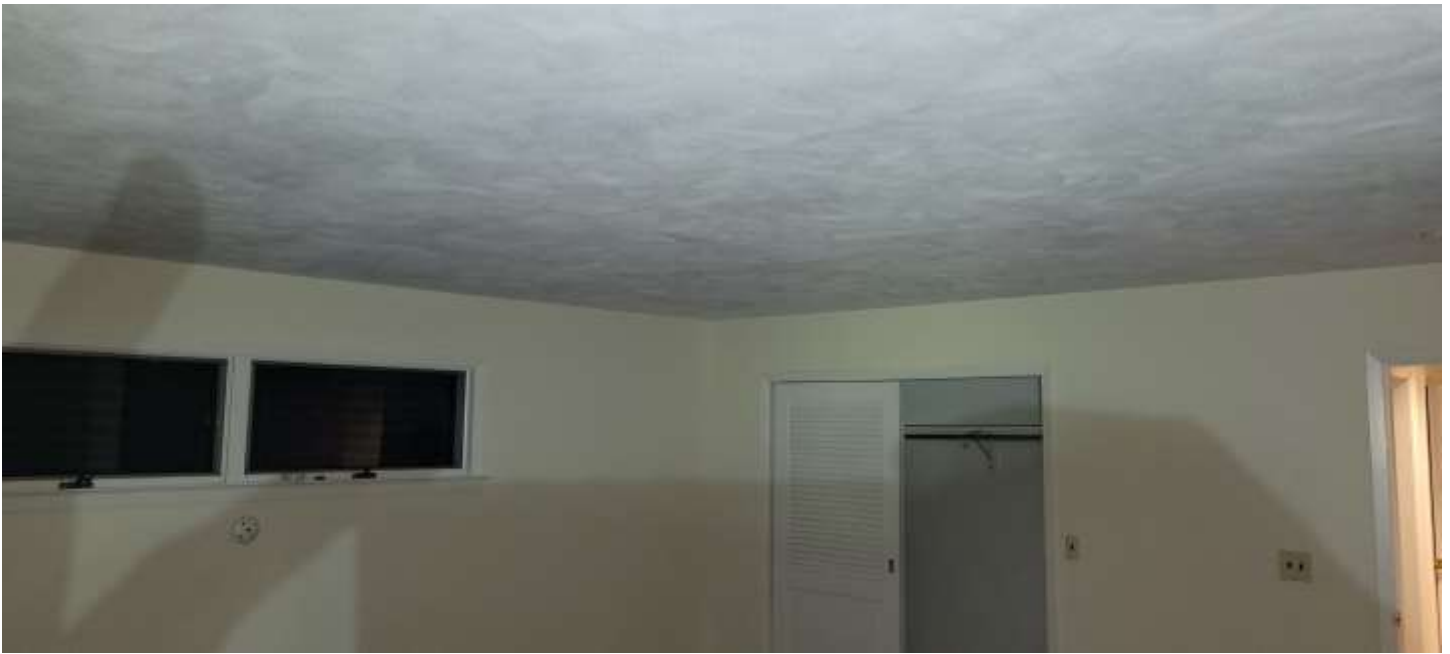
Master bedroom.

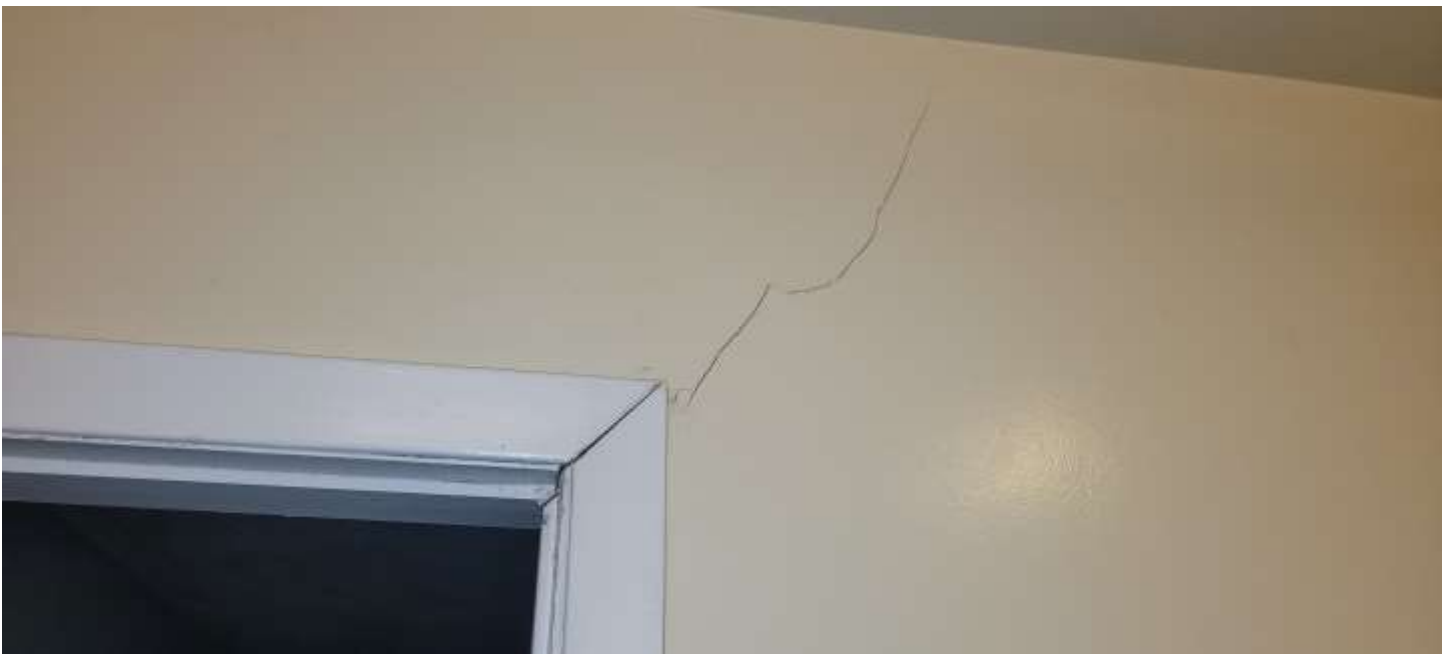
Crack in the wall between the master bedroom and master bathroom. I don't think this is a structural issue. There was also no translation of this crack to motion of the foundation directly underneath this in the foundation area.

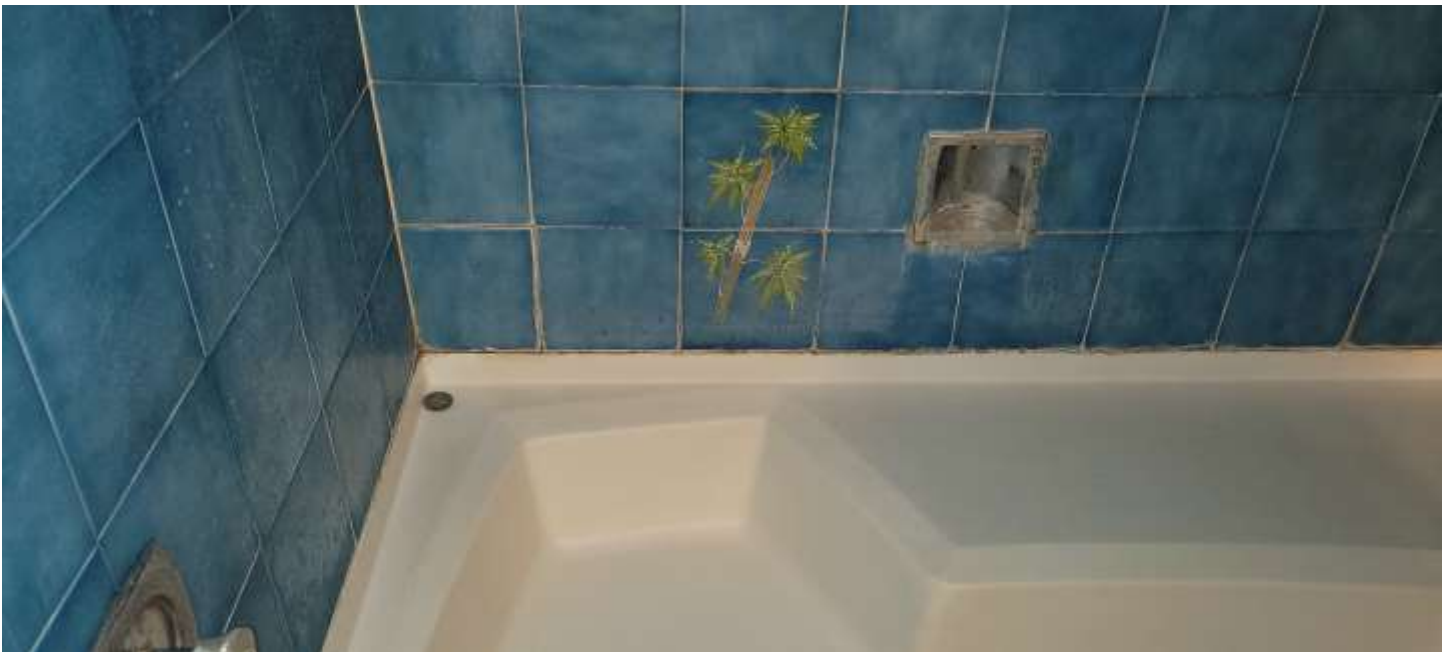
Tile grout could use a little bit more scrubbing.

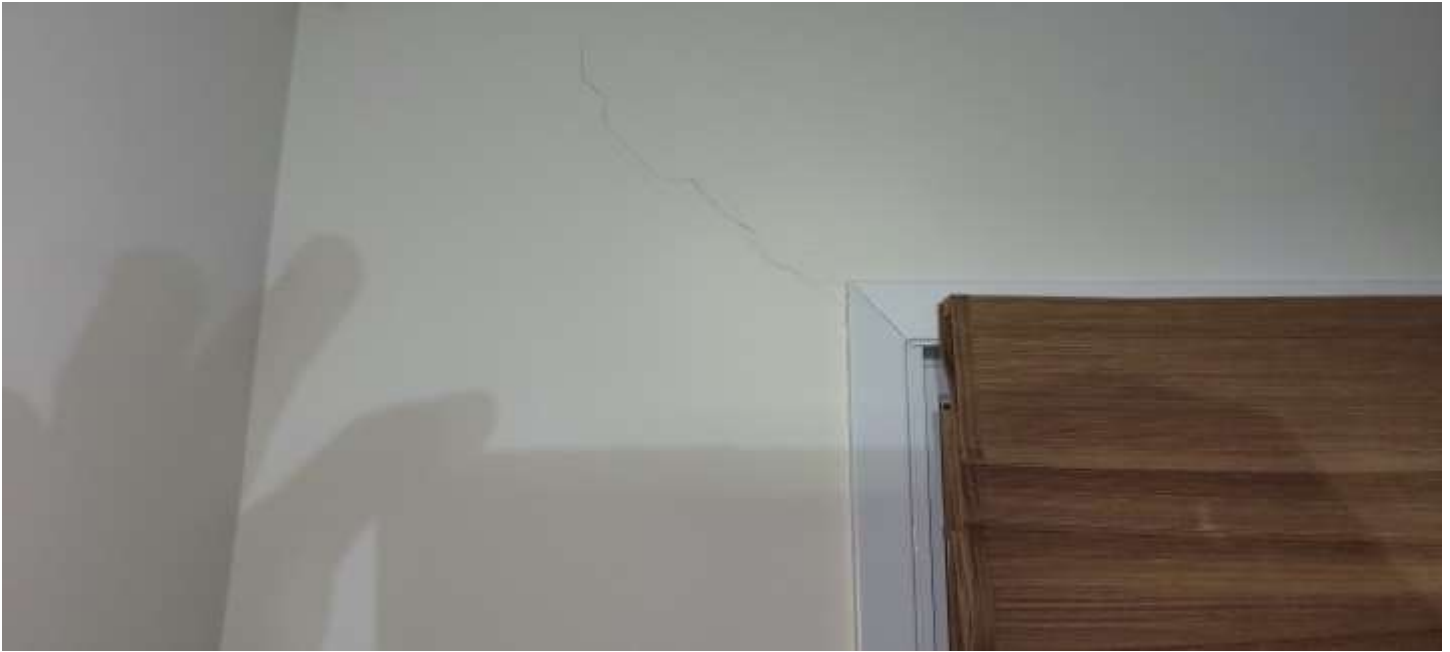
This crack in this bedroom was directly under the quarter inch crack we found in the foundation. I believe this is an indication of the foundation moving. And I think this needs to be addressed in the near future. I don't think this is a structural issue right now, but I strongly encourage you to get an estimate.

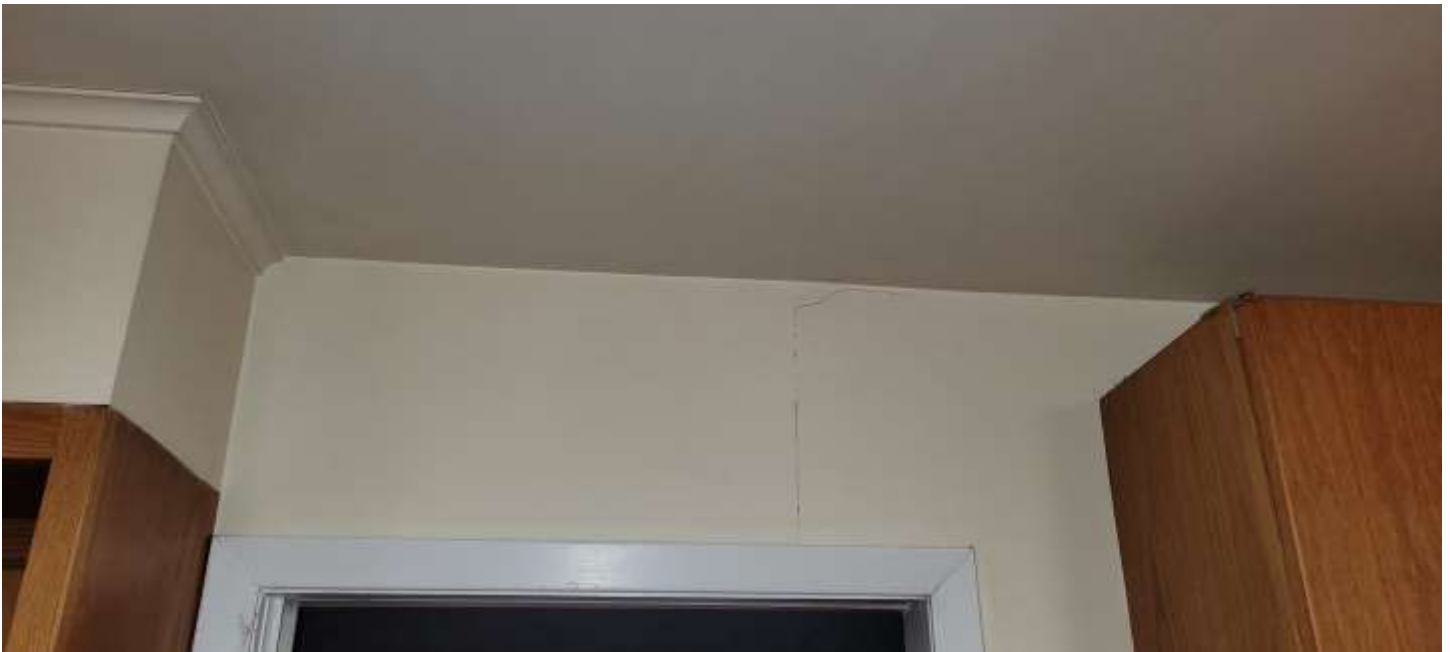
I think this crack in the kitchen is due to workmanship and age.

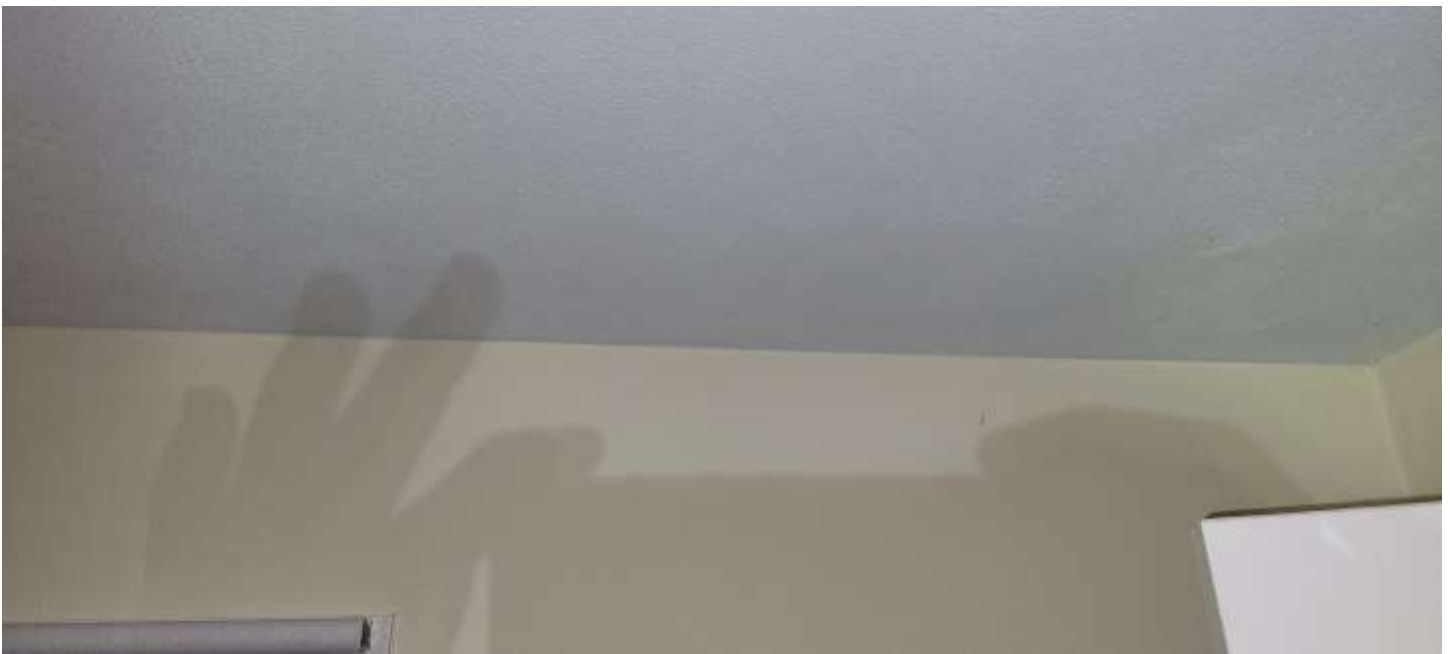
Upper corners generally are clean and dry, and show no signs of water ingress. That's good.

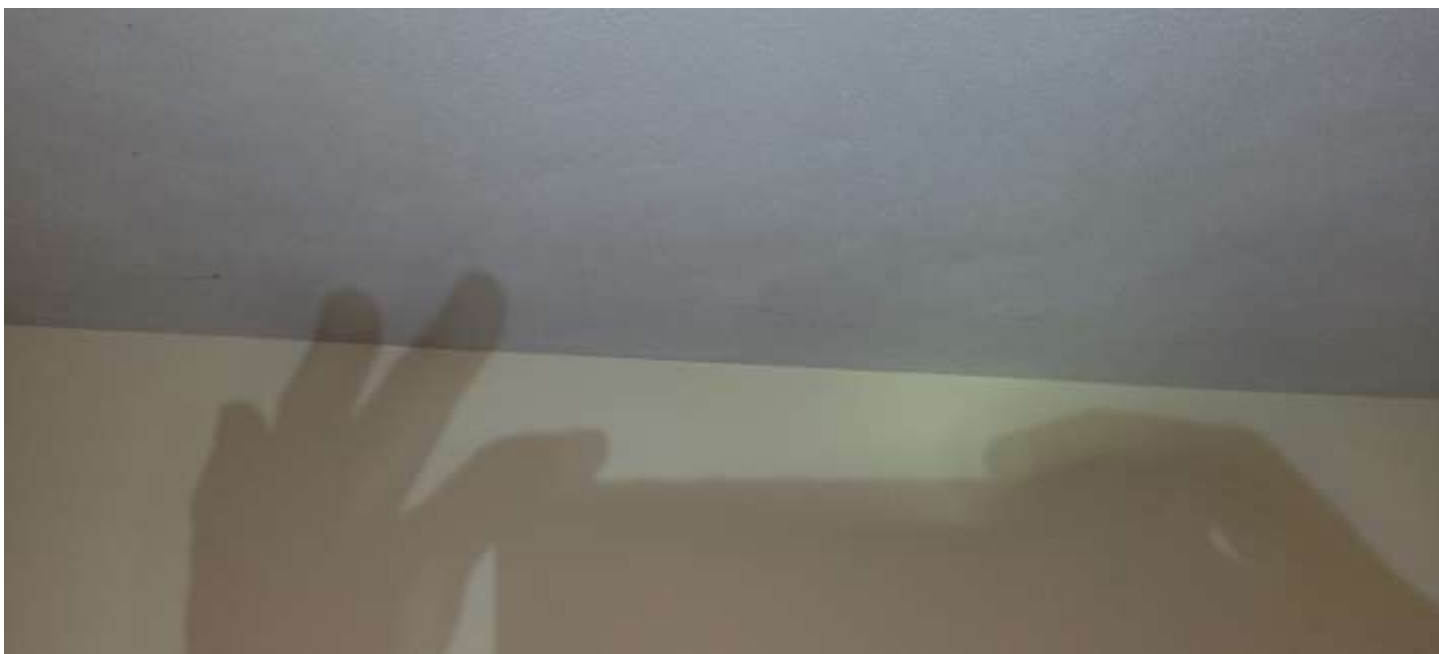
Upper corners generally are clean and dry, and show no signs of water ingress. That's good.

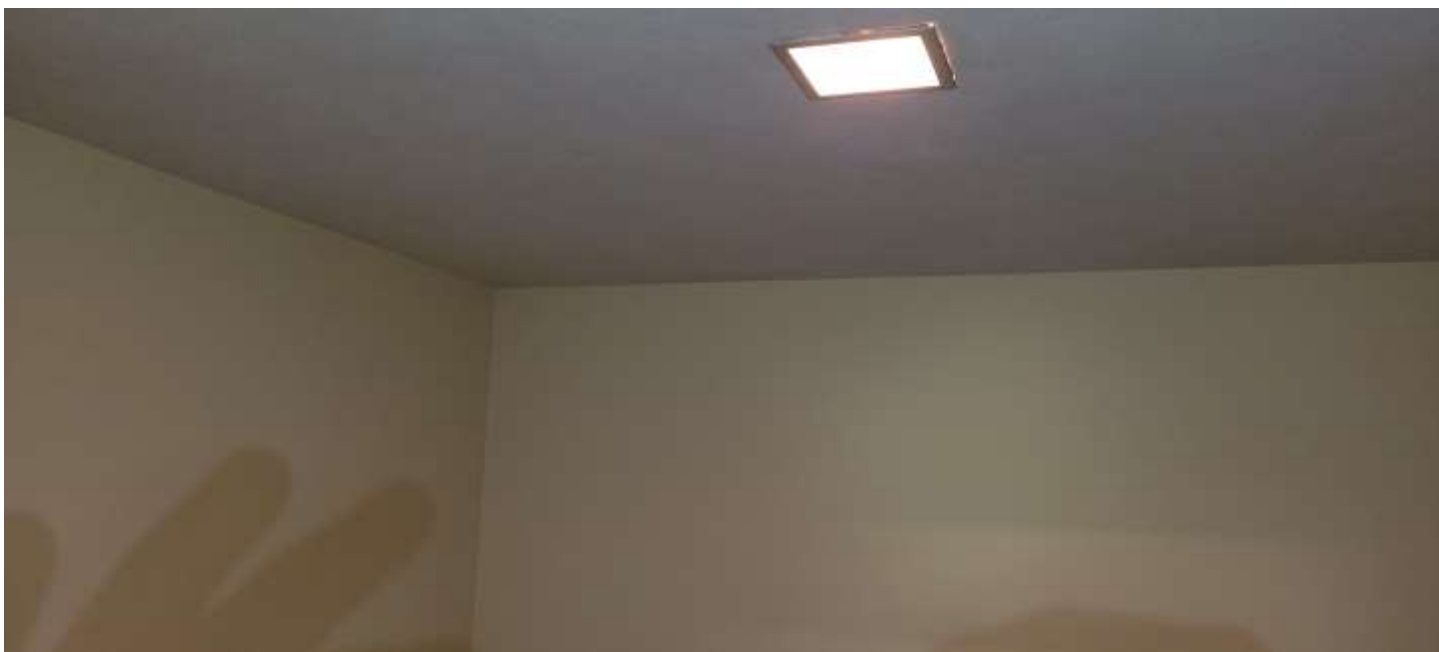
Upper corners generally are clean and dry, and show no signs of water ingress. That's good.

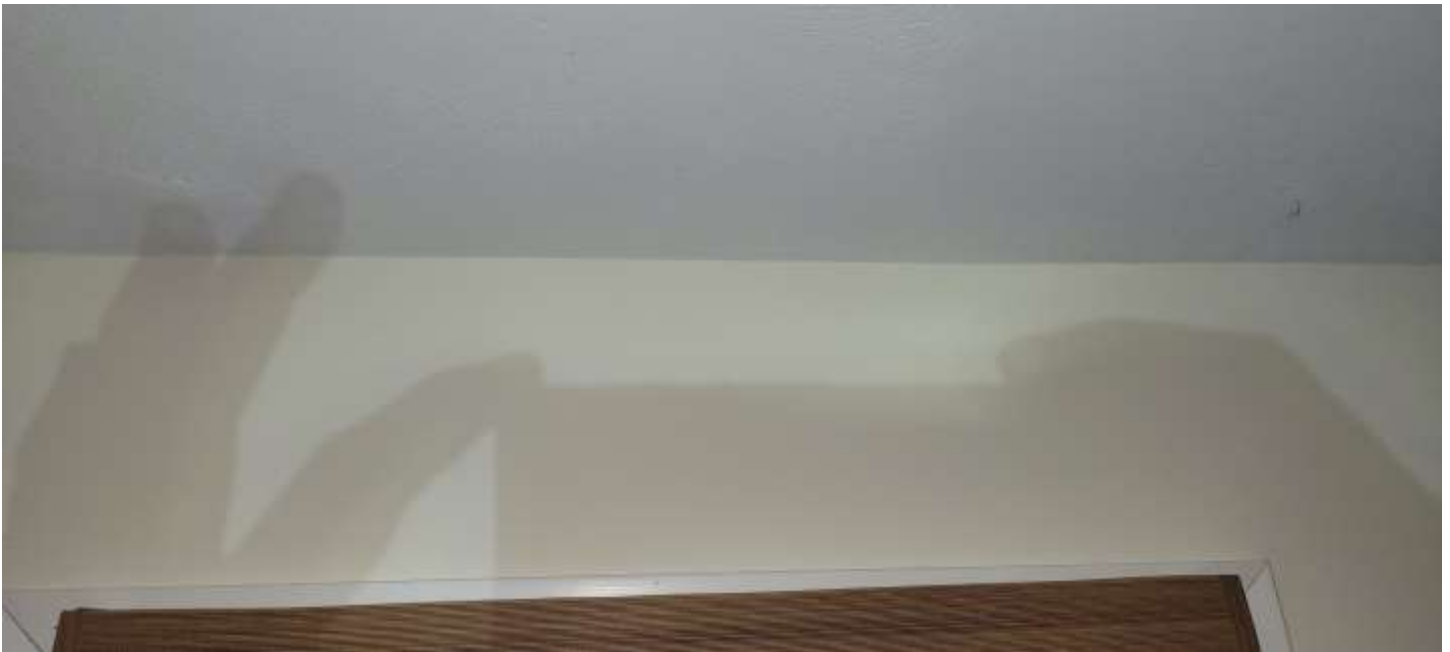
Upper corners generally are clean and dry, and show no signs of water ingress. That's good.

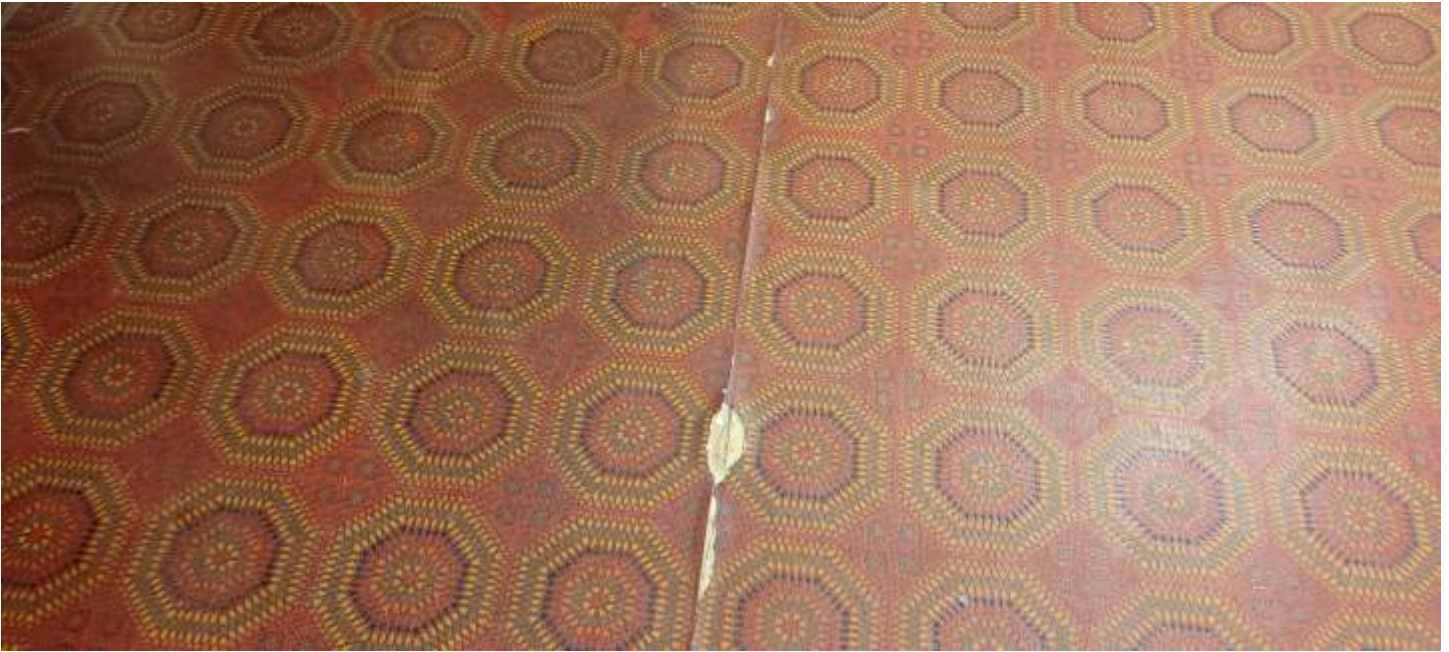
Kitchen floor is ripped.

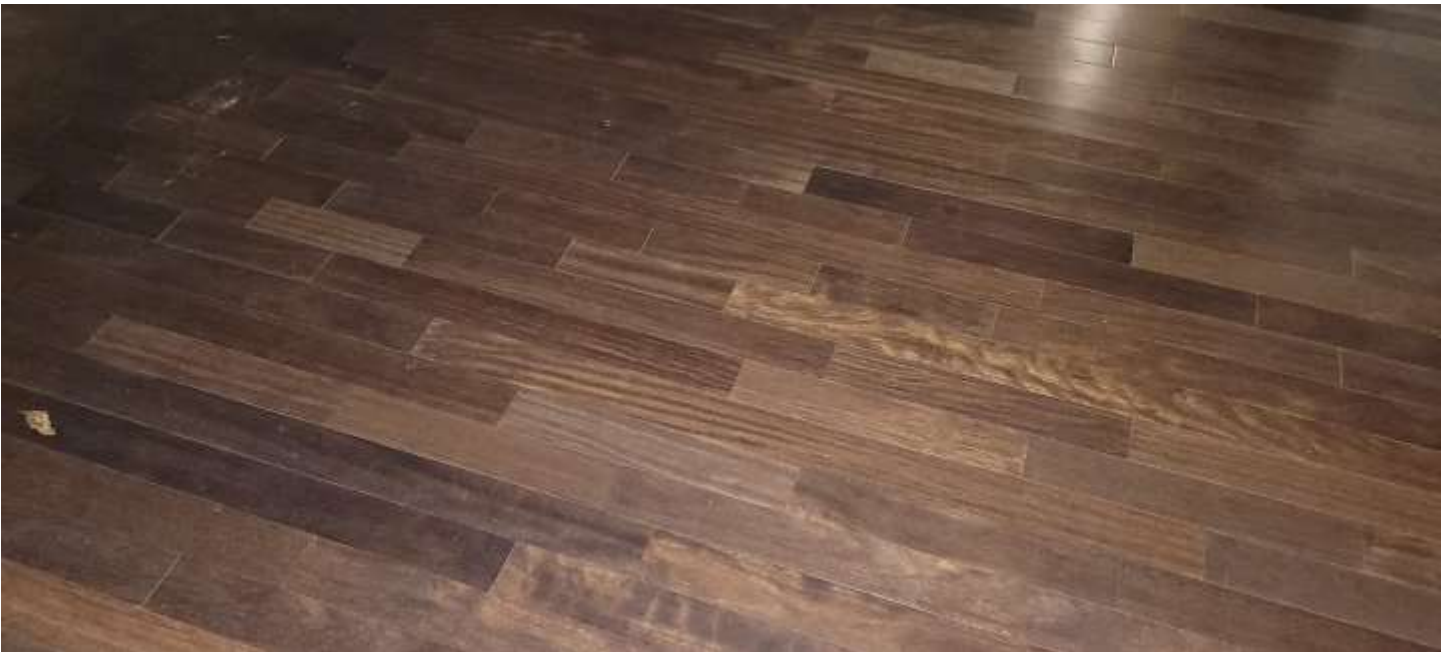
Generally the wood floors were in good condition. I suspect this was some kind of wood floor covering.

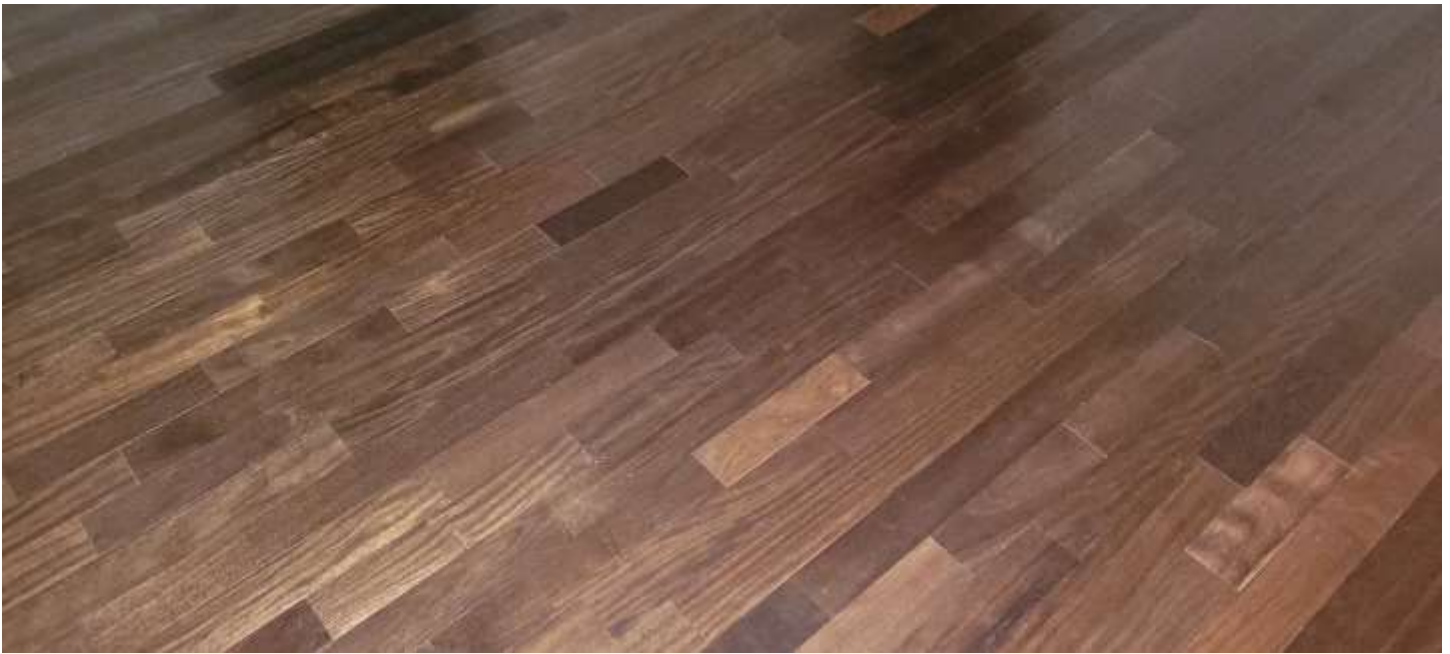
Generally the wood floors were in good condition. I suspect this was some kind of wood floor covering.

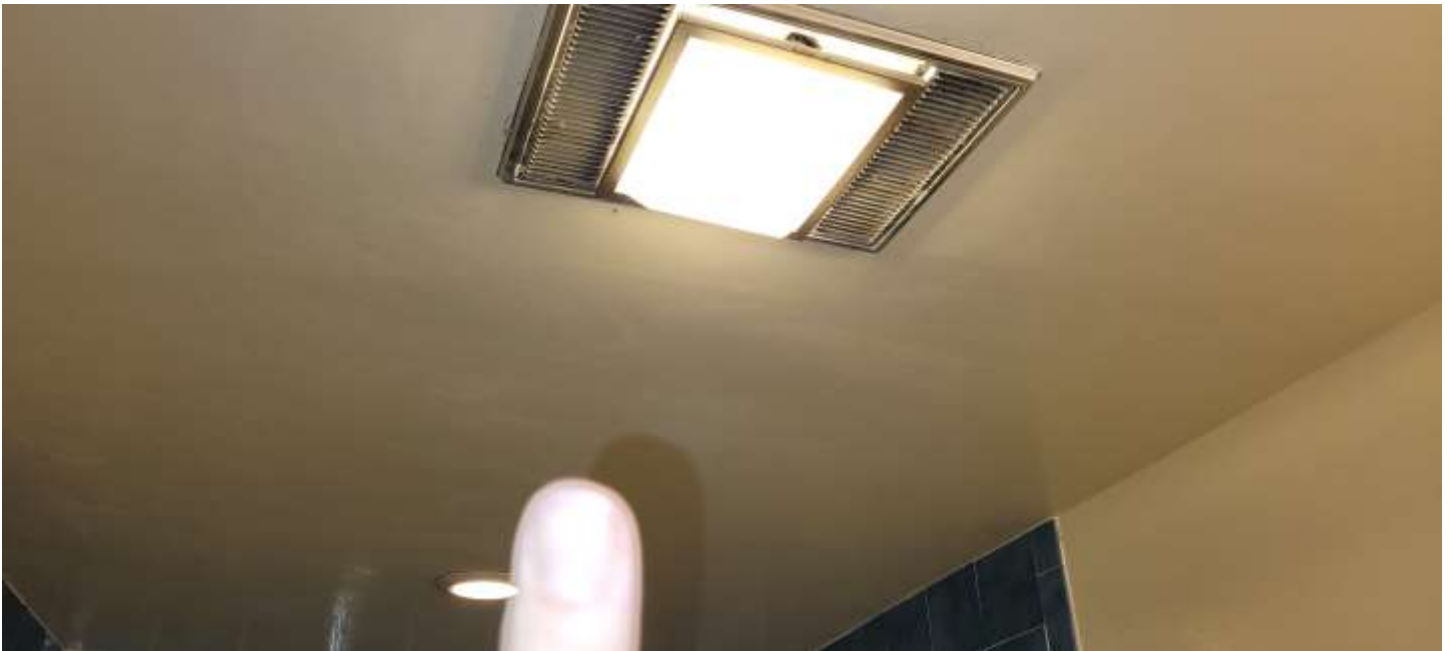
This vent functions.

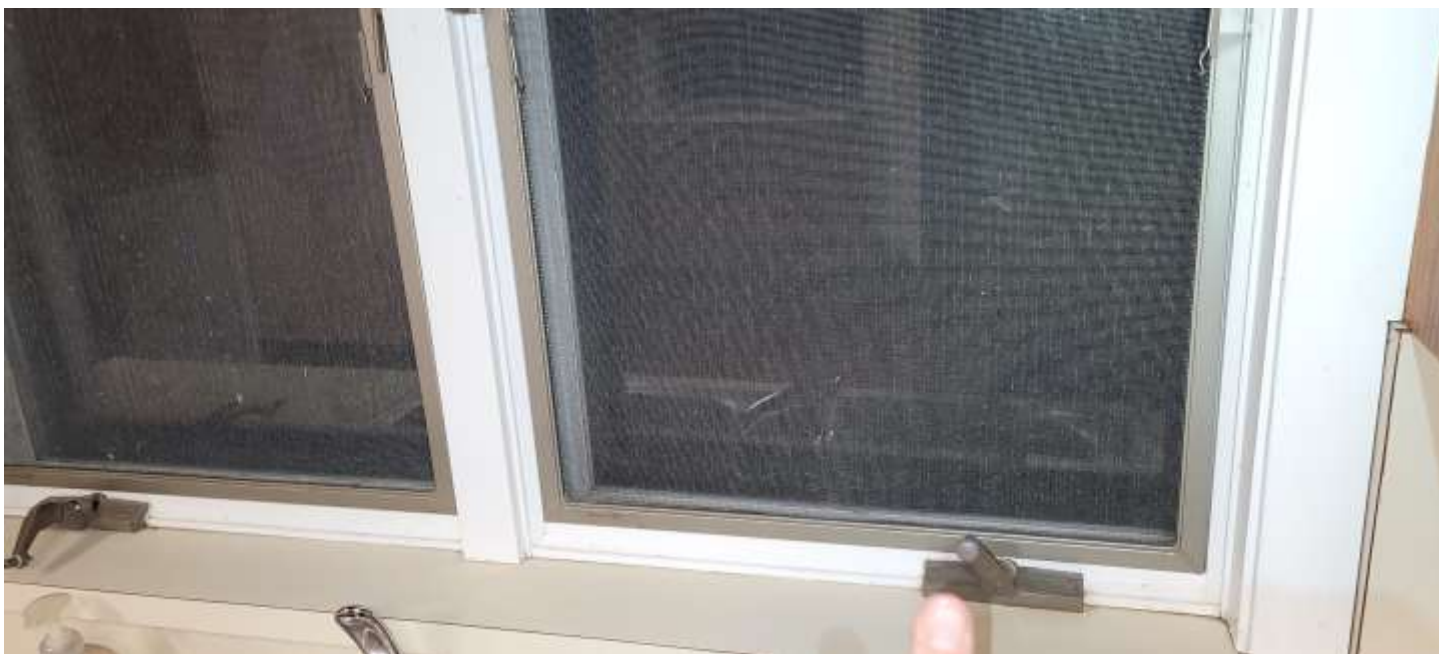
This window functions.

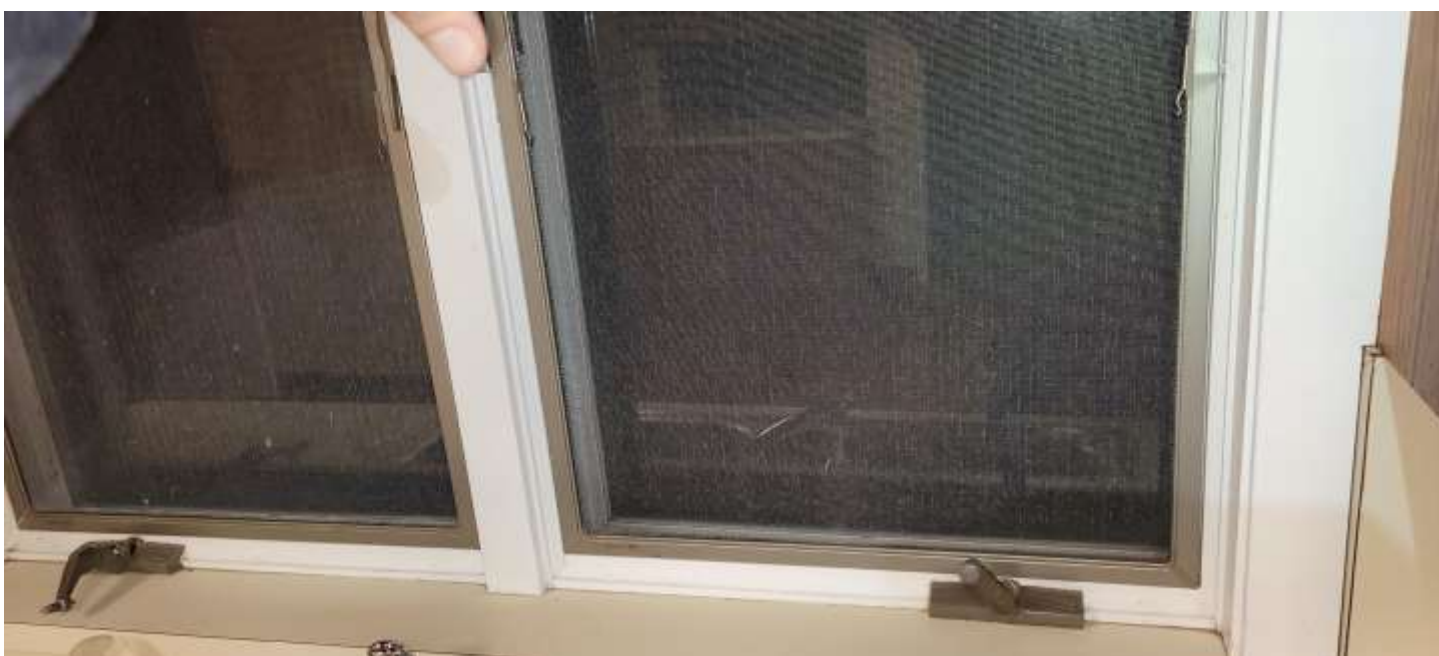
But the lock does not.

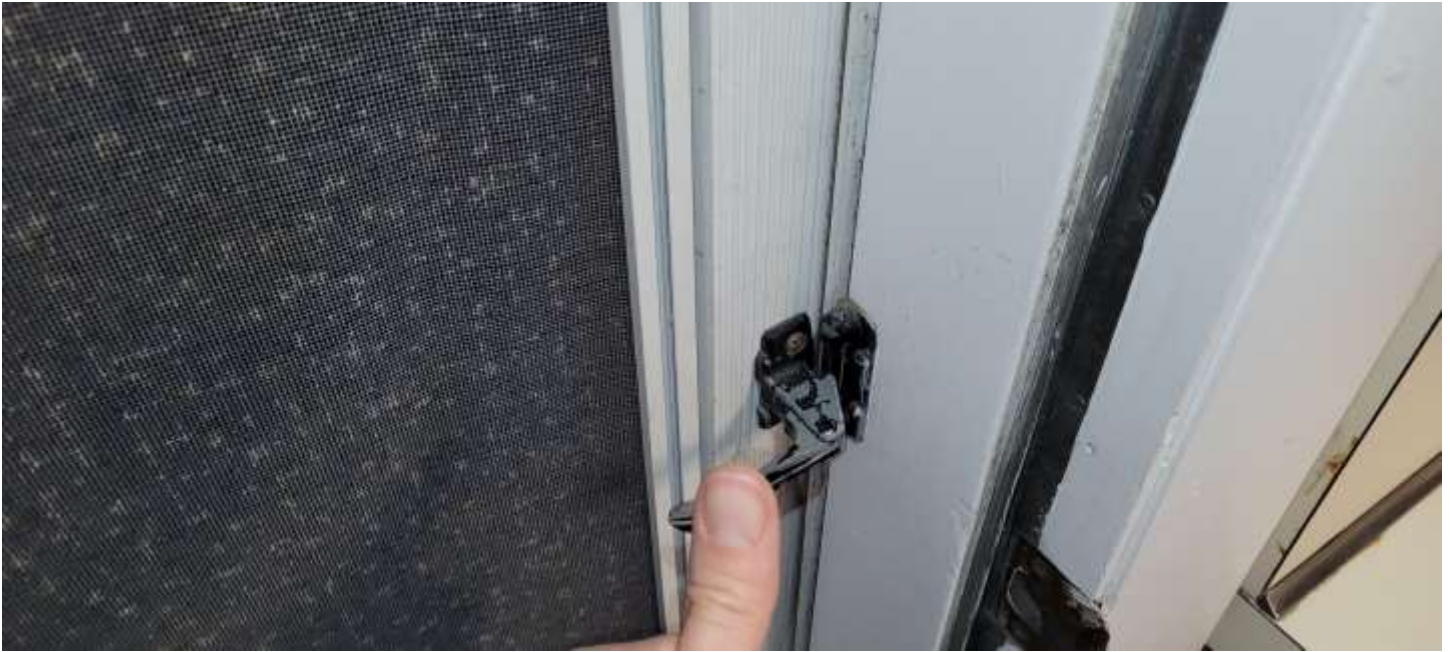
Storm door functions.
