Property: 123 Main Street, Anytown, NY  
Date: 15Jan2021  
Present: Louis Csak, insp.; ####, buyer; ### agent.  
Conditions: 40's, overcast

**Executive summary:** (details in report)

The house was not well maintained, and the garage foundation is beginning to show serious issues, and very likely there is a regular water occurrence that will eventually affect the main foundation badly.

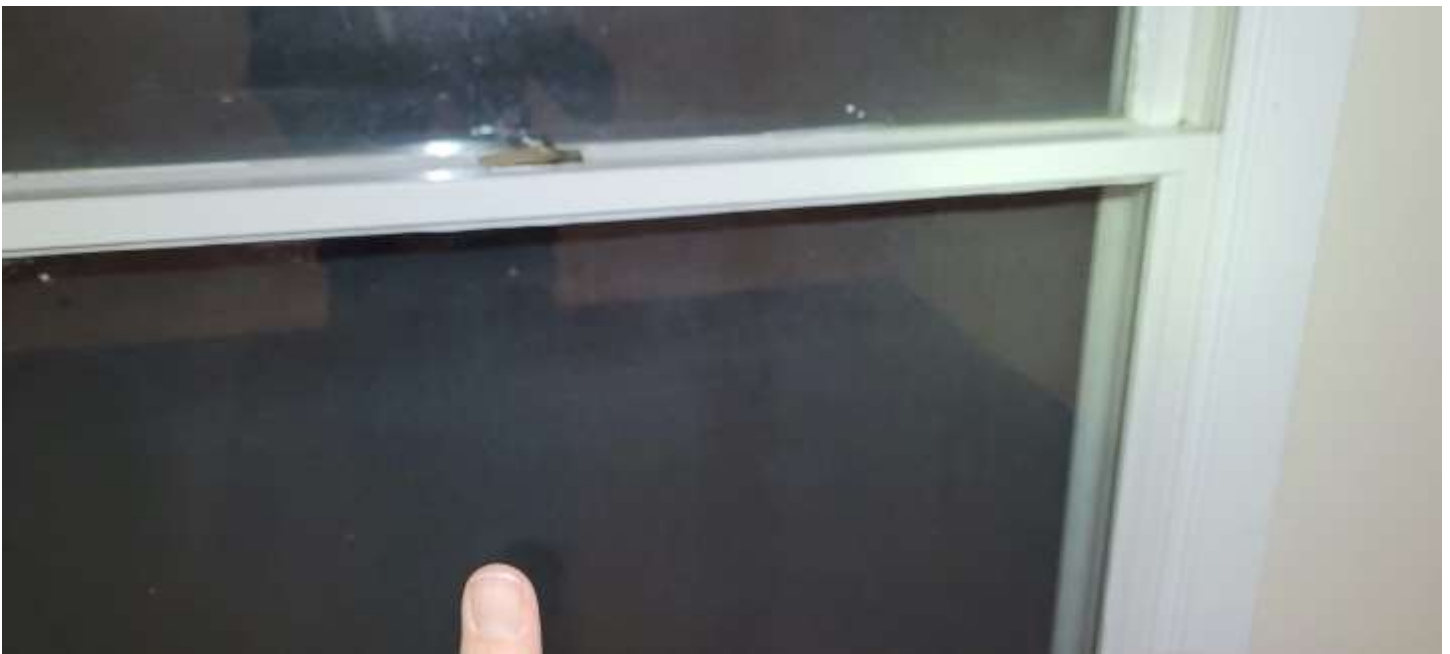
This window functions properly.

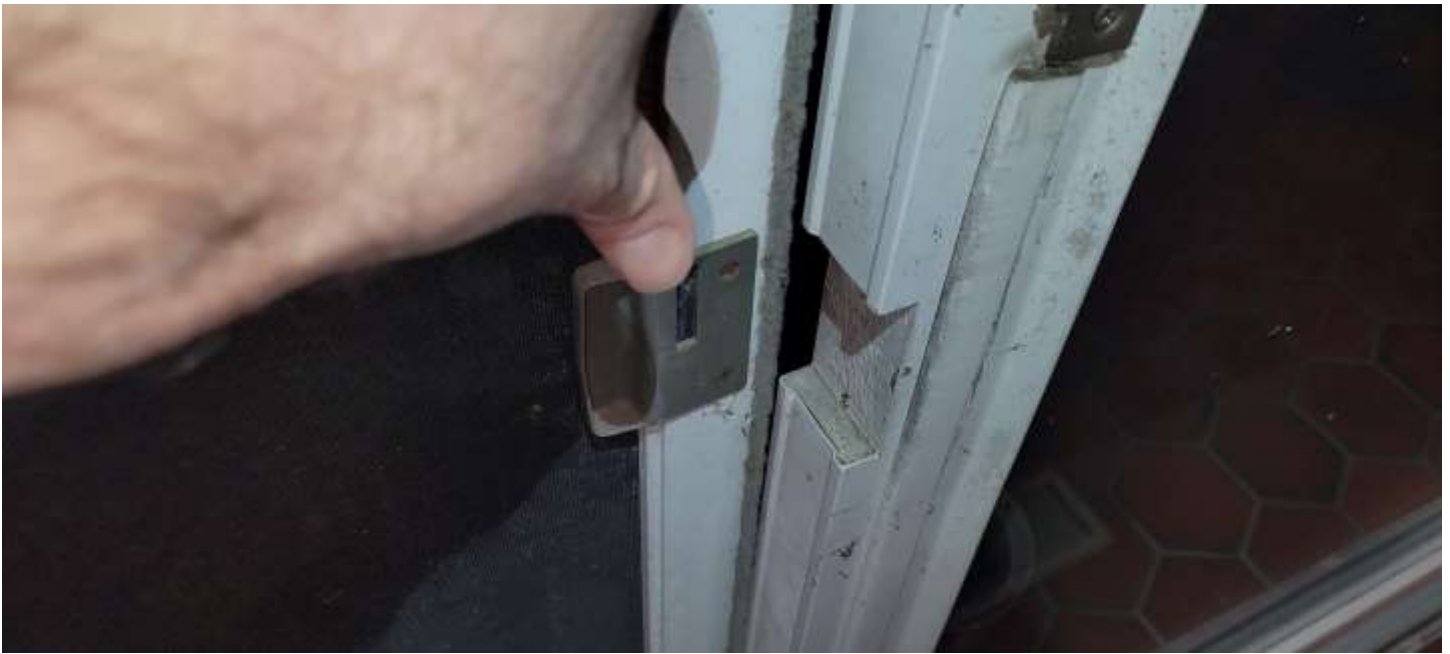
The lock from this screen door is missing.

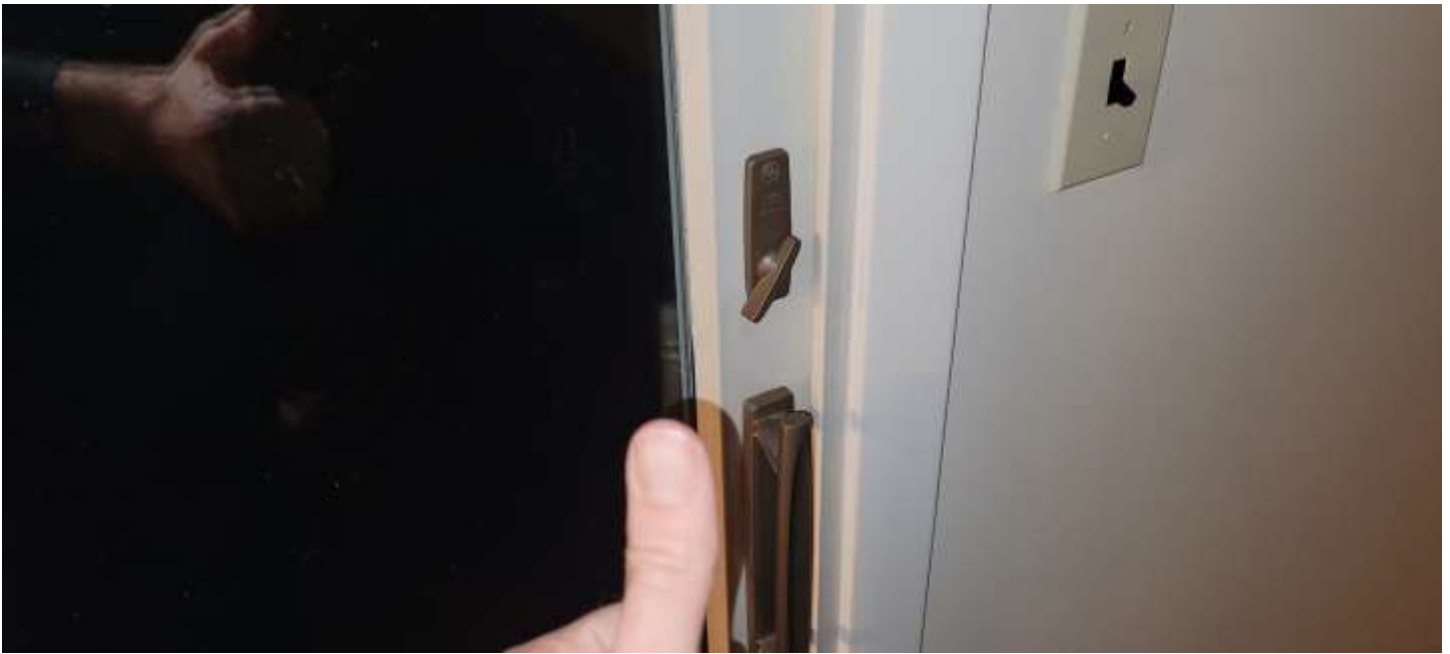
This lock also functions.

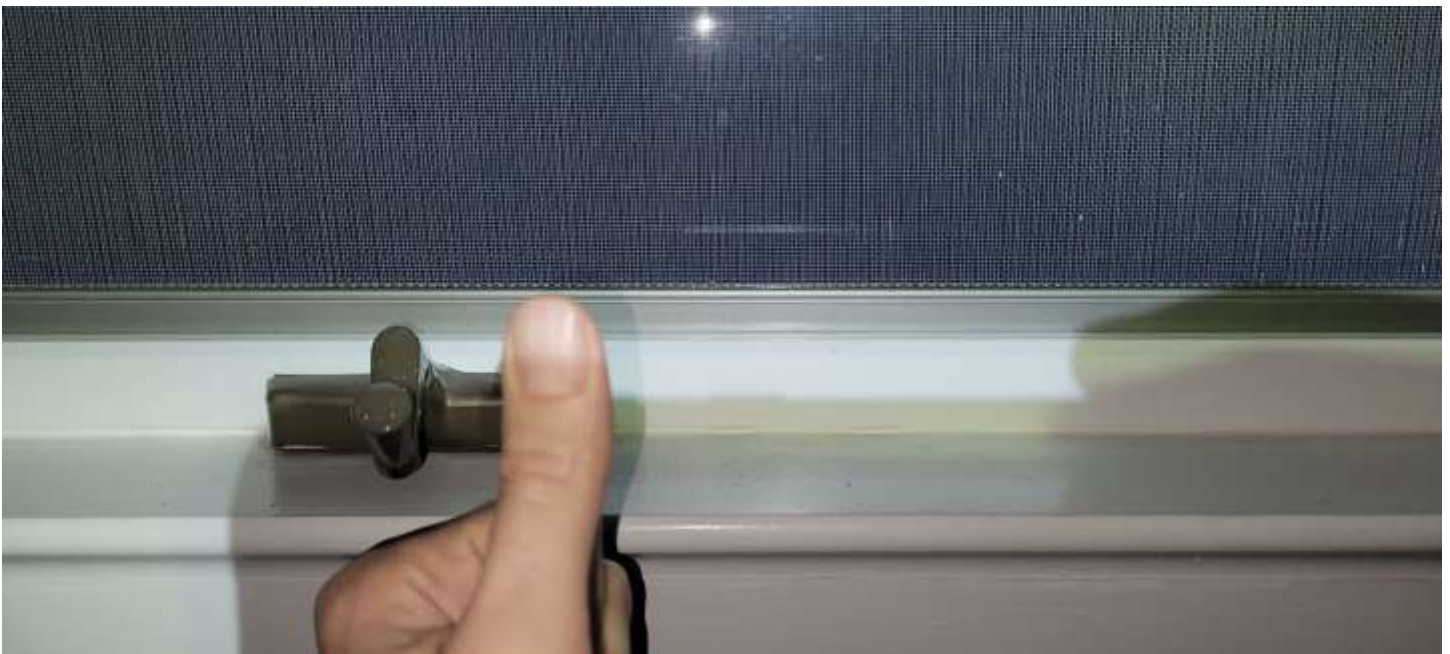
This window functions.

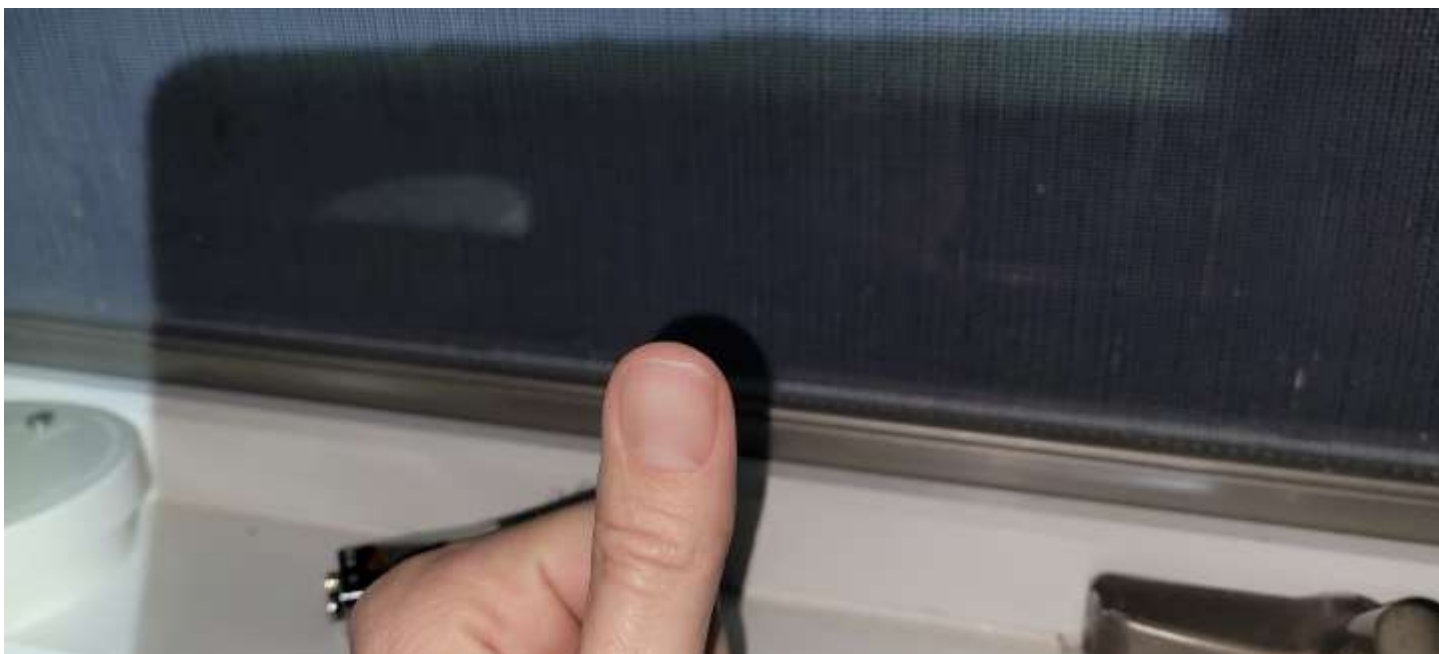
This window functions.

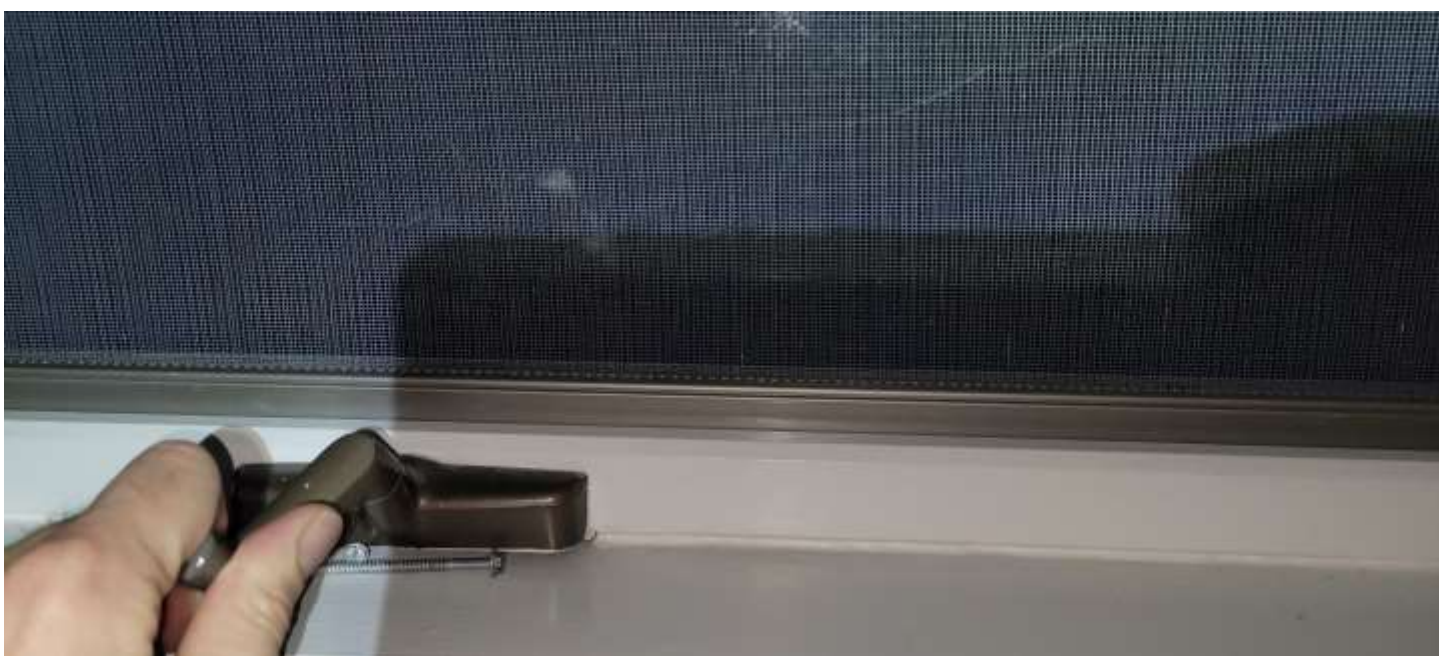
This window functions.

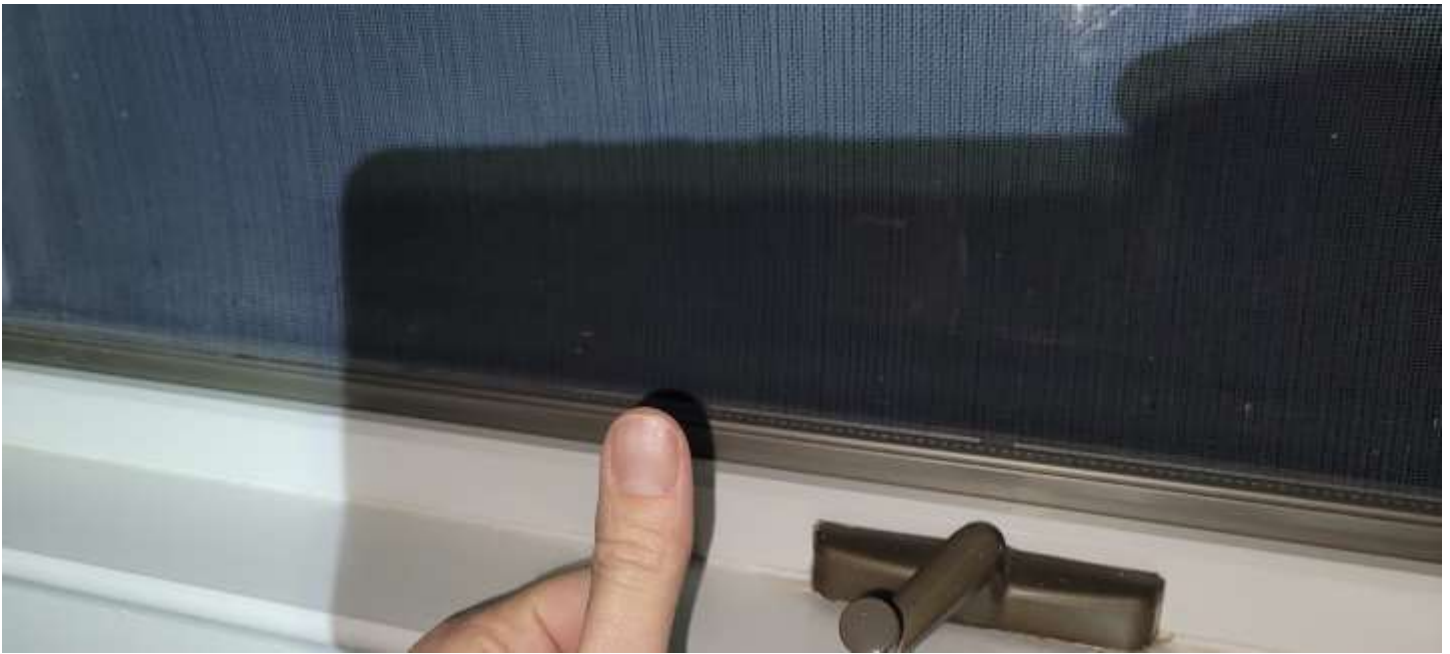
This window functions.

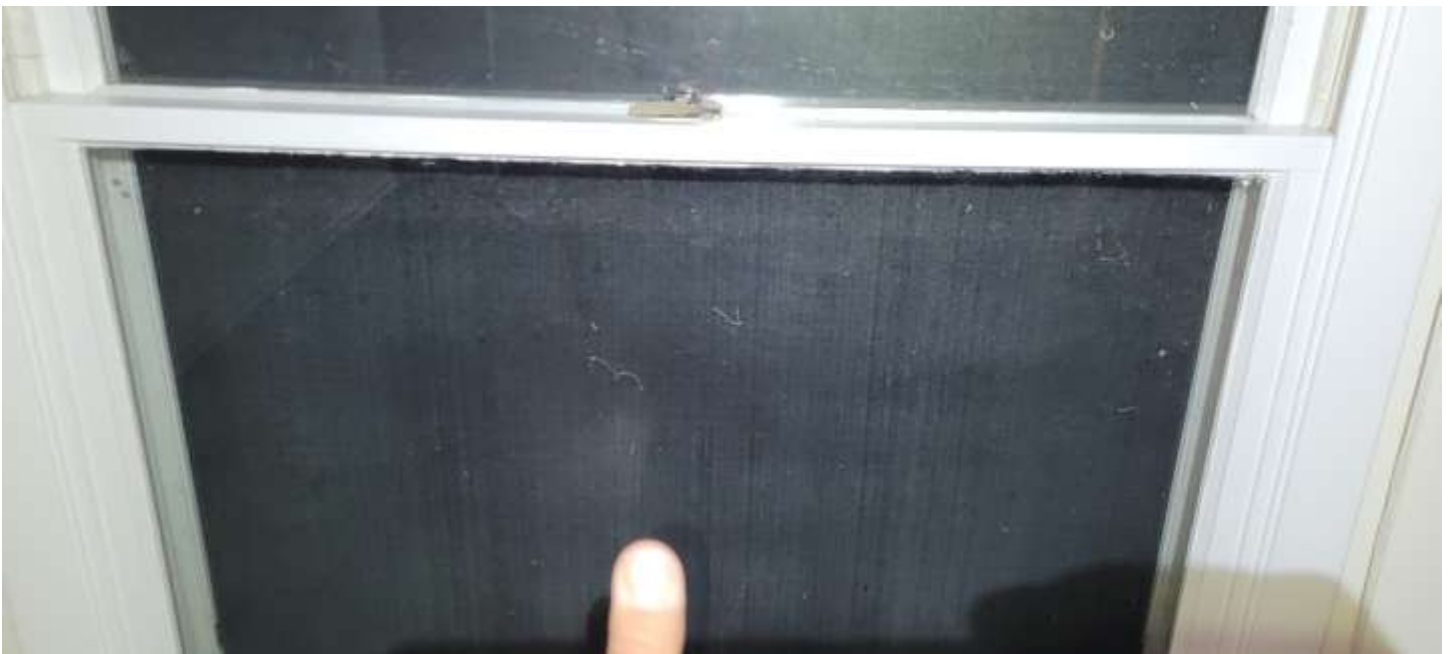
This window functions.

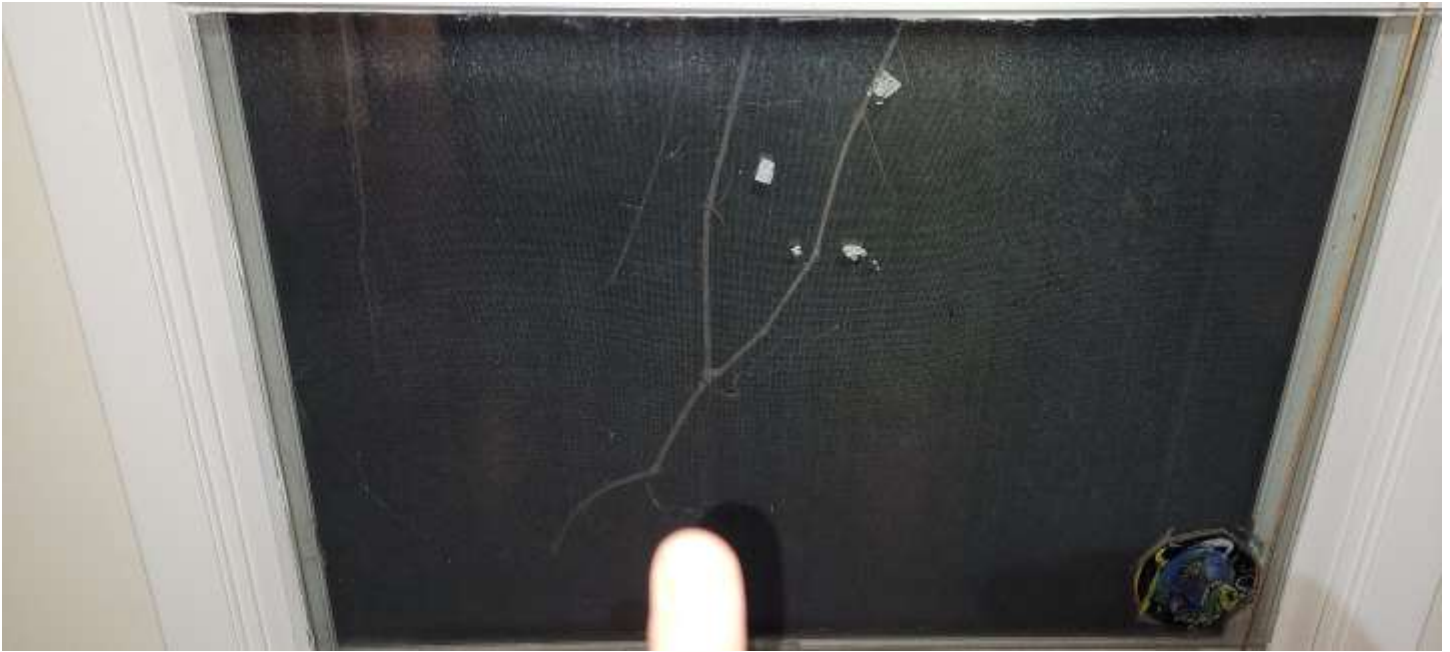
This window functions.

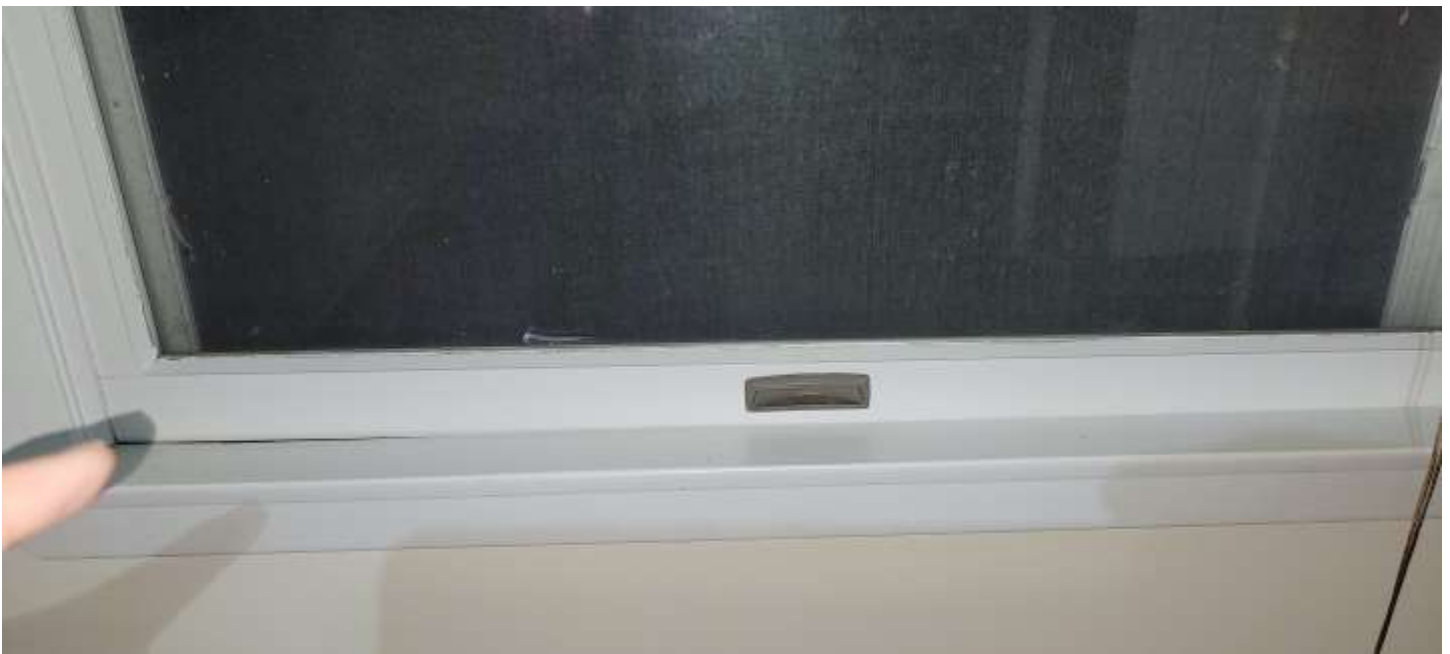
This window functions.

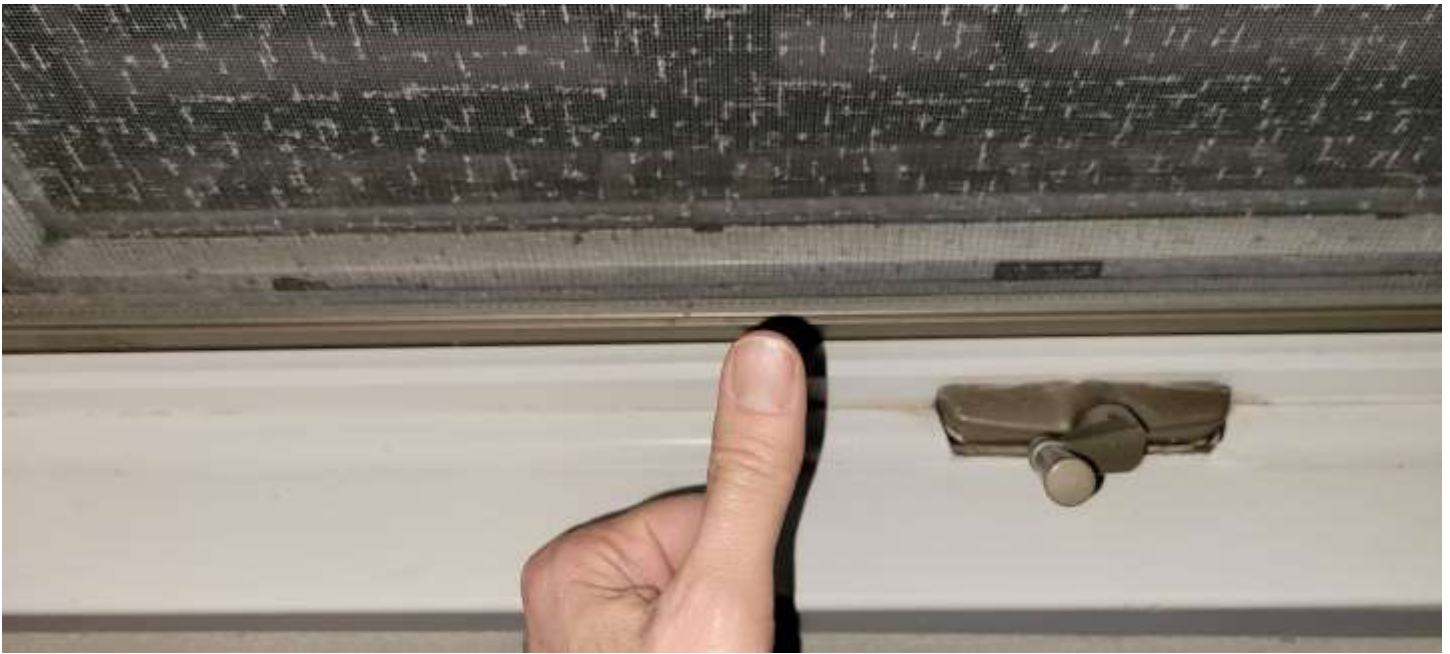
This window functions.

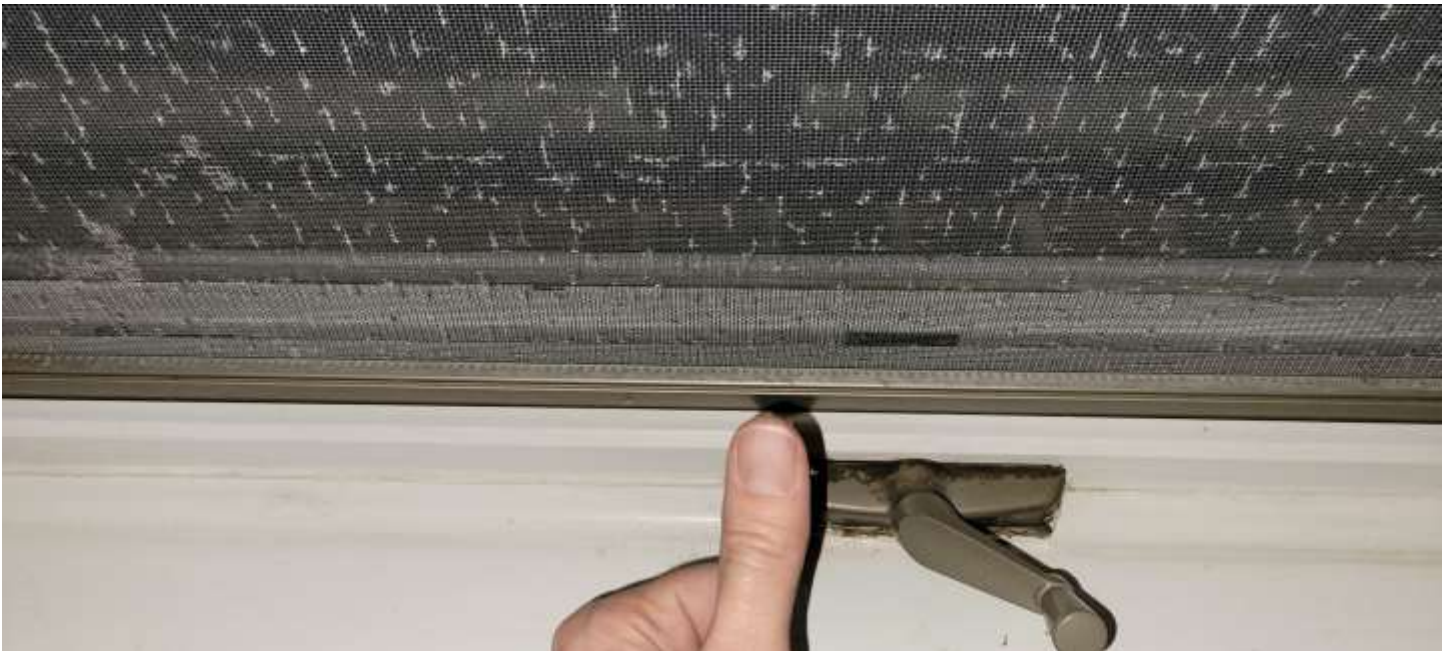
This window functions.

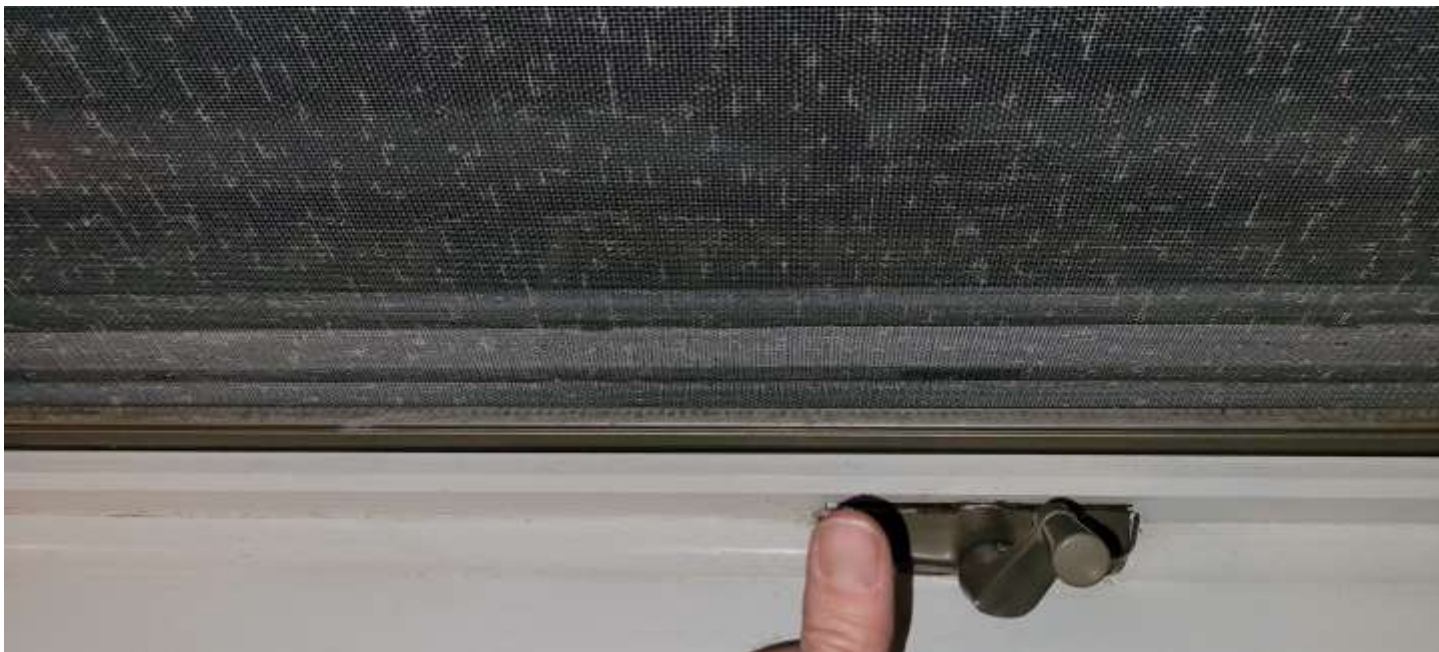
This window functions.

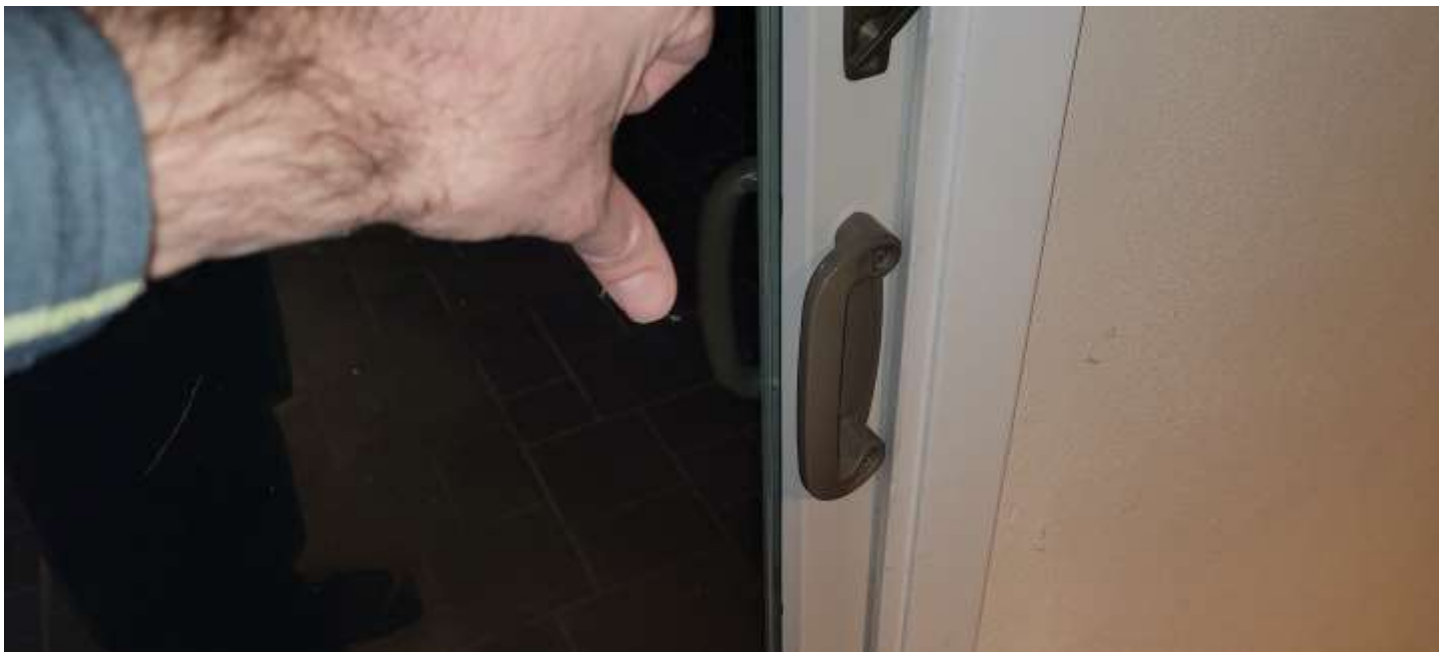
This lock does not function, this door is sealed shut.

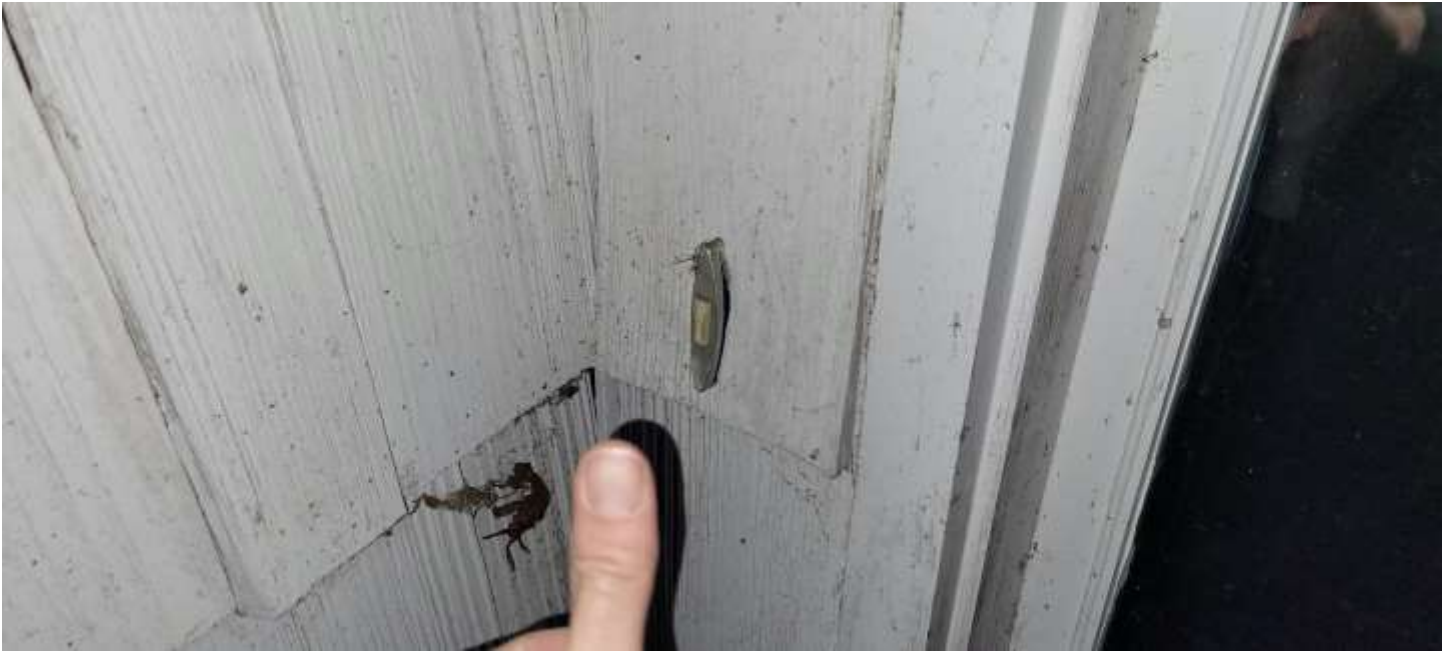
Doorbell functions.

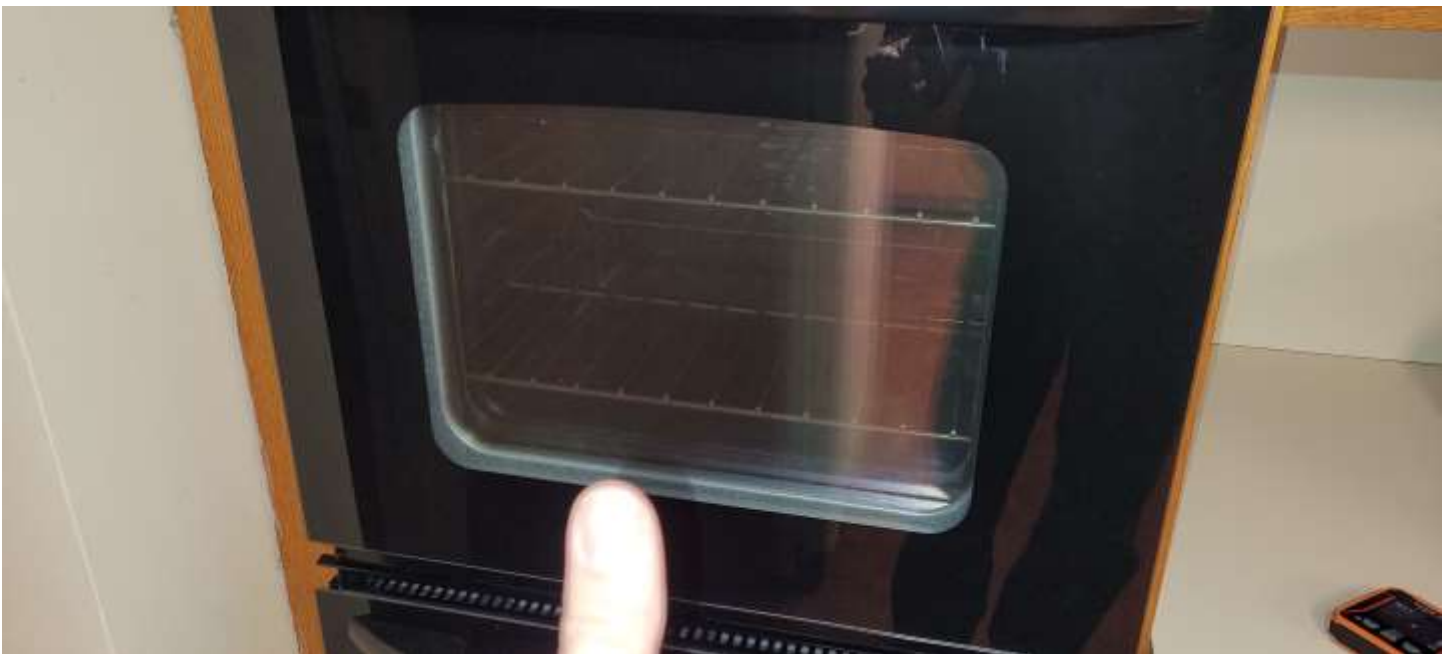
Upper oven functions.

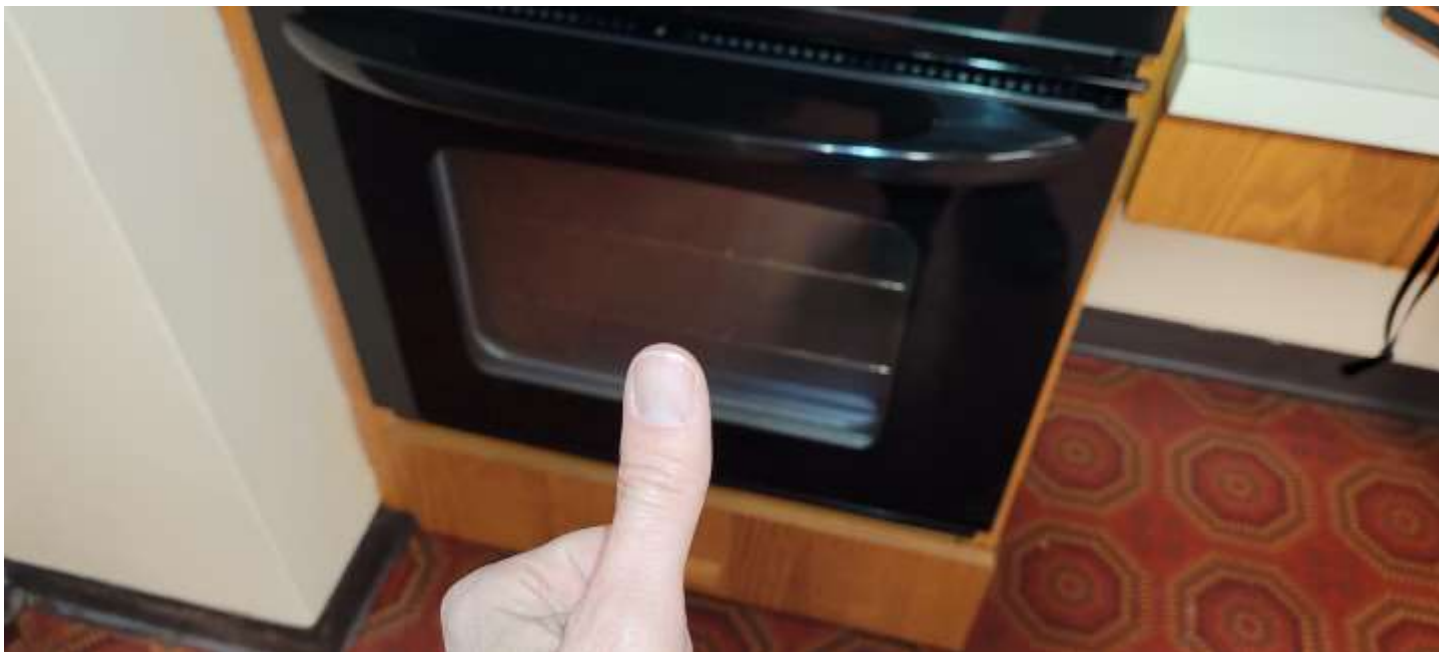
Lower oven functions.

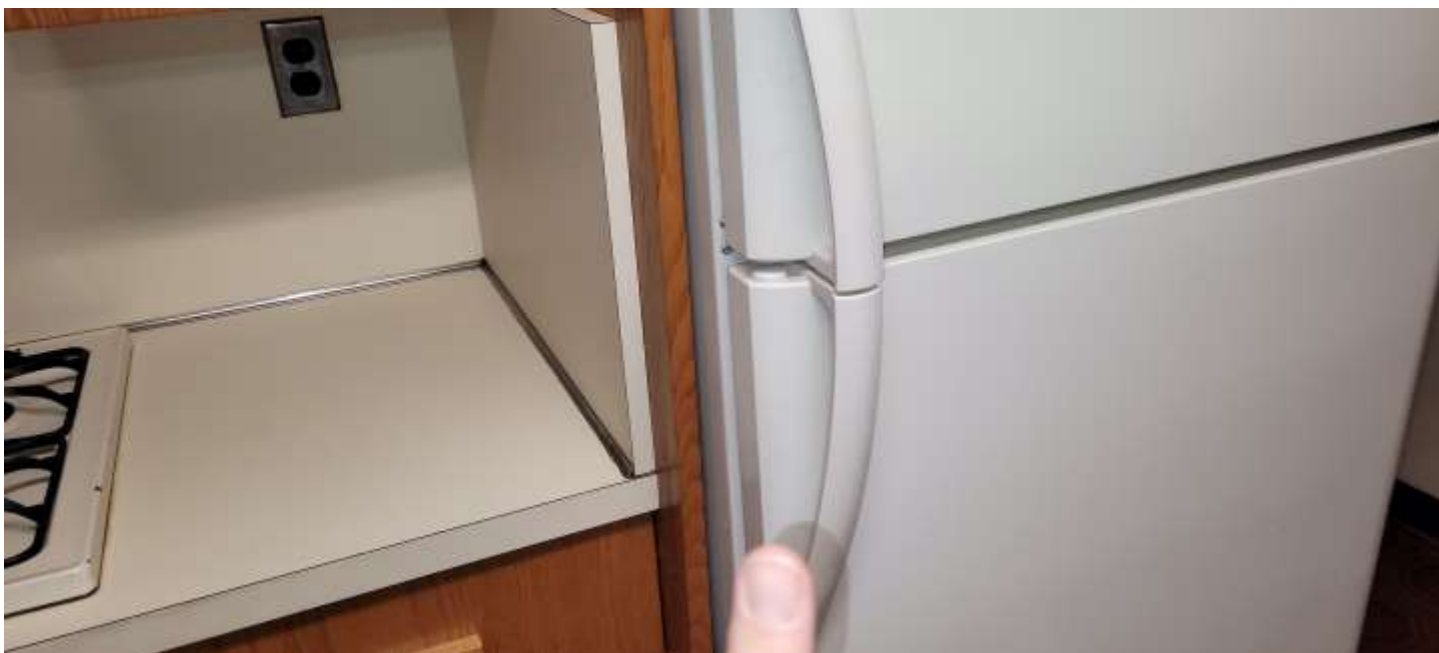
Refrigerator functions.

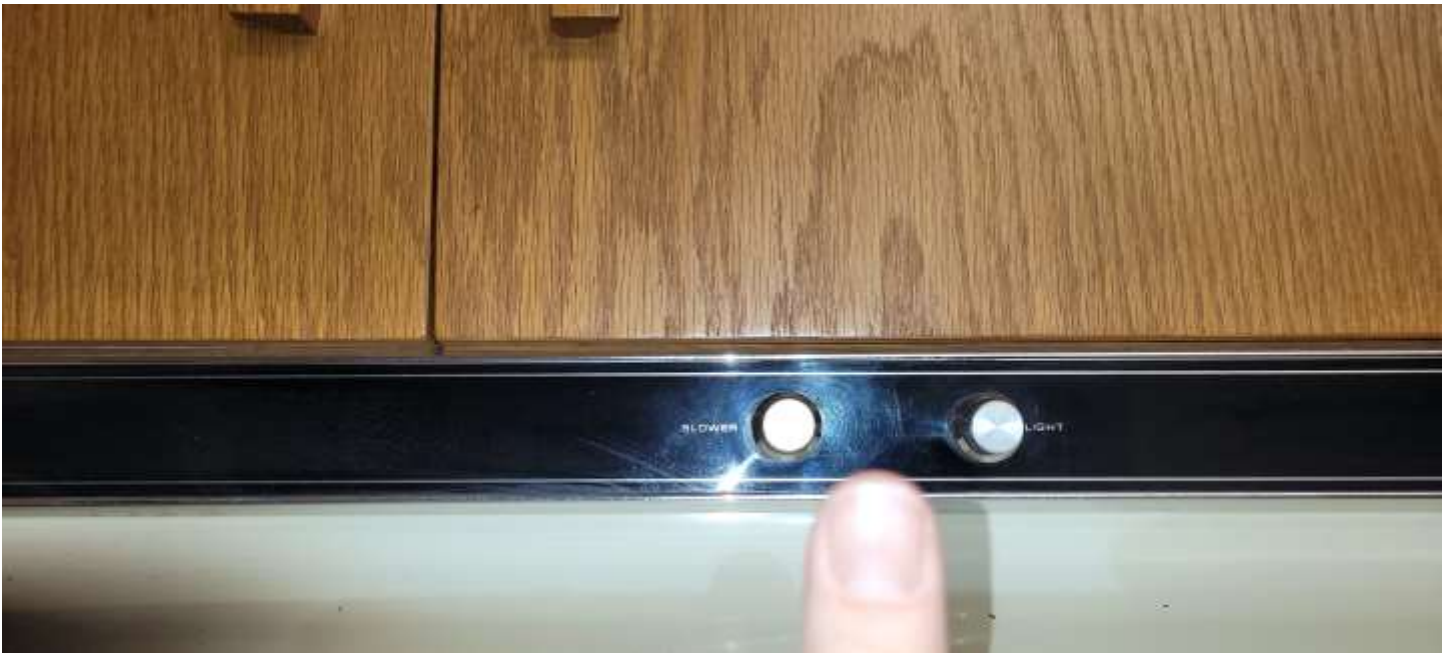
Oven and range hood vent and light function.

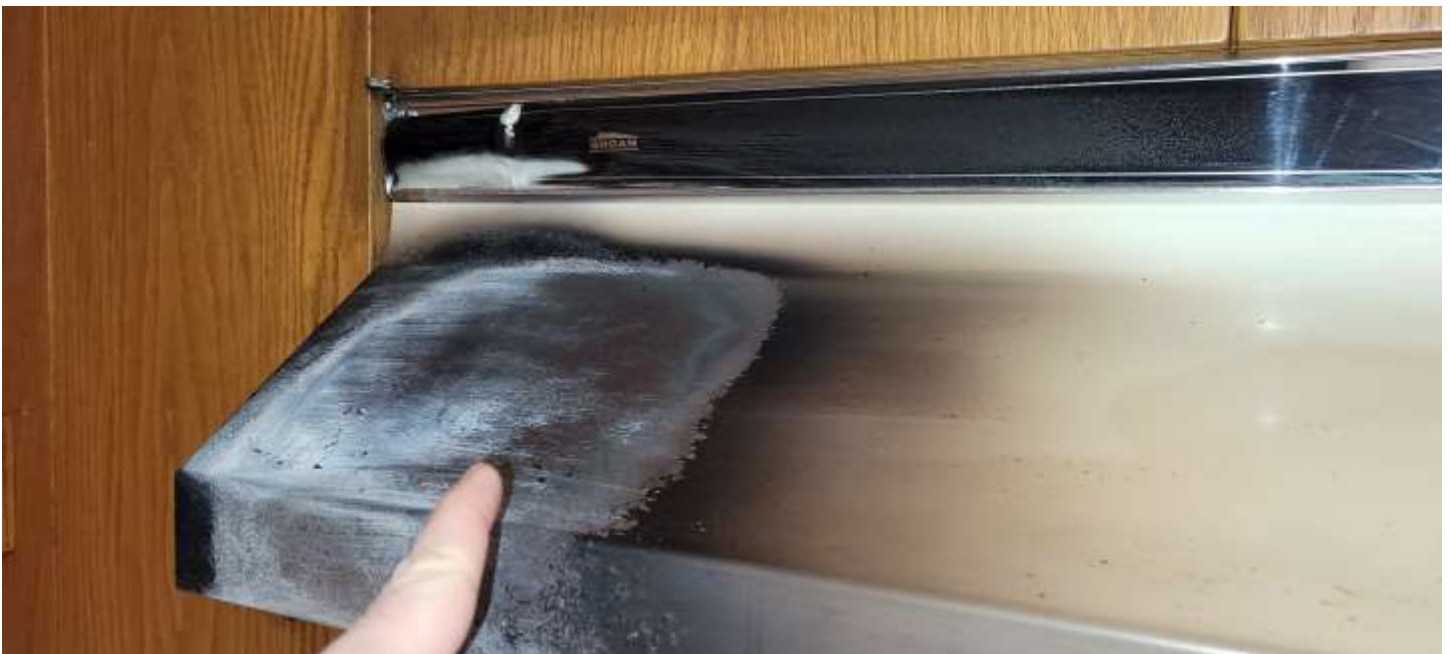
Notice the burns on this hood vent. I suspect this is strongly correlated to the smoke stains on the ceiling about 3 feet away.

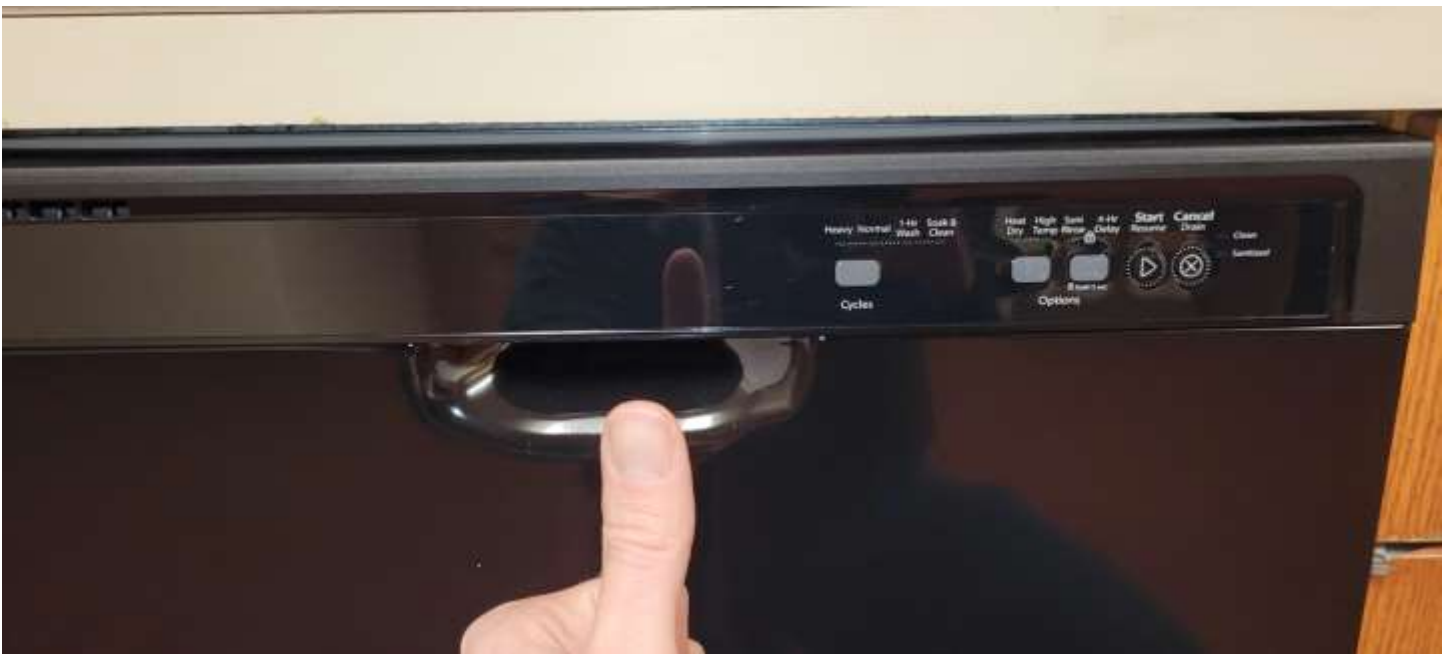
Dishwasher powered up.

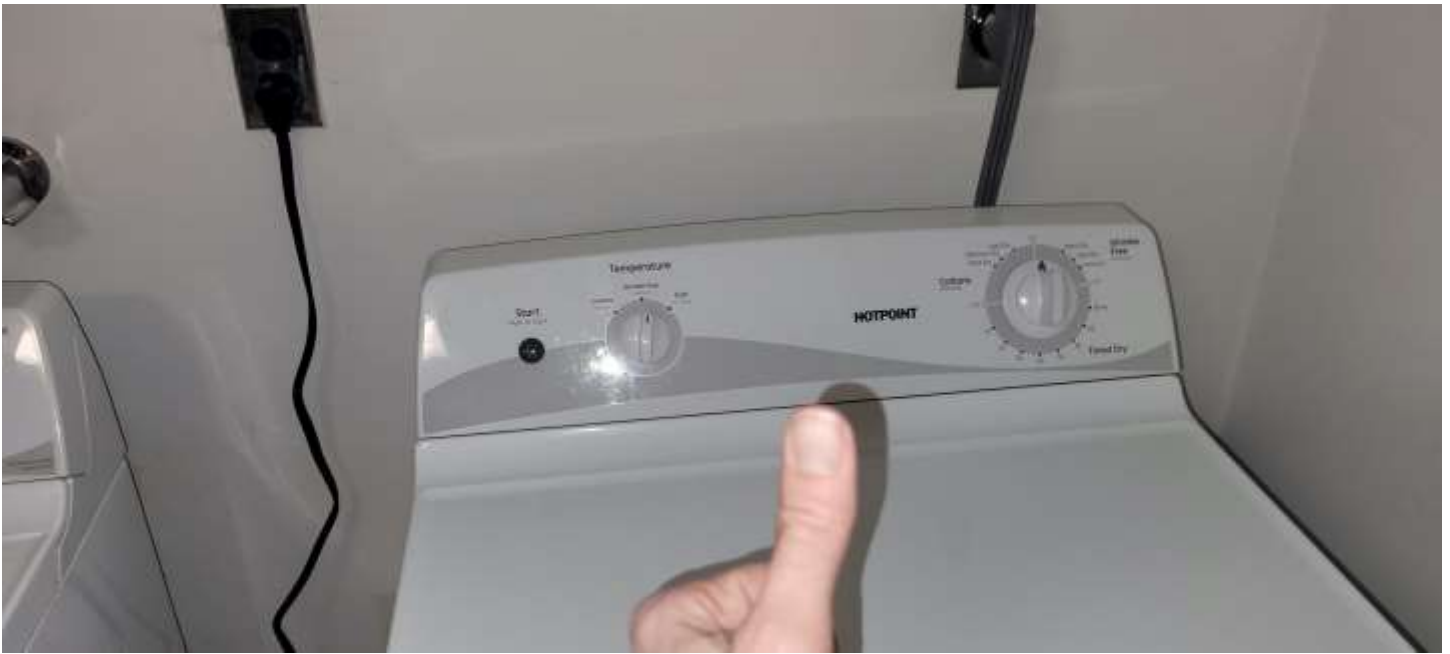
Laundry washer and dryer both powered up.

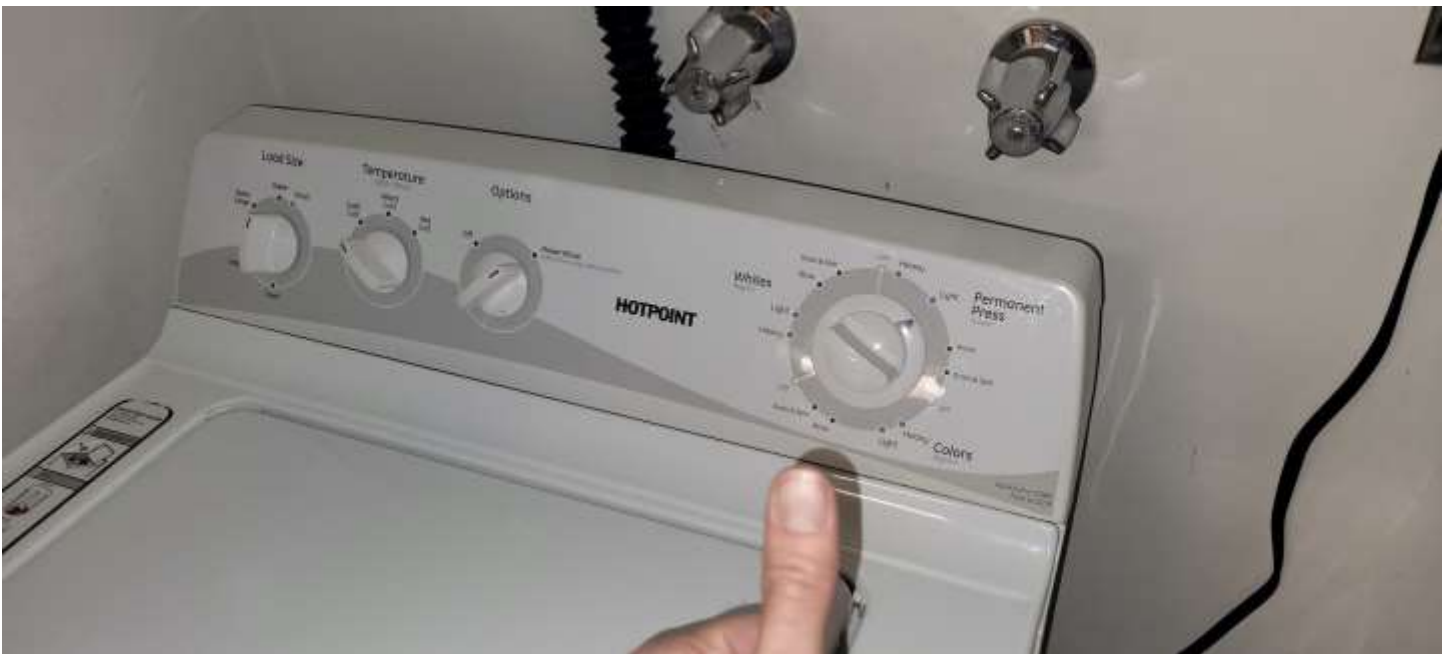
Laundry washer and dryer both powered up.

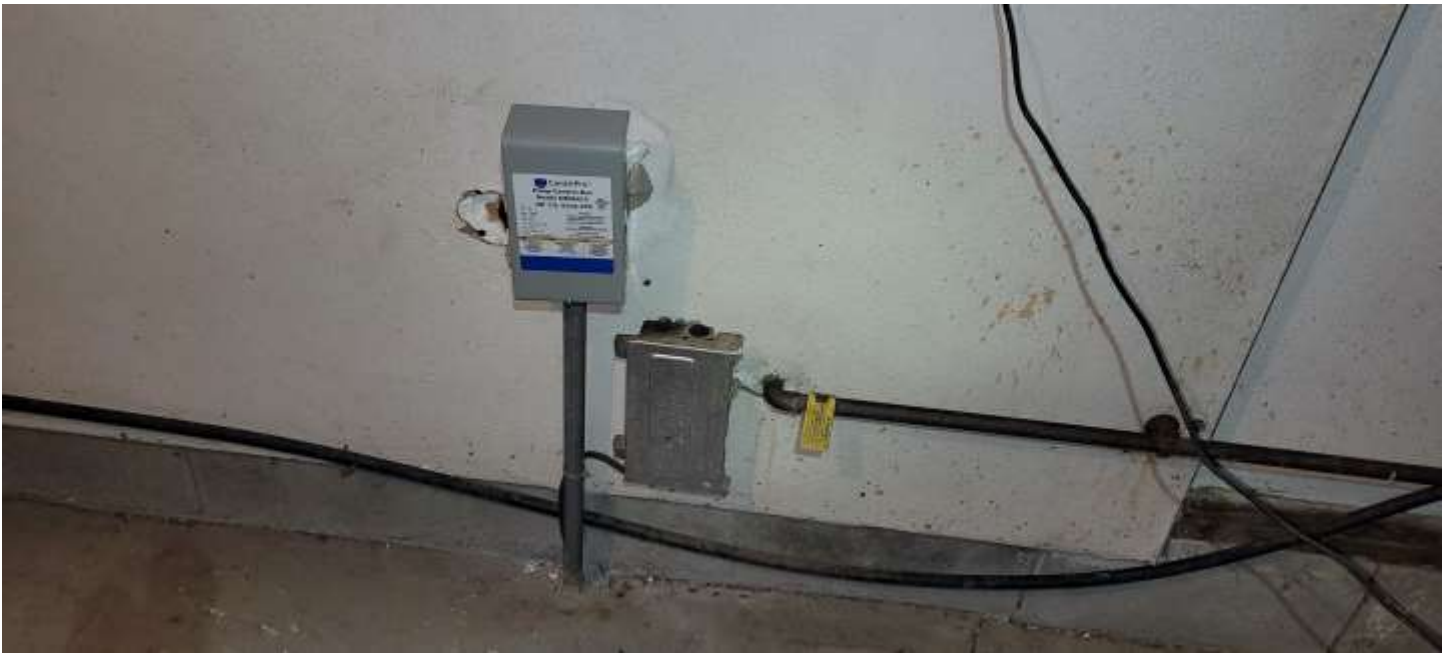
This appears to be a remote controlled sprinkler setup.
