Property: 123 Main Street, Anytown, NY  
Date: 15Jan2021  
Present: Louis Csak, insp.; ####, buyer; ### agent.  
Conditions: 40's, overcast

**Executive summary:** (details in report)

The house was not well maintained, and the garage foundation is beginning to show serious issues, and very likely there is a regular water occurrence that will eventually affect the main foundation badly.

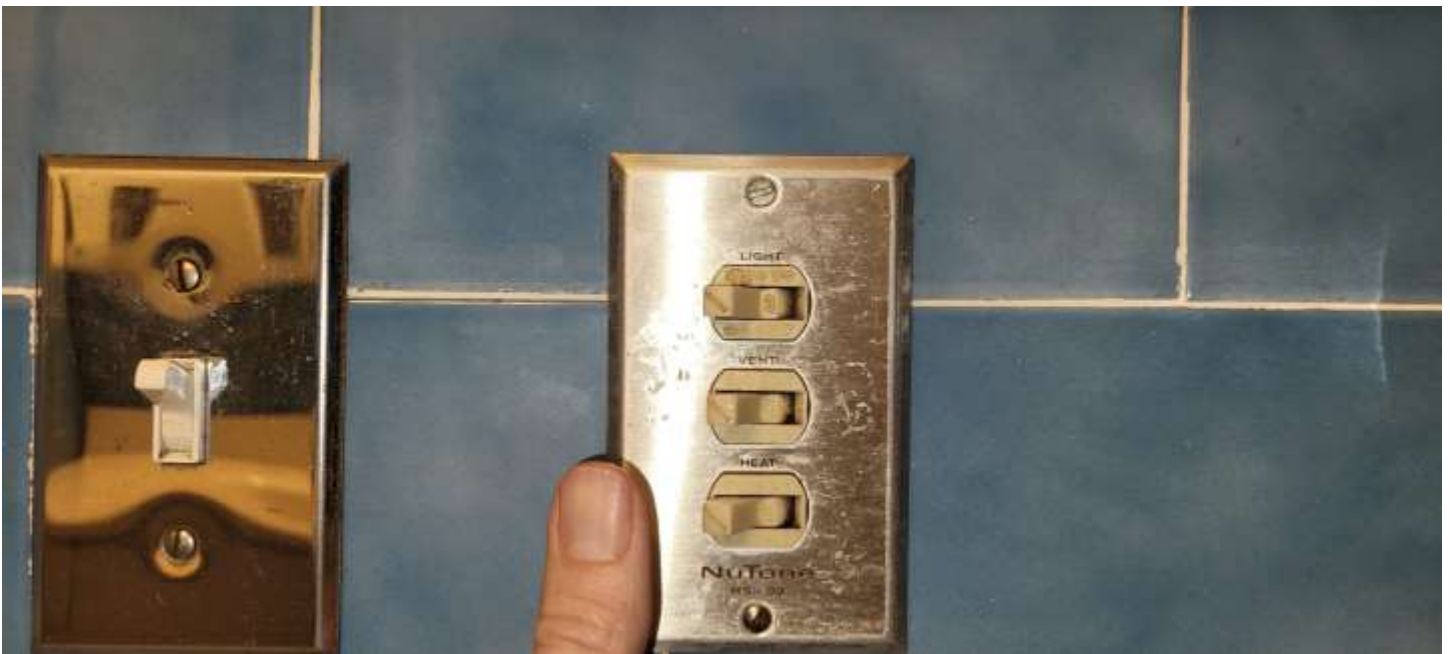
Master bathroom vent light vent and heated light seemed to function.
